**AVIATION INVESTIGATION REPORT
A10A0056**

CONTROLLED FLIGHT INTO TERRAIN

**NORTH WIND AVIATION LTD.
PIPER NAVAJO PA31-350 C-FZSD
CARTWRIGHT, NEWFOUNDLAND AND LABRADOR, 60 NM W
26 MAY 2010**

Report Number A10A0056

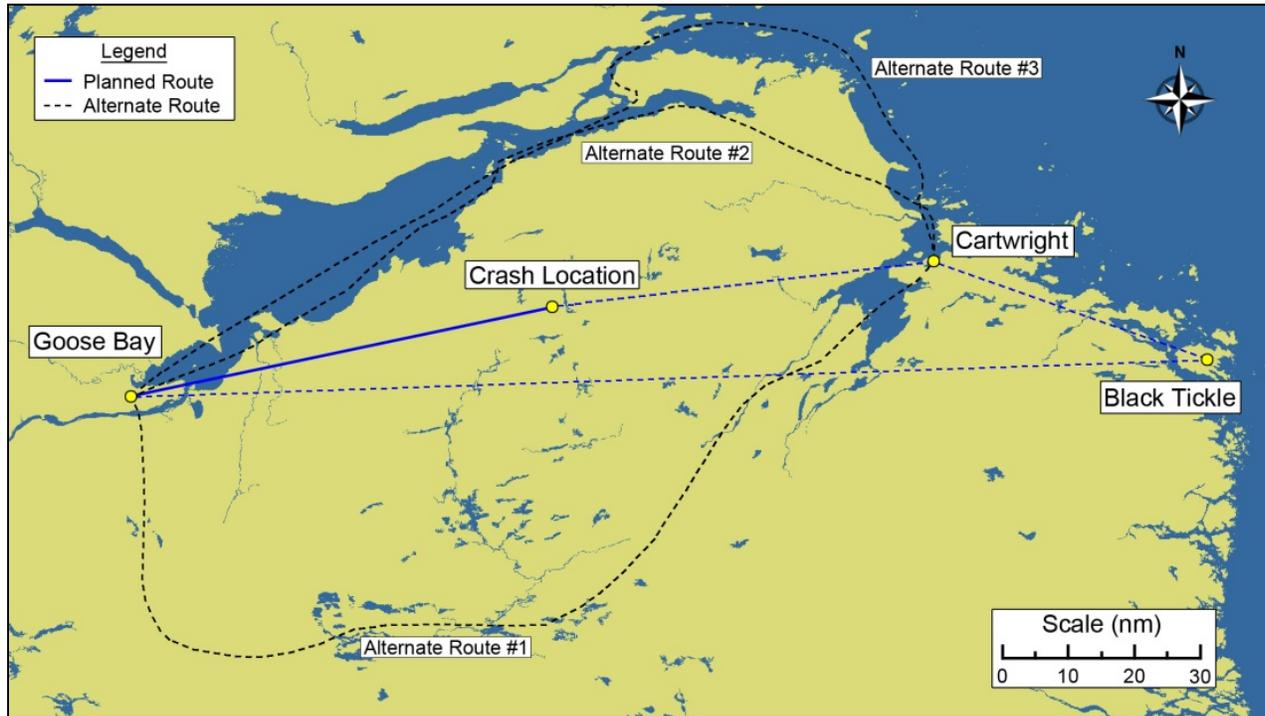
Figure 1. Route map

The most common route from Goose Bay to Cartwright is direct. However, weather conditions may require flying around the Mealy Mountains. Pilots who routinely fly the coast of Labrador choose any one of the following alternate routes (see Figure 1):

Alternate Route 1: Follow the Kenamu River Valley until south of the Mealy Mountains, then proceed eastward and follow the Eagle River.

Alternate Route 2: Proceed northeast from Goose Bay along the south shore of Lake Melville to Frenchman Point, then follow the English River to the North River, which can be tracked to the coast.

Alternate Route 3: Fly to Lake Melville and through the Narrows to the coast proceeding down the shoreline to Cartwright.

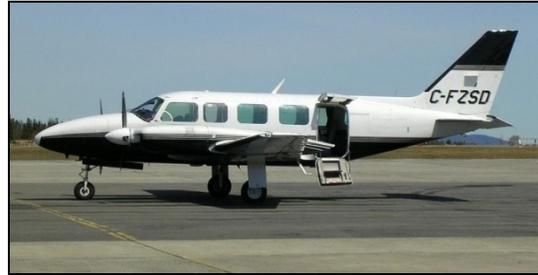
Photo 1. Photo of accident aircraft

The Piper Navajo is a low-wing, twin-engine aircraft with retractable tricycle landing gear (see Photo 1). The aircraft was equipped for instrument flight rules (IFR); however, North Wind Aviation Ltd. was not authorized for this type of operation. A portable global positioning system (GPS) was installed, but was not operating at the time of the accident.
