**AVIATION INVESTIGATION REPORT**  
**A09Q0203**

**CONTROLLED FLIGHT INTO TERRAIN**  
**EXACT AIR INC. BEECH A100 C-GPBA**  
**CHICOUTIMI/SAINT-HONORÉ AIRPORT, QUEBEC,**  
**3 NAUTICAL MILES NW**  
**09 DECEMBER 2009**

Report Number A09Q0203

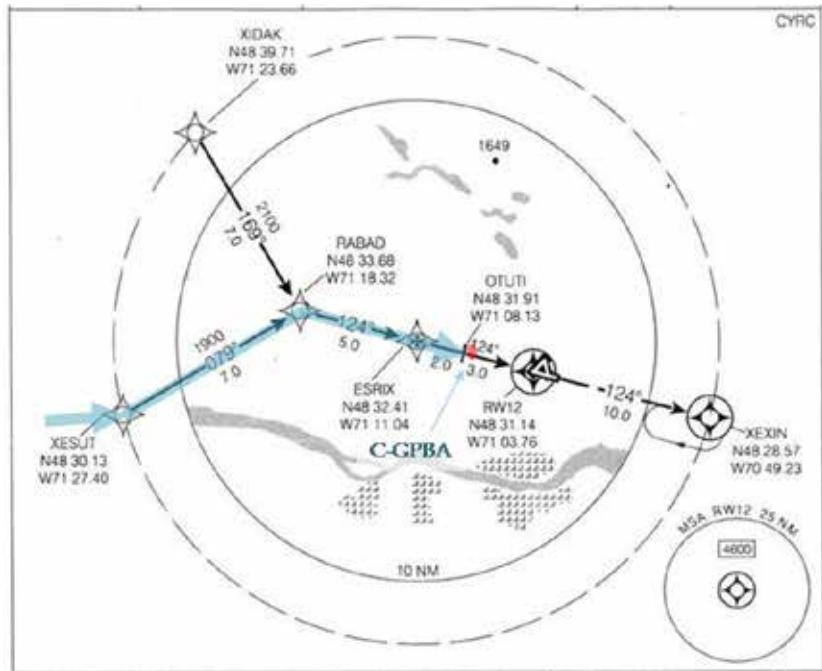
Figure 1. RNAV (GNSS) Runway 12 approach course

The last radar position was recorded at 2249, 0.5 nautical miles (nm) after crossing the ESRIX fix, still at 1100 feet asl, i.e. approximately 600 feet above ground level (agl), at a distance of 4.5 nm from the threshold of Runway 12.

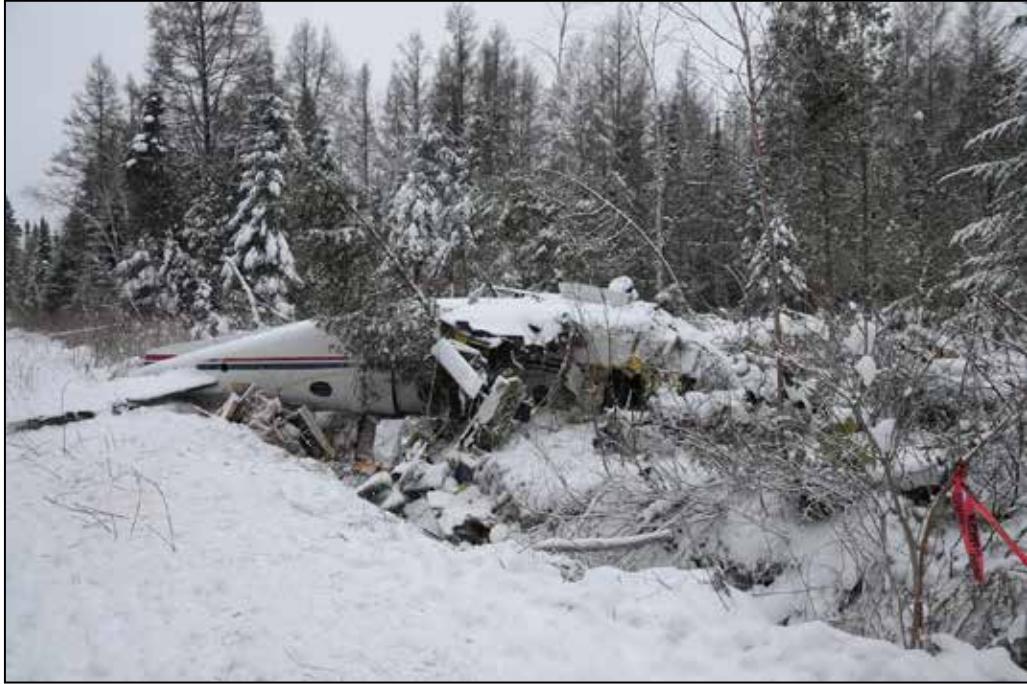
**Photo 1.** Aircraft wreckage

After initial contact with the treetops, the aircraft travelled 340 feet before the right wing was severed by large trees. The aircraft then began a pronounced roll to the right, hitting trees that partially severed its left wing. It then struck the ground and tumbled, finally coming to a rest inverted, 300 feet away (Photo 1). The wreckage was transported to the TSB Laboratory.

The nose of the aircraft sustained heavy damage upon impact with the ground. The fuselage was breached in spots due to the compressive forces exerted on the right side and the tensile forces exerted on the left. Only the passenger cabin retained sufficient shape necessary for survival.

The cockpit was severely compressed on impact with the ground and, as a result, there was insufficient space remaining to allow the 2 pilots to survive. The passenger cabin was damaged by compressive and tensile forces, causing a significant breach in the structure. However, the passenger cabin space preserved its initial shape.

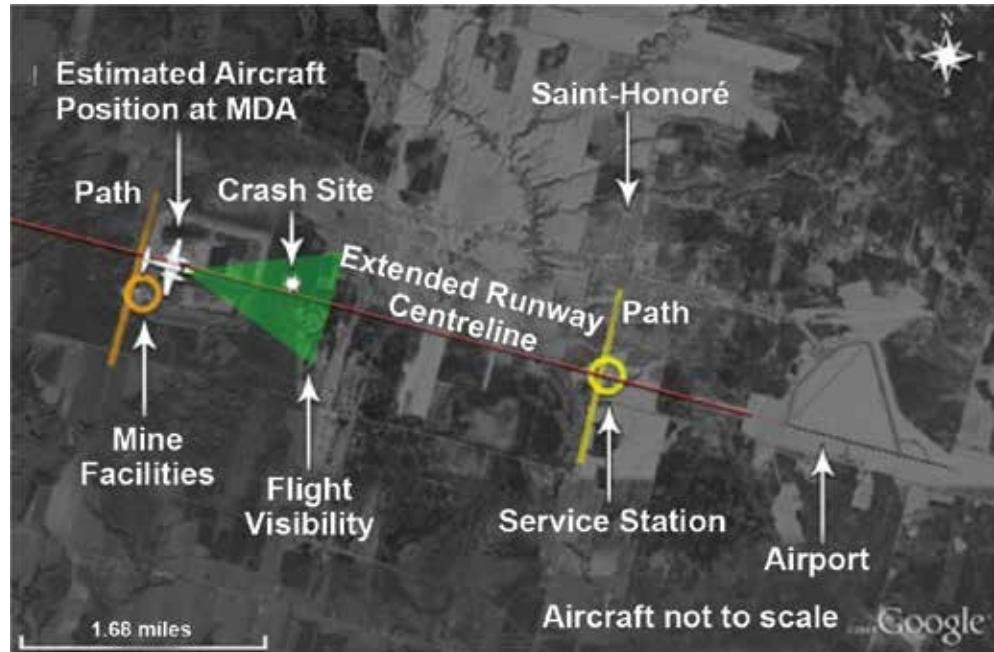
Figure 2. Satellite mosaic with lights on approach

The night flight revealed the presence of light sources along the approach path, i.e. the lights at a mine located approximately 4 nm from the threshold of Runway 12 and the lights of a service station located 1 nm from the threshold. However, the absence of lights in the vicinity of the accident site was also noted. According to available information, the intensity of the lights at the mine has increased significantly over the past few years.

The TSB Laboratory created a composite image of the final approach by superimposing the light sources over a satellite mosaic image (Figure 2). The image shows the estimated position of the aircraft at MDA, relative to the cluster of lights at the mine and the service station.

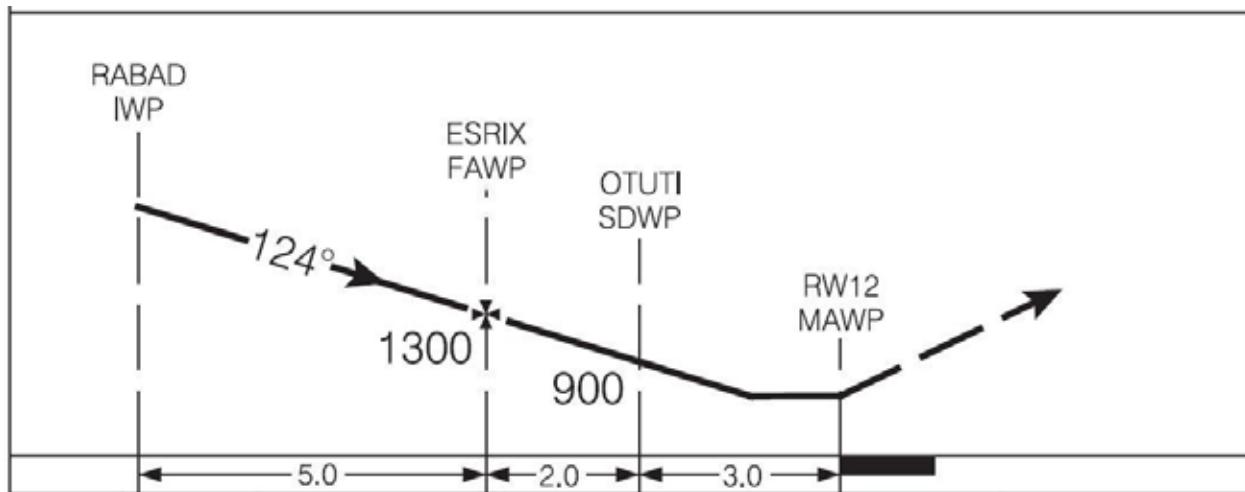
**Figure 3.** Descent profile published in the CAP

According to the recommended practices in Annex 4, the chart should include a rate of descent table<sup>42</sup>, and the profile view should include a terrain profile or a depiction of minimum altitudes, using either a continuous line to represent the terrain profile or shaded blocks indicating the minimum altitudes of the intermediate or final approach segments<sup>43</sup> (Appendix C). The RNAV (GNSS) Runway 12 approach chart at CYRC published in CAP does not incorporate the recommended practices set out in Annex 4 (and is not required to) on the following points:

- The chart does not include a rate of descent table.
- The terrain profile or the shaded blocks indicating minimum altitudes are not depicted.

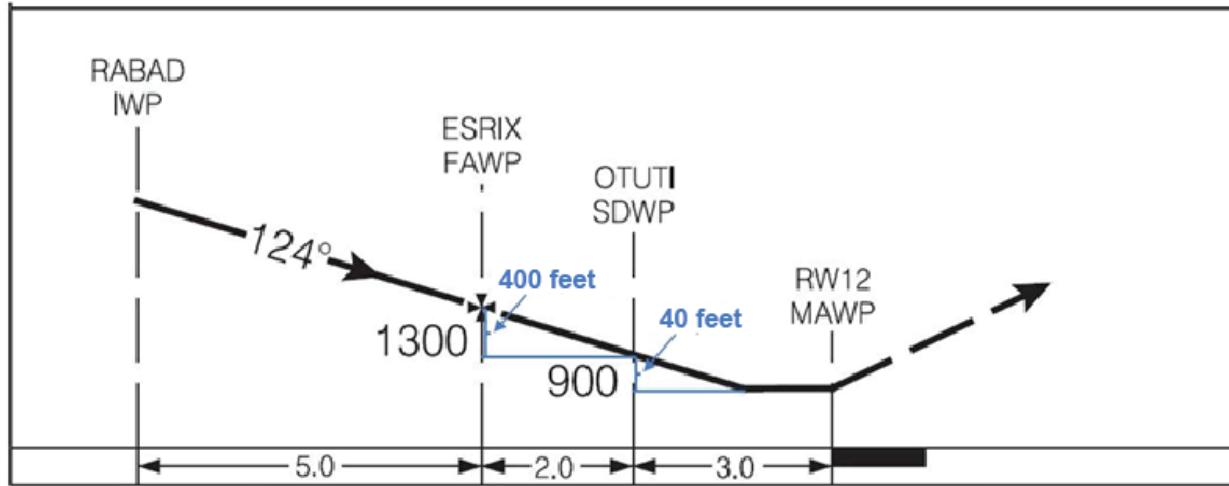
**Figure 8.** RNAV (GNSS) profile – Runway 12

The RNAV (GNSS) approach chart for Runway 12 at CYRC published in the CAP does not incorporate all of the depiction recommended practices in Annex 4, and TC does not require compliance with them. Consequently, the approach charts published in the CAP exclude the visual aspects recognized for their beneficial effects on positional awareness relative to terrain, such as:

- Angle of descent
- Depiction of the optimum descent path
- Altitude/distance table
- Profile of terrain below the approach

The only line with an arrow appearing on the RNAV (GNSS) approach chart profile for Runway 12 shows what appears to be the course to be flown (Figure 8). According to the designers, these altitudes are obstacle clearance minimums and pilots should not necessarily follow them. In 1998 and again in 2011, articles published by TC asked why pilots fly at these altitudes. However, no other options are indicated on the chart and TC does not publish formal reference documents to explain instrument flight procedures in Canada.

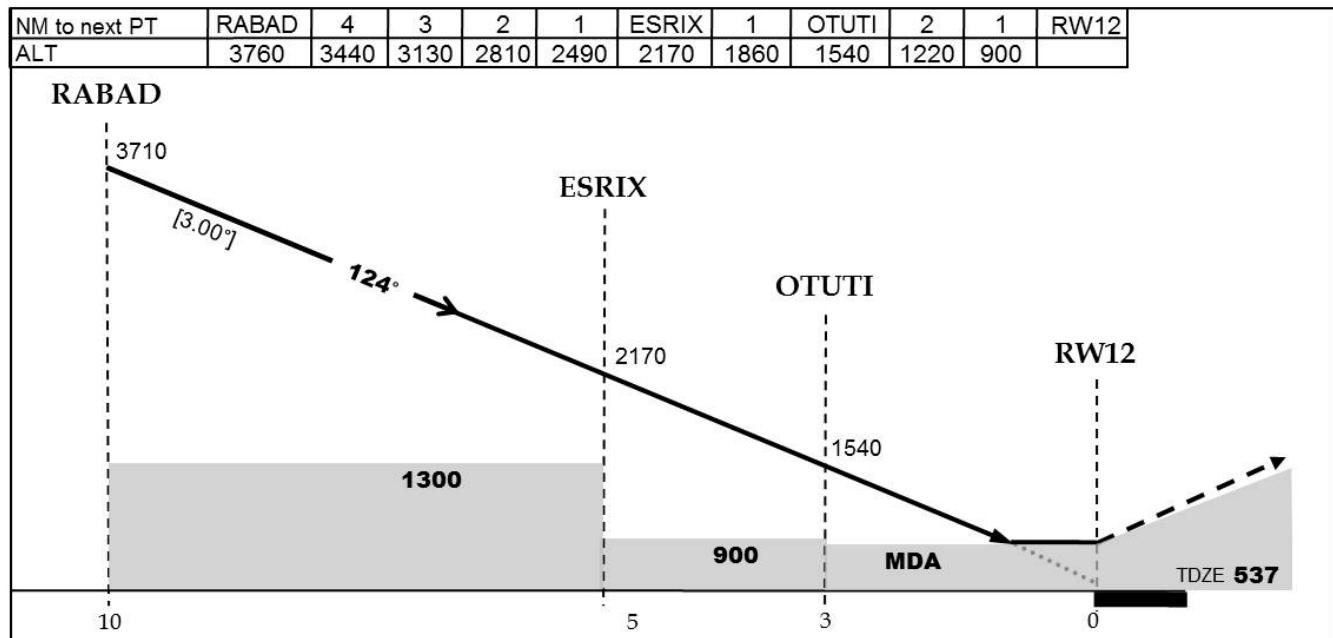
**Figure 9.** Descent profile incorporating Annex 4 recommendations

Using an altitude /distance table is cognitively easier when executing and monitoring a descent on final, since the calculations are already made and it is simply a matter of comparing the altitudes and distances. Given the possibility that the crew was experiencing task-induced fatigue, which has a negative effect on the operational memory used for mental calculations, the use of such a table would reduce the risk of error when performing the descent.

Approach charts published in the CAP do not include terrain profiles. A pilot must, therefore, develop knowledge of the height above the terrain by means of deduction, which, in and of itself, requires greater cognitive effort than if the terrain were shown visually on the charts. The instrument approach charts that incorporate the recommendations of Annex 4 provide a precise visual image of the path to be followed, while indicating the minimum obstacle clearance altitudes. These visual elements, which are recognized for their beneficial effects on positional awareness relative to terrain, reduce the required cognitive effort and, by extension, workload when flying an approach.
