Investigation Report

Type of Occurrence:	Accident
Date:	7 December 2009
Location:	Egelsbach
Aircraft:	Fixed Wing
Manufacturer / Model:	Beechcraft / King Air F90
Injuries to Persons:	Pilot and two occupants fatally injured
Damage:	Aircraft destroyed
Other Damage:	Crop damage
Source of Information:	Investigation by BFU
State File Number:	BFU 3X178-09

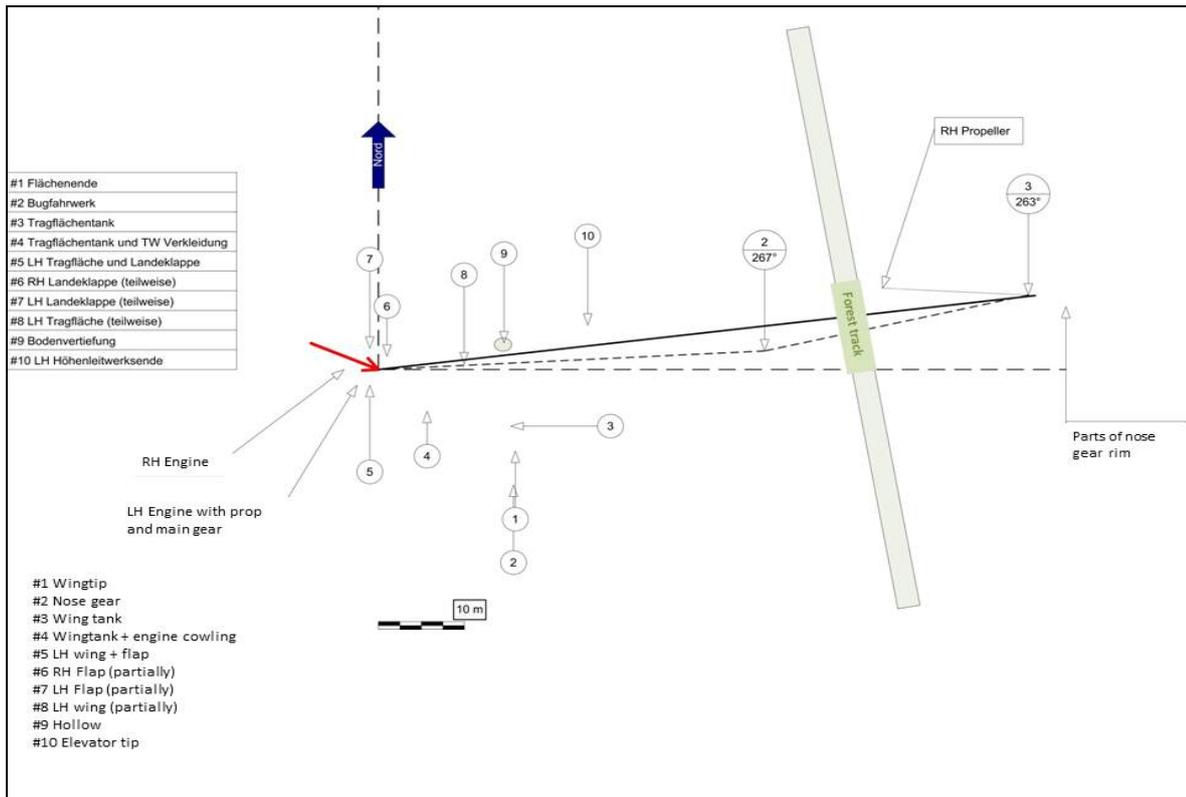
Wreckage distribution

The accident site was in a forest about 1.8 NM East of the special airfield and located under the approach path to runway 27. The aircraft had cut a visible lane oriented 259° starting with the initial impact point on the trees, the main wreck coming to rest on the ground after about 153 metres. A trail of components was found along this path including the weather radar, parts of the airframe, engine cowls, landing gear and tailplane. The right hand propeller was found about 60 metres in advance of the main wreckage. Some of the propeller blades been severed about 40 cm from the tip.

The main wreck was inverted and twisted about 5° to the right in the direction of flight; the cockpit came to rest on a heading of about 084°. The main wreckage area consisted of the wings, the landing gear and the left engine with propeller. Likewise, the tips had been severed from the left propeller and the blades were bent. The right engine had broken away from the wing and came to rest behind the main wreck. The airframe and part of the wings were destroyed by the outbreak of fire.

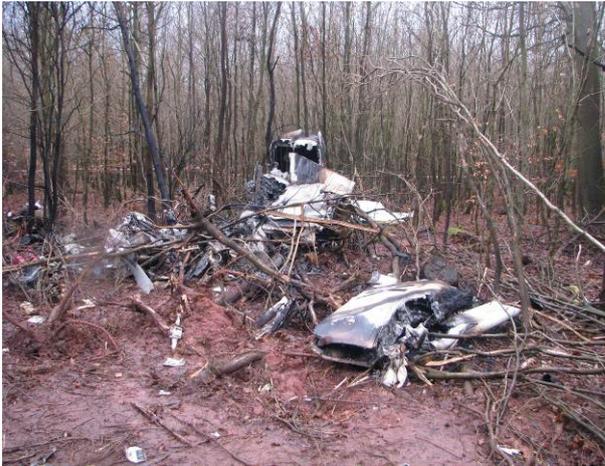
Main wreckage

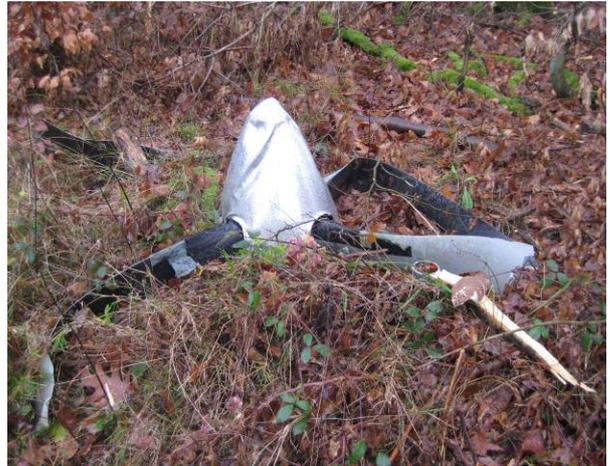
Right propeller

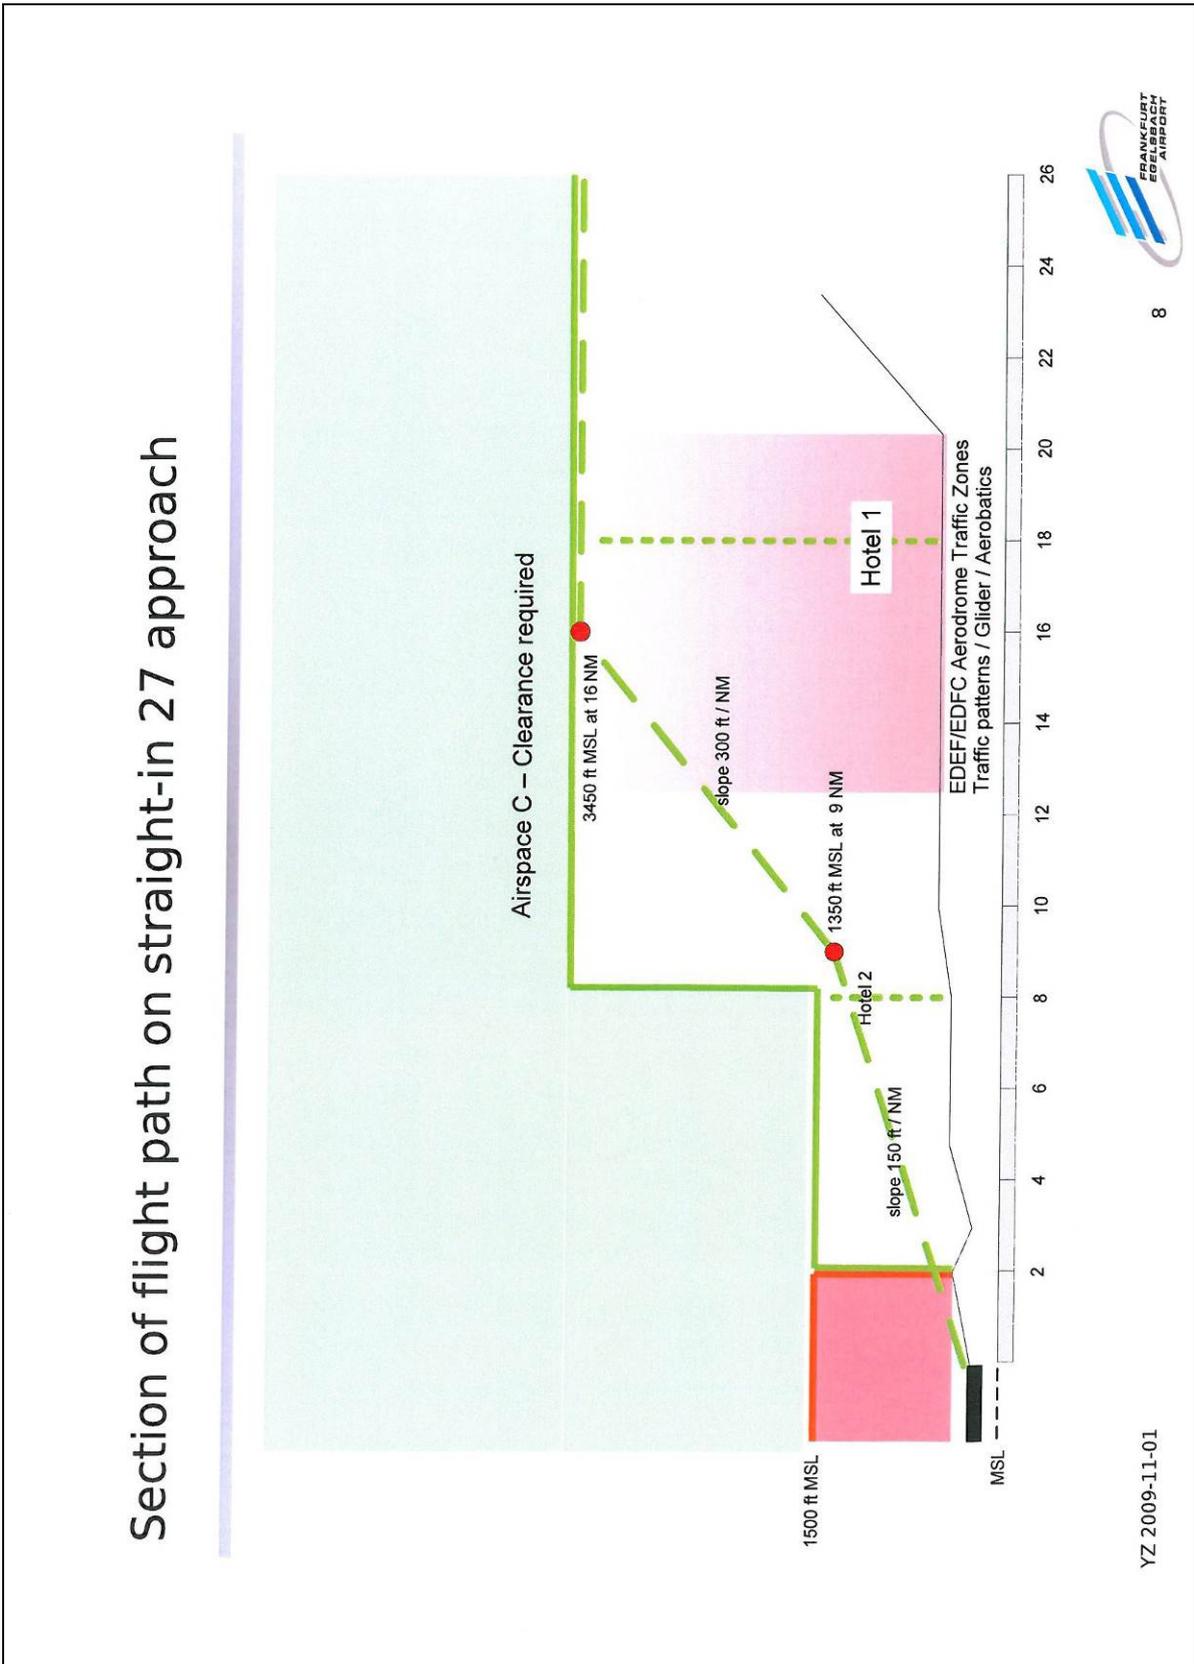
Vertical profile HPA-approach EDFE

This document, which was published on the homepage of Egelsbach Special Airfield up until about February 2010, showed among other things a vertical approach profile for the HPA-Approach. This profile gave descent specifications from 1,350 ft AMSL to the airport.

The vertical approach profile on the homepage of Egelsbach Airfield was inaccurate concerning the final approach. Because a descent to 0 ft AMSL was calculated, this particular profile with a descent rate of 150 ft/min would have led directly into the ground and therefore to a crash at about 4 NM before the airfield. At a distance to the airfield of about 2 NM flight altitude would have been 300 ft. This equals about 400 ft below terrain height.

It is to be regarded as positive that the document was initially amended – issue date 25 February 2010 – and finally removed from the homepage.

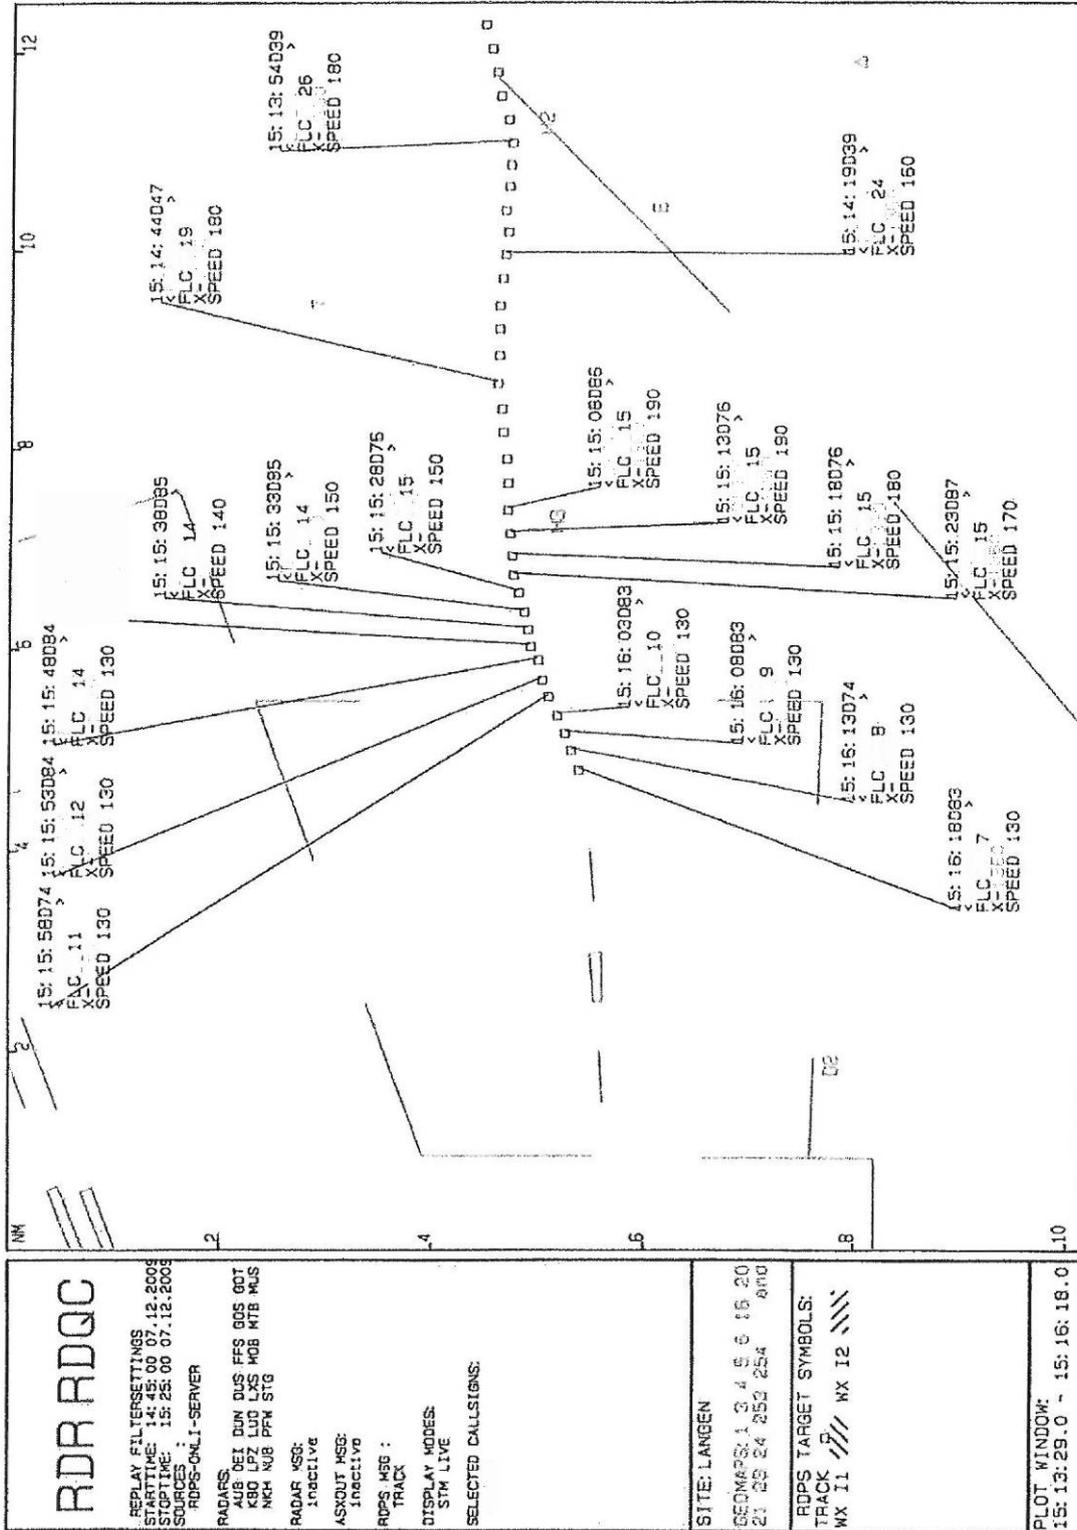
Radar traces

During the subsequent approach, the aircraft ground speed reduced over a distance of about 1.3 NM from about 190 kt to about 130 kt (distance to aerodrome about 3 NM). The radar trace indicates that from a position of 3.7 NM from the aerodrome to 2.5 NM from the aerodrome, the aircraft descended from 1,500 ft to 1,000 ft.

The radar trace indicates that at this time the aircraft descended from 900 ft to 800 ft. When Egelsbach Info advised “check your altitude”, the aircraft was at an altitude of about 800 ft. After a further two seconds, at 1616:18 hrs, the radar data indicated the
