Ditching – Israel Aircraft Industries Westwind 1124A, VH-NGA

5 km SW of Norfolk Island Airport | 18 November 2009

ATSB Transport Safety Report
Aviation Occurrence Investigation
AO-2009-072
Final

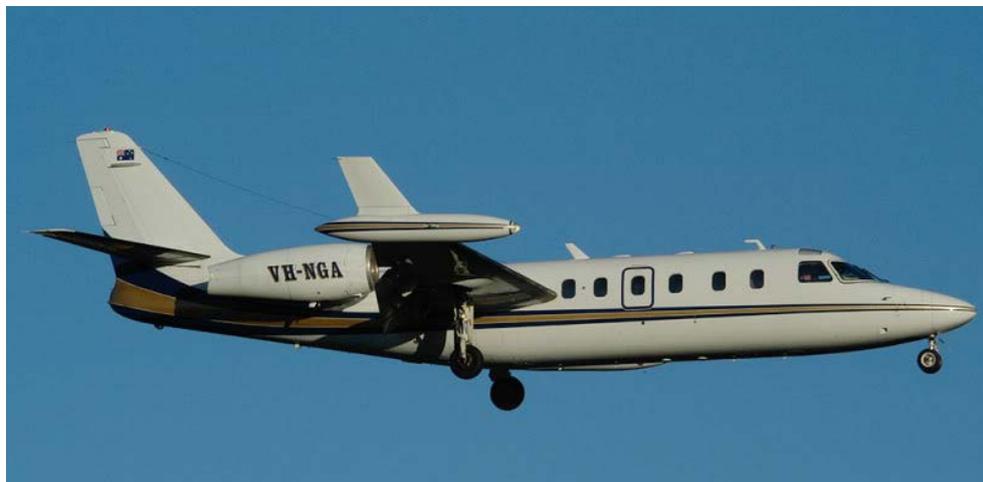
Figure 1: VH-NGA

The aircraft was seriously damaged.²⁹ The fuselage broke in two and sank in 48 m of water. The aircraft was not recovered.

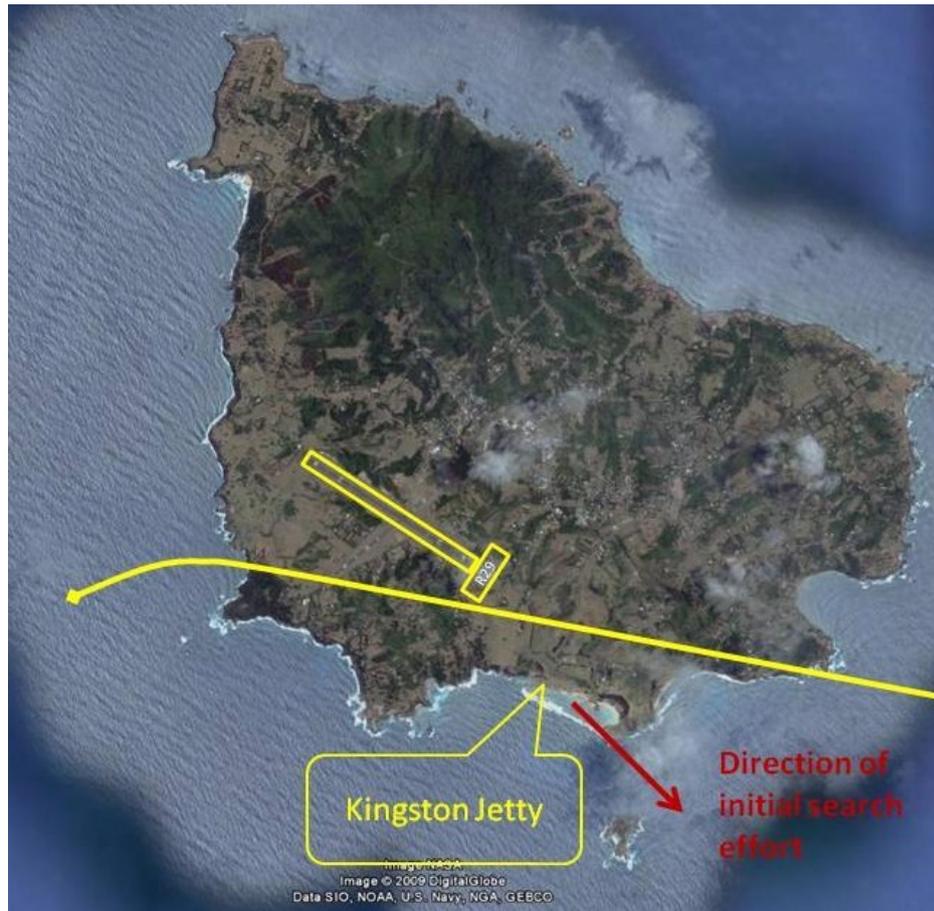
Figure 5: Approximate aircraft track before the ditching

The crew indicated that they climbed the aircraft to 1,200 ft above mean sea level (AMSL), turned left in a south-westerly direction (Figure 5), and configured the aircraft to land without extending the landing gear. The flight crew descended towards the water while monitoring the digital height readout from the aircraft's radar altimeter (RADALT)²⁸, which was mounted near the attitude indicator in the cockpit instrumentation.

The crew reported initiating a landing flare at about 40 ft RADALT and that the aircraft first contacted the water at an airspeed of about 100 kts. The flight crew recalled that, although they had selected the landing lights ON, they did not see the sea before impacting the water. Although there was no recorded MAYDAY or other radio call coincident with the ditching, a short unintelligible radio transmission was recorded on the Unicom frequency at 1026:02.

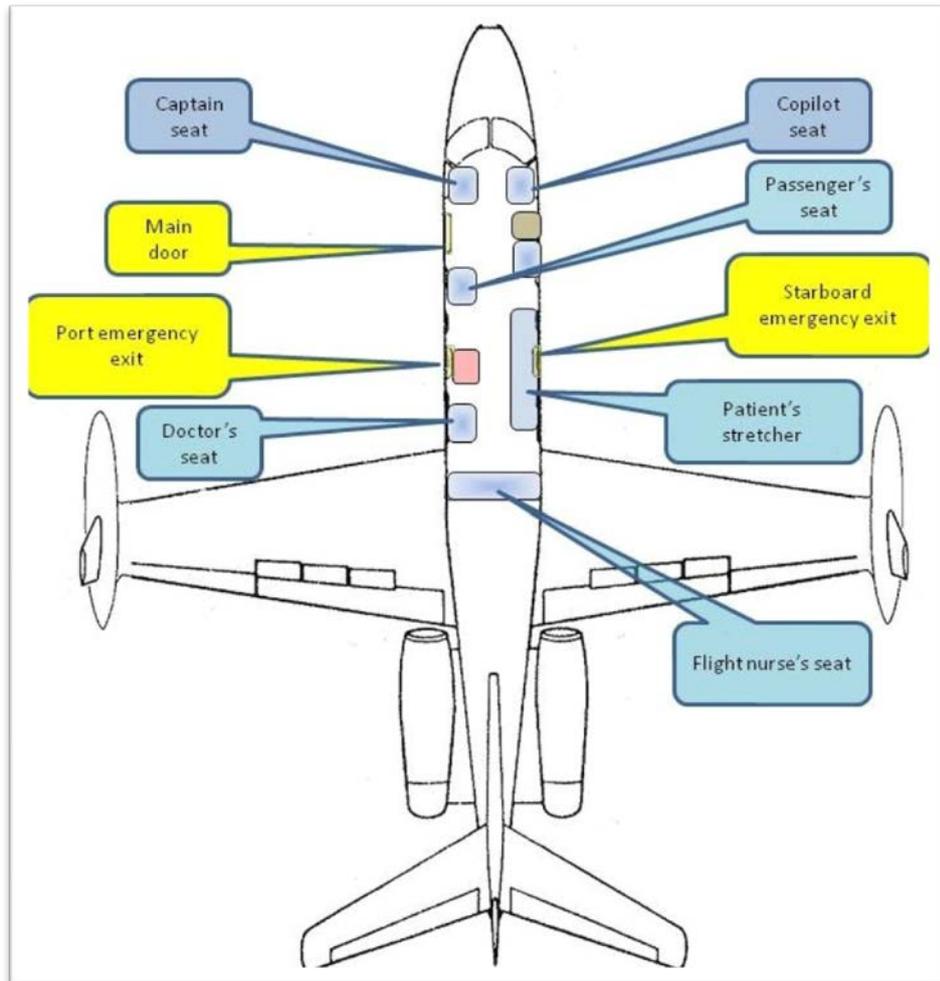
Figure 7: Seating positions at the time of the ditching

The aircraft occupants recalled two or three large impacts when the aircraft contacted the water. Those in the front of the aircraft described the impact forces acting in a horizontal, decelerating direction. The flight nurse, who was seated in the rearmost seat in the aircraft (Figure 7), reported far stronger vertical accelerations during the deceleration sequence compared with the other aircraft occupants. That was consistent with the nature of the injuries sustained by the nurse.

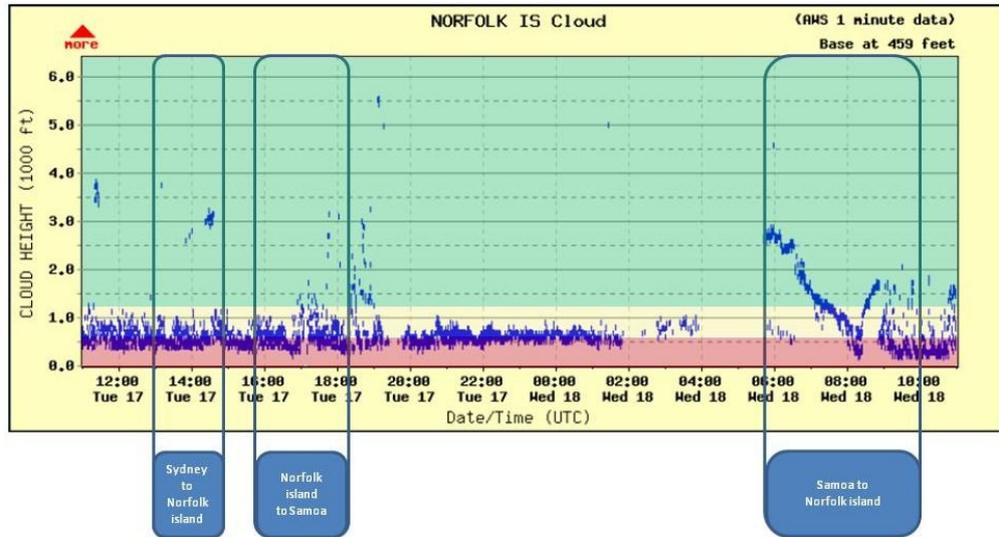
Figure 8: Graphical representation of the cloud base observations at Norfolk Island during the period of the flights

The aerodrome weather reports indicated a slight increase in cloud developing at Norfolk Island between 0600 and 0700. The end of daylight at Norfolk Island Airport was at 0750. The cloud base continued to descend (Figure 8), and at 0739, the automatic weather station (AWS) issued an extra report beyond its normal half-hourly reports. The extra report was issued as the weather conditions had deteriorated to the extent that the reported aerodrome weather report had changed from requiring the issue of a METAR to that of a SPECI (special), because overcast cloud had been observed 1,100 ft above the ARP, which was less than the highest alternate minima. The wind direction had not changed.

The aerodrome weather reports indicated that the cloud base continued to descend after 0830. At 0925, the AWS issued another report beyond its normal half-hourly reports. The weather conditions had deteriorated to the extent that a safe landing was unlikely to be achieved following an instrument approach because Broken cloud was observed 300 ft above the ARP. The horizontal visibility had deteriorated from over 10 km to 6,000 m in the previous 31 minutes. It also started to rain at around this time.
