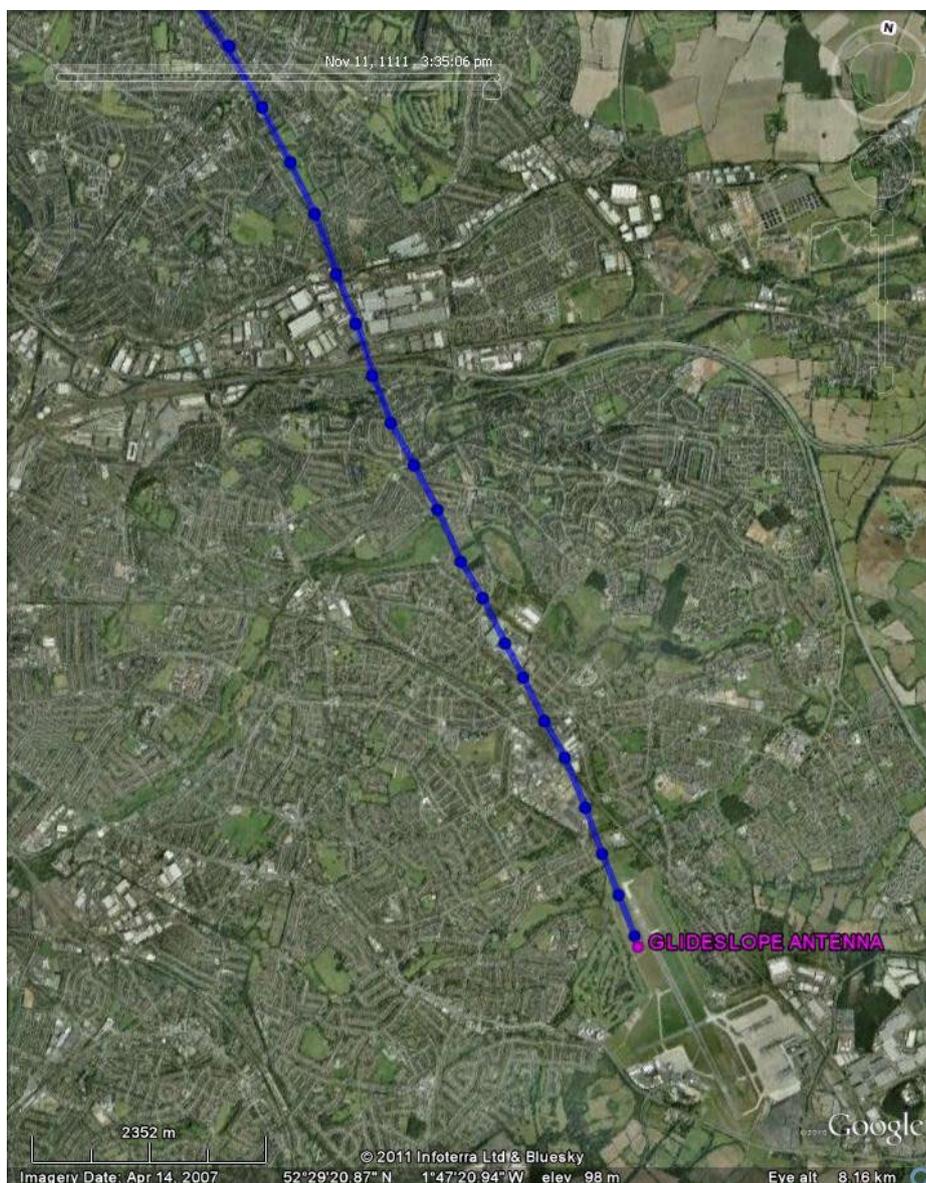
The aircraft was fitted with a Mode S transponder, so this radar data included altitude information which, for this installation, had a resolution of ± 50 ft. Figure 3 illustrates the approach to Runway 15 from about 5 nm out, with the last radar return (1535 hrs) placing the aircraft about 100 m from the glideslope antenna (shown).

Approach to Runway 15 from about 5 nm of G-VUEM based radar information
