# Collision with terrain, VH-FNM

## Wynella Station, Queensland

### 20 December 2010

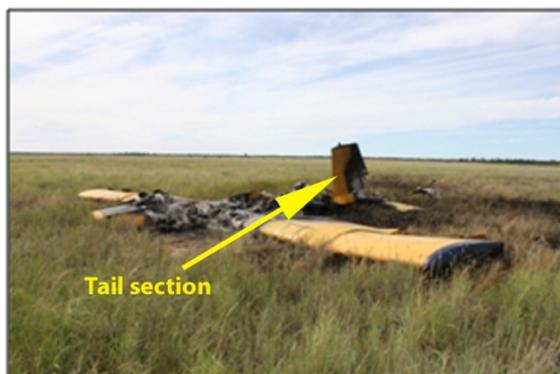
Figure 2: Aircraft wreckage

The aircraft was seriously damaged as a result of impact forces and a post-impact fire (Figure 2). The aircraft impacted the ground slightly left-wing low and about 20° nose down.

The wreckage trail was orientated on a heading of 150°(M), and the distance from the initial impact point to the main wreckage was about 31 m. The outboard sections of the left and right wings had fractured at the trailing edge. The propeller had separated at the engine crankshaft attachment and was located to the right of the wreckage trail.

A high intensity, post-impact fire destroyed the left and right inboard wing sections, aft cabin, cockpit

and the centre fuselage back to the rear cabin door. There was no indication of an in-flight fire.

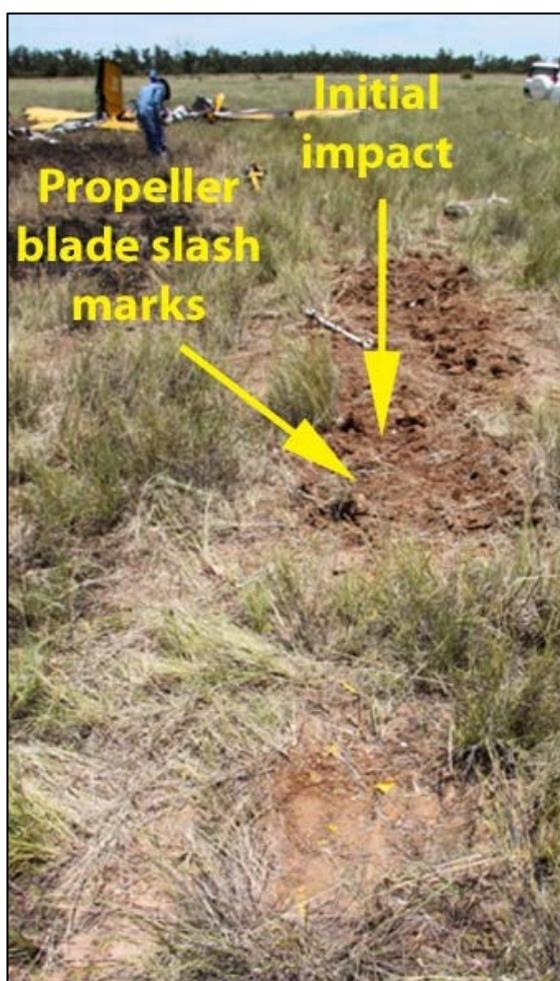
Figure 3: Initial impact ground marks

One propeller blade showed significant chordwise scratching and forward bending, indicating that the engine was delivering significant power at the time of impact. Based on a normal engine operating RPM of 2,300, propeller blade ground scars indicated a forward groundspeed of about 73 kts at the time of impact (Figure 3).
