FINAL
KNKT.12.05.09.04

Aircraft Accident Investigation Report

**Sukhoi Civil Aircraft Company
Sukhoi RRJ-95B; 97004
Mount Salak, West Java
Republic of Indonesia
9 May 2012**

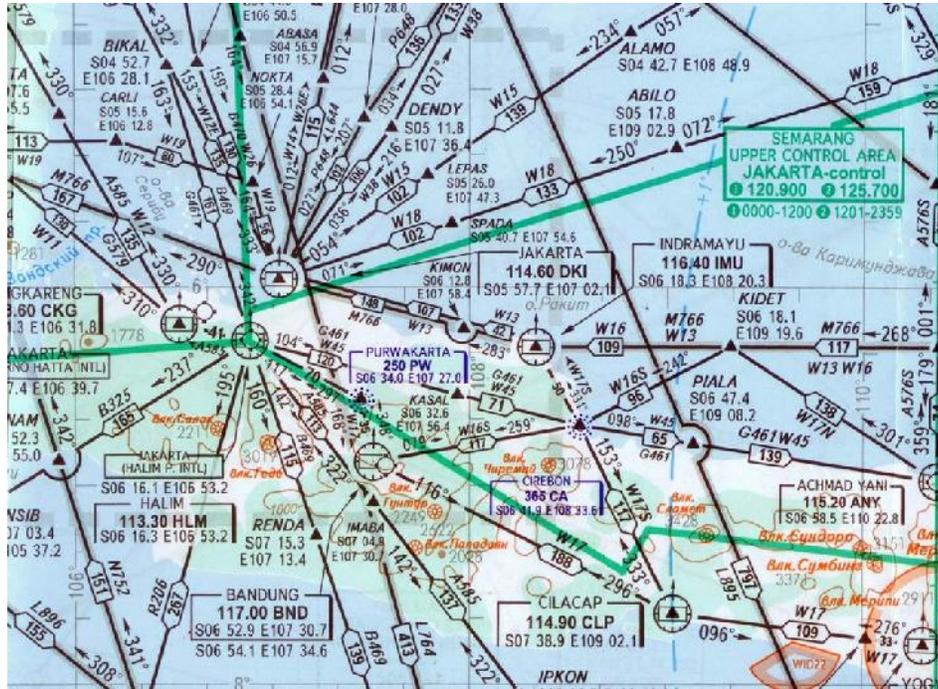
Figure 8: Navigation chart available in the aircraft

The navigation chart for the purpose of this flight did not contain information related to the Atang Sanjaya Training Area / WI(R)-4 and the terrain contour.

Figure 8 shows the chart that was available in the aircraft. This chart was typical of an instrument navigation chart that was suitable for en-route flight.

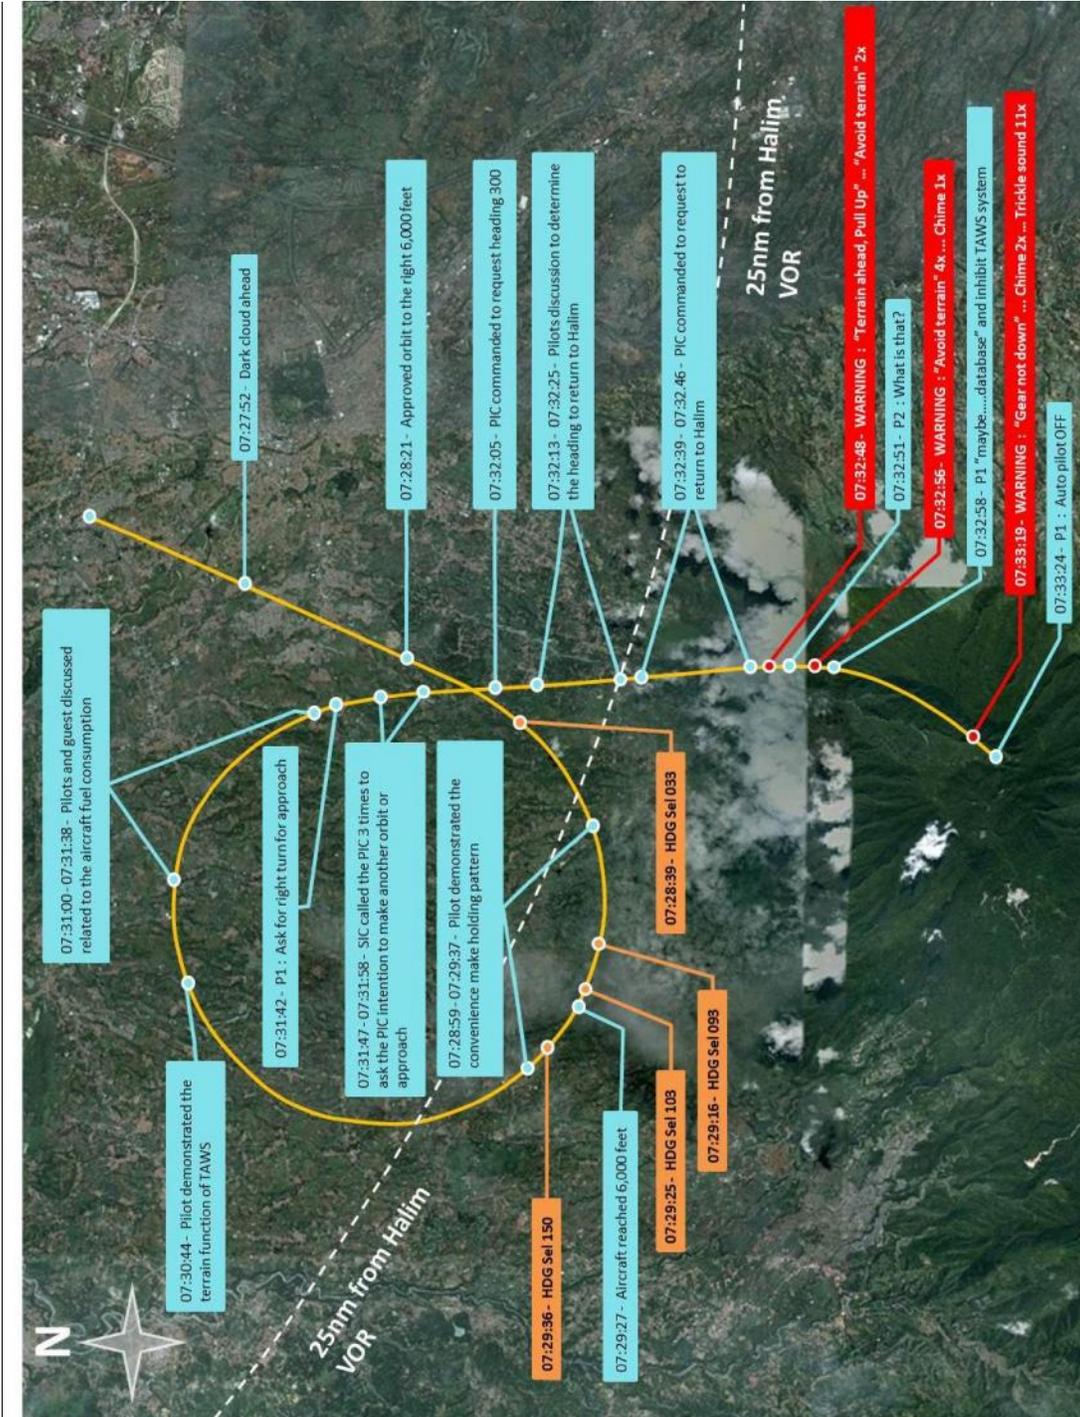
Figure 17: Event link of the final segment of the flight

At the final segment of the recording approximately 38 seconds before the end of recording, there were several alerts and warnings from the TAWS and from the aircraft warning system.

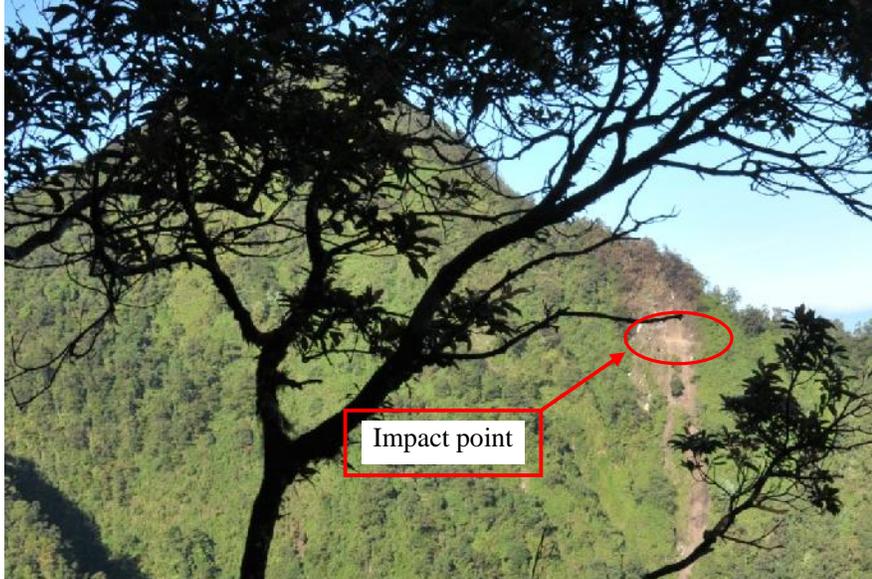
Figure 18: The ridge facing to the east

The aircraft impacted terrain at 6,000 feet ASL on an approximately 85 degree slope ridge. The wreckage was spread over a wide area. Most of the wreckage such as landing gear, engines and vertical stabilizer were found at the bottom of the valley at approximately 500 meters below the impact point.

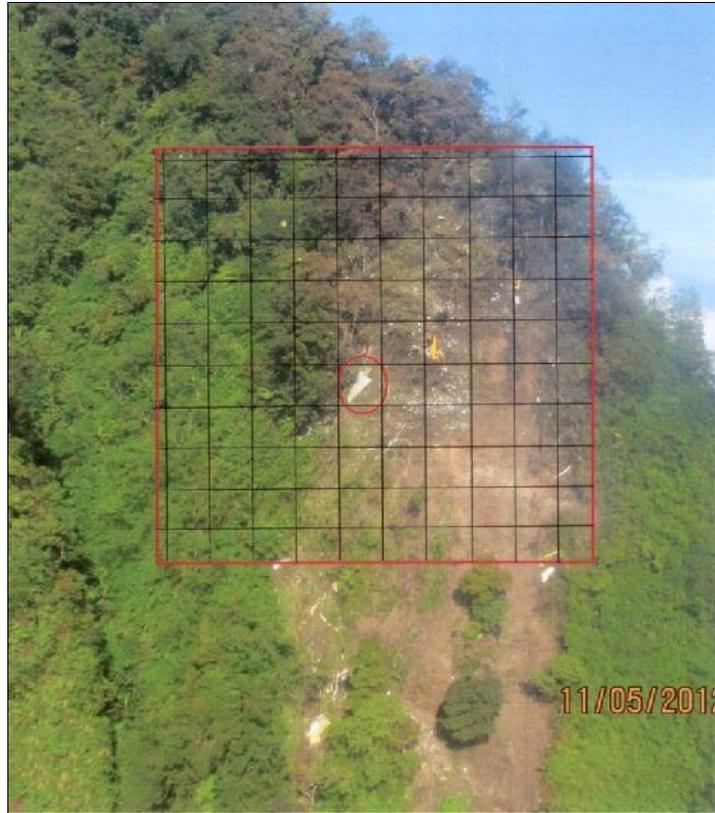
Figure 19: The accident site

The area surrounding the impact point was burnt. Some wreckage in that area was found partially burnt.

The aircraft was destroyed by impact forces and post-impact fire.

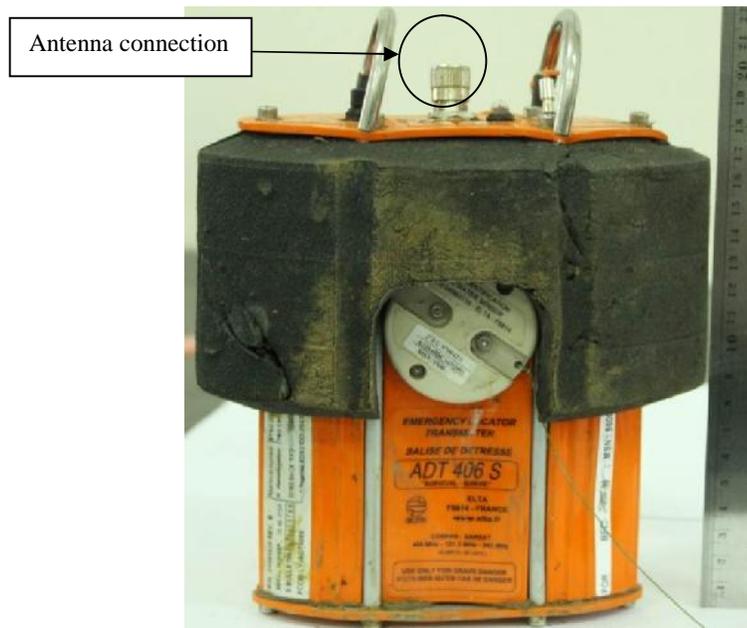
The ELT was found with the antenna detached due to the high magnitude of impact force. The separation of the antenna from the ELT unit explained the reason why no distress signal was transmitted.

Figure 21: Emergency Locator Transmitter with antenna detached

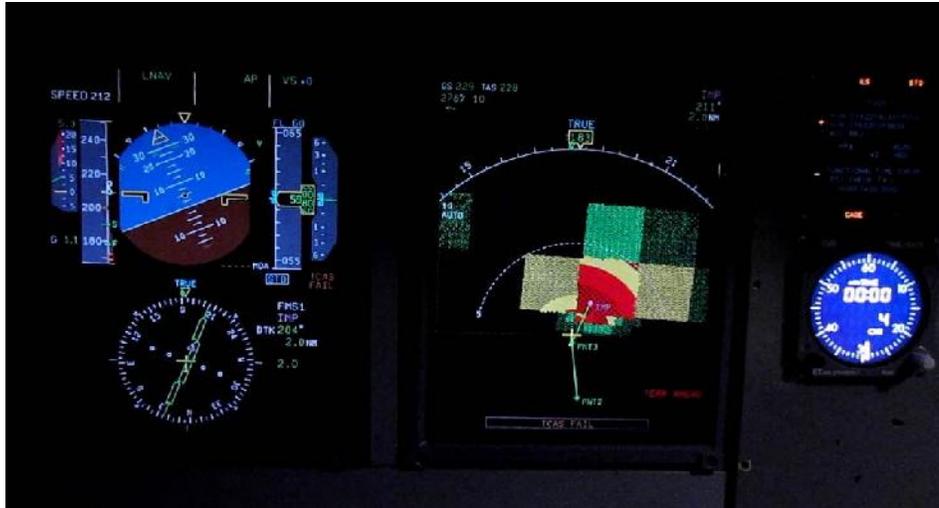
Figure 22: The cockpit instrument displayed in the simulation of the last segment of the flight

The collision with the terrain could be avoided if the crew performed the appropriate actions in responding the TAWS warning within 24 seconds after the first TAWS warning activated.
