## CIVIL AERONAUTICS BOARD

## ACCIDENT INVESTIGATION REPORT

TRANSCONTINENTAL AND WESTERN AIR - HANFORD, CALIFORNIANOVEMBER 4, 1944

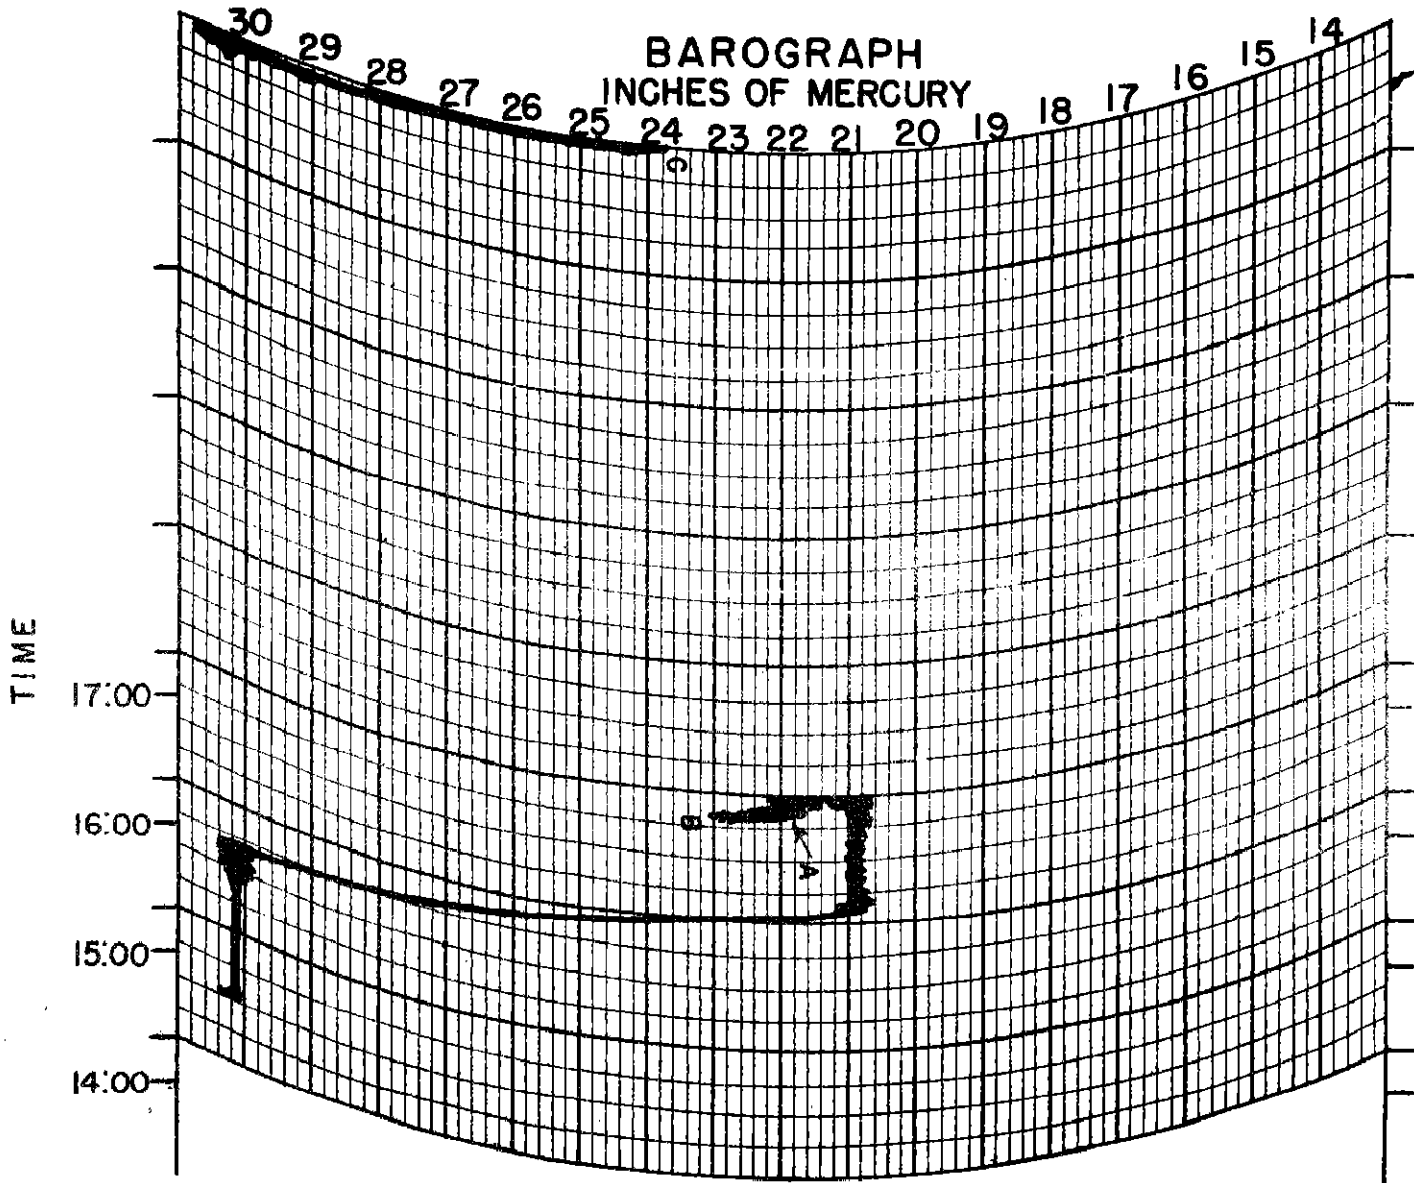
FLIGHT ANALYZER RECORD  
T.W.A. DC-3 NC28310  
November 4, 1944

The card indicates normal operation of the airplane from the time of take-off from San Francisco until about 1713, at which time there can be noted an abrupt gain of altitude to about 10,200 feet, immediately followed by a long descent, evidenced by a series of irregularities in the graph. First there were two instances (at approximately 9600 and 9200 feet) where the descent seemed to have been checked (or reversed) with a simultaneous displacement back along the "time" direction. The descent continued to about 8400 feet, at which altitude the graph indicates the beginning of a rapid ascent to an altitude of 9000 feet, accompanied by a displacement of the time element by about  $1/32$  of an inch. From 9000 feet, the descent is resumed with an additional slight reversal of the time element. At 7400 feet, there occurs a complete discontinuity of the graph, which is finally picked up at the extreme upper end of the card at an altitude of 6600 feet, from where it continues to the ground. Due to the effect of time reversal present on the graph, it is not possible to establish quantitatively the rates of descent and ascent indicated in the last portion of the graph.

The two most significant points on the graph are the reversal of time (marked A on the reproduction) and the discontinuity (from point B to point C on reproduction). In order to interpret this action of the graph correctly, it is essential to correlate it with the position of the flight analyzer as it was located in the airplane. This instrument was mounted upright against the left wall of the fuselage, with the plane of the card and carrier coincident with the fore-n-aft plane of the aircraft. The downward movement of the carrier, driven by clockwork, gives the time element on the card, the pen being stationary in the up and down direction and pivoted from above to swing with the change in atmospheric pressure. The gears driving the carrier have a small amount of play, which is apt to vary somewhat with each instrument; however, it is not expected to exceed  $1/32$  of an inch or so. The friction in the clockwork can be overcome by a pull of about  $1\frac{1}{2}$  pounds (24 ounces).

With the above in mind, the significance of points A, B and C of the graph becomes clear. First, there is little doubt that the aircraft was carried from 8400 to 9000 feet, probably by an updraft. This, however, was accompanied by a reversal of time; i.e., by the movement of the carrier in an upward direction with respect to the instrument proper. Such a notion, with the airplane in an updraft, could only occur if the instrument were upside down; i.e., the aircraft inverted. Otherwise the motion would be inconsistent with the inertia effects in an updraft. Since the airplane was being lifted by an updraft, the logical deduction is that it was in an inverted position at that time. After descending to 7400 feet, there occurs the discontinuity of the graph. Not only were the carrier and card moved down abruptly, but the pen was separated from the card. As stated before, such a downward movement of the carrier can occur only under an acceleration of at least 10g with the force acting from below the instrument. The separation of the pen is most apt to occur under loads from the face of the instrument; i.e., lateral forces from the right side of the fuselage. Forces of 10g or more are extremely unlikely in a DC3 as a result of air loads. Therefore, a force other than that originating from a gust or from a maneuver must have occurred at an altitude of 7400 feet. It is believed that the force causing the discontinuity of the graph resulted from the wing striking the fuselage.

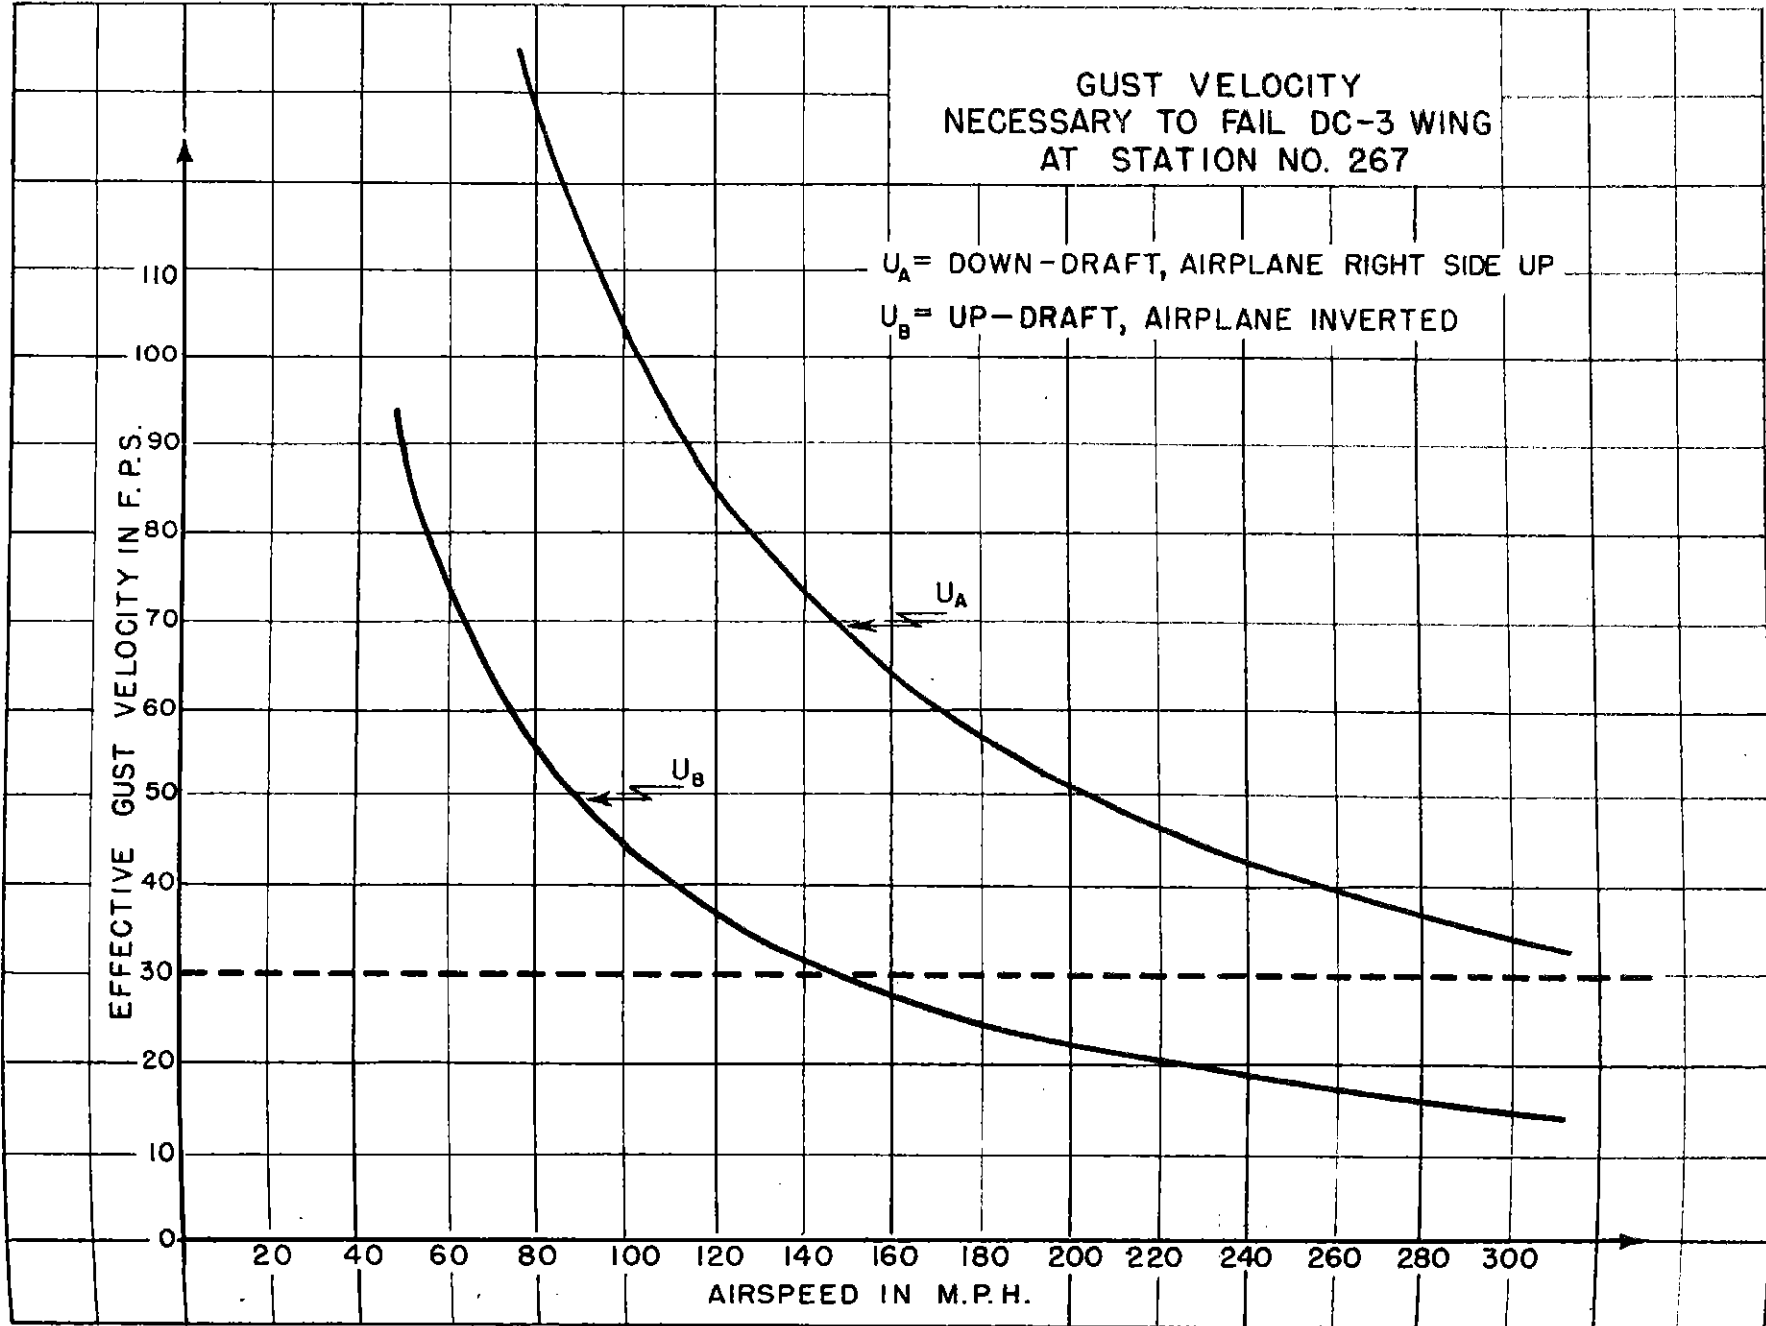
GUST VELOCITY  
NECESSARY TO FAIL DC-3 WING  
AT STATION NO. 267

Curves for  $U_A$  and  $U_B$  are drawn on the attached sheet. The horizontal line running through the 30 fps gust value is the limit of probable gust velocities encountered, as expressed by the design criteria in the Civil Air Regulations.

Referring to the curves and assuming arbitrarily a 15-foot per second down-gust, it will be noted that, in order to fail the wing in a downward direction (aircraft in normal attitude), the airplane would have to attain an impossibly high speed. Even for the design 30-foot per second down-gust\*, the speed would have to be above 300 m.p.h. which, although possible, appears extremely improbable under the circumstances. This seems to preclude almost definitely an assumption that a down-gust was responsible for the wing failure. On the other hand, if an up-gust equal to the design value of 30 feet per second (sharp-edged) had occurred while the airplane was inverted the curves reveal that failure could have occurred at any speed above 150 m.p.h. This definitely indicates a much greater probability of the wing failing in an up-gust while the airplane was in an inverted position, and is consistent with the conclusions reached from the study of the flight analyzer record.
