B-111
Docket No. AC-3

REPORT OF THE CIVIL AERONAUTICS BOARD

On the investigation of an accident involving aircraft of United States registry NC 41380 in the Bay of Explois, Bonaville, Newfoundland, on October 3, 1942

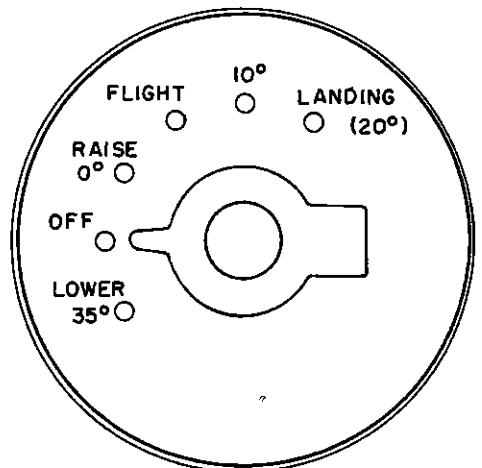
9. The flap control switch had been equipped with a safety stop to prevent an inadvertent application of 35° flaps, but the evidence indicates that this safety stop had been broken or removed sometime previous to the subject flight.

CONTRIBUTING FACTOR: Absence of the required stop-spring on the flap control switch which was for the sole purpose of preventing inadvertent application of the 35° flap.

SWITCH AS IT WAS ON
SUBJECT FLIGHT
(NO STOP)

It has been recommended that the Civil Aeronautics Administration check any of this type aircraft engaged in commercial operation and require the safety stop-spring to be reinstalled on the flap selector switch.
