REPORT OF THE CIVIL AERONAUTICS BOARD

On the Investigation of an Accident in Scheduled Air Carrier
Operation which Occurred in the Province of
Arequipa, Peru, on January 22, 1943

PANAGRA AIR CARRIER ACCIDENT NEAR CHAPARRA - PERU JANUARY 22, 1943

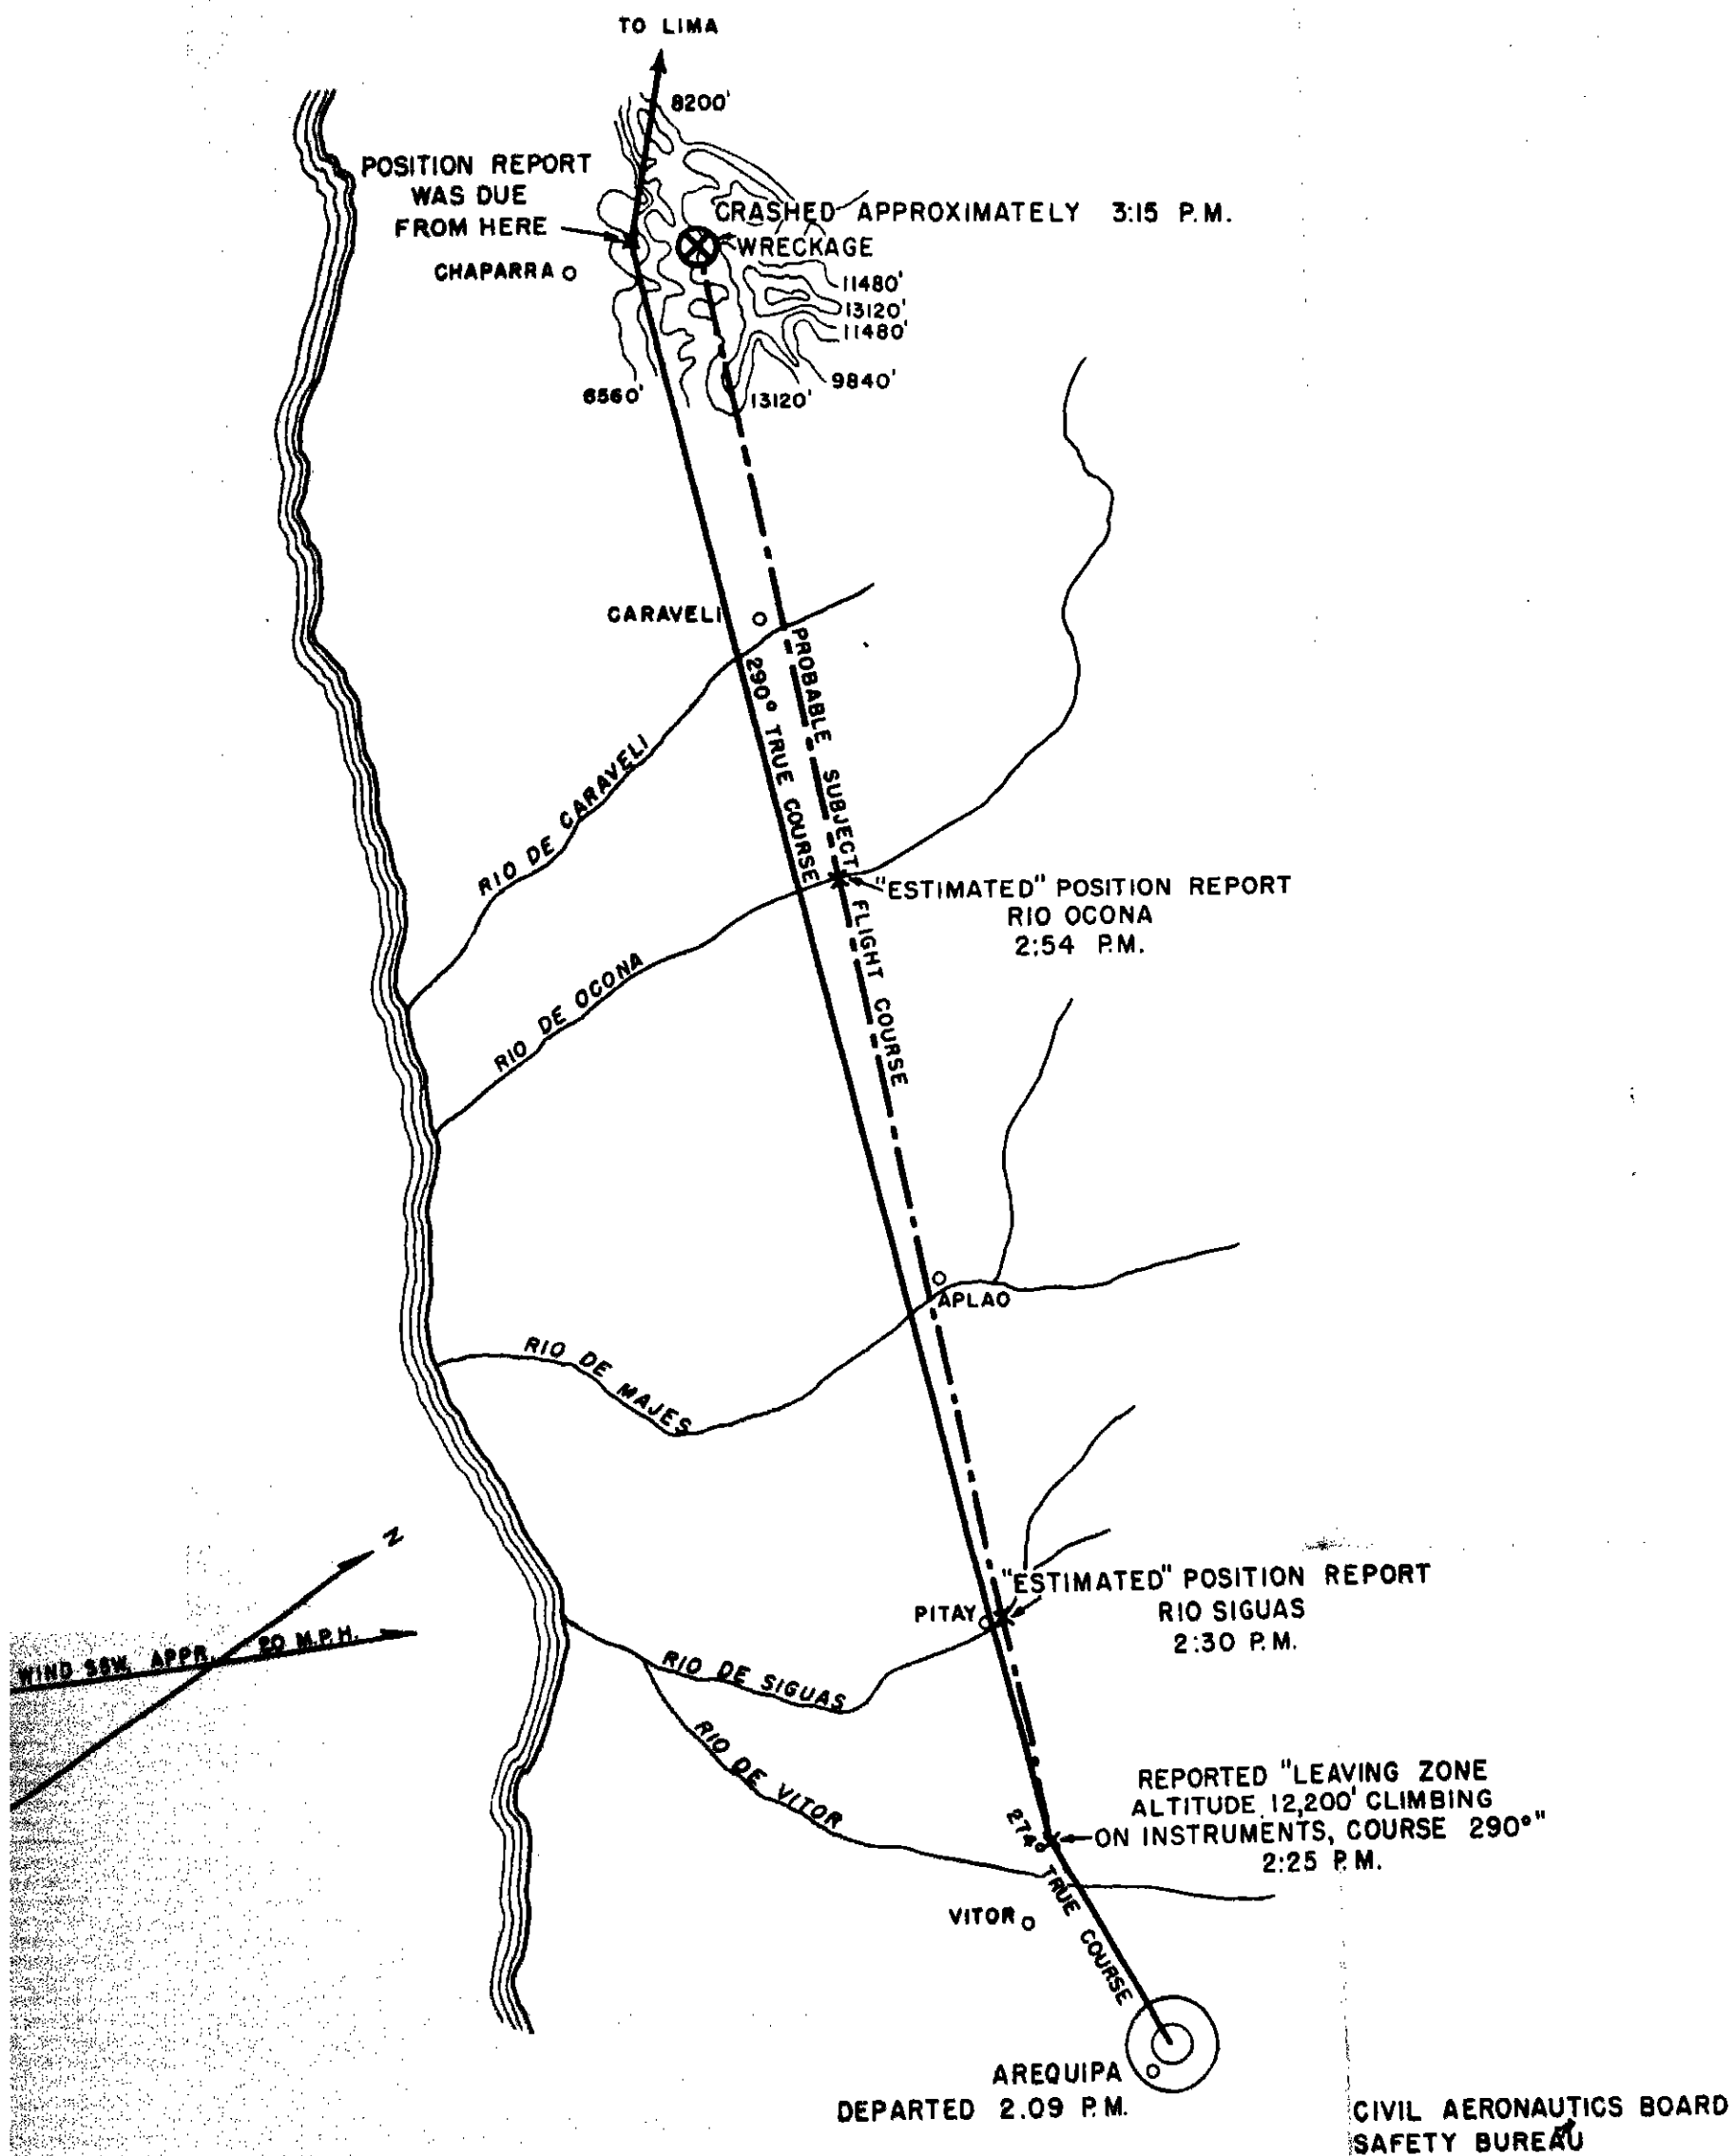
It is apparent that the subject flight left Arequipa at 2:09 p.m., contact, and entered the overcast on instruments at the time of, or before, it reported leaving the airport control zone at 2:25 p.m. It was evidently still on instruments when its estimated positions were reported by CW to Lima at 2:30 p.m. and at 2:54 p.m. However, the dispatcher at Lima had no way of determining whether the pilot was proceeding on top of the overcast, as he would be permitted to do, or in the overcast, which was against company flight procedure. According to the statement of the surviving passenger, the flight probably never did break out of the overcast. The accident occurred at approximately 3:15 p.m. It is evident, therefore, that the flight had been proceeding on instruments in the overcast, contrary to Panagra's flight procedure, for about 50 minutes. Coincidental with the subject accident, investigation disclosed that a Peruvian pilot of Faucett Airlines reported that he had flown from Arequipa to Lima about an hour earlier on the same day and had encountered bad weather in the vicinity of the accident. However, he changed his course from 285° to 270° (West), proceeded to the coast line, and then resumed his heading toward Lima.

9. On account of the SSW wind (approximately 20 m.p.h.) the flight had drifted off course NNE over the higher terrain.
