C I V I L A E R O N A U T I C S B O A R D

ACCIDENT INVESTIGATION REPORT

EASTERN AIR LINES - USAF - NEAR FLORENCE, S.C. - JULY 12, 1945

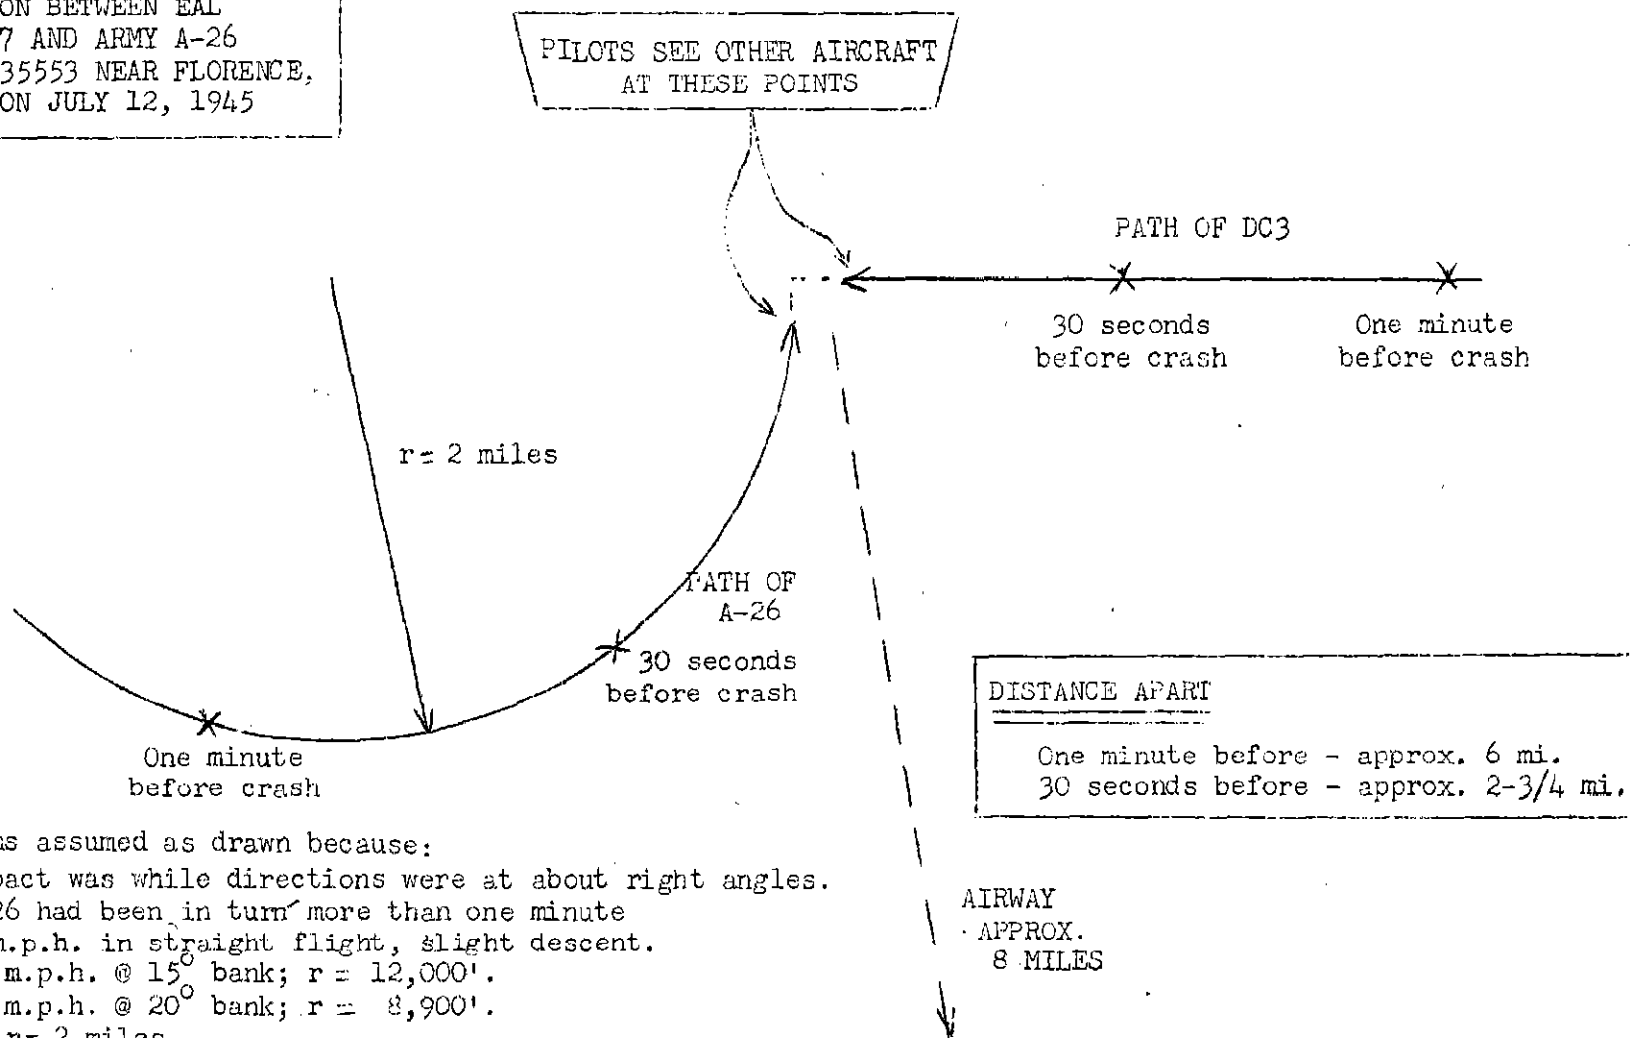
PLAN VIEW

COLLISION BETWEEN EAL
NC 36757 AND ARMY A-26
NO. 44-35553 NEAR FLORENCE,
S. C., ON JULY 12, 1945

1. Flight paths assumed as drawn because:
 - (a) Impact was while directions were at about right angles.
 - (b) A-26 had been in turn more than one minute
2. DC3 @ 170 m.p.h. in straight flight, slight descent.
3. A-26 @ 220 m.p.h. @ 15° bank; $r = 12,000'$.
4. A-26 @ 220 m.p.h. @ 20° bank; $r = 8,900'$.
5. \therefore Assume $r = 2$ miles.
6. A-26 would make about 107° of a 2-mile radius turn in one minute.

NOTE: This diagram is based on collision during flight at right angles. There is some evidence to indicate that the angle of contact was slightly more than 90° . However, if this were the case the above figures would not be changed substantially.
