CIVIL AERONAUTICS BOARD

ACCIDENT INVESTIGATION REPORT

NORTHWEST AIRLINES, INC.—MT. SANFORD, ALASKA—MARCH 12, 1948

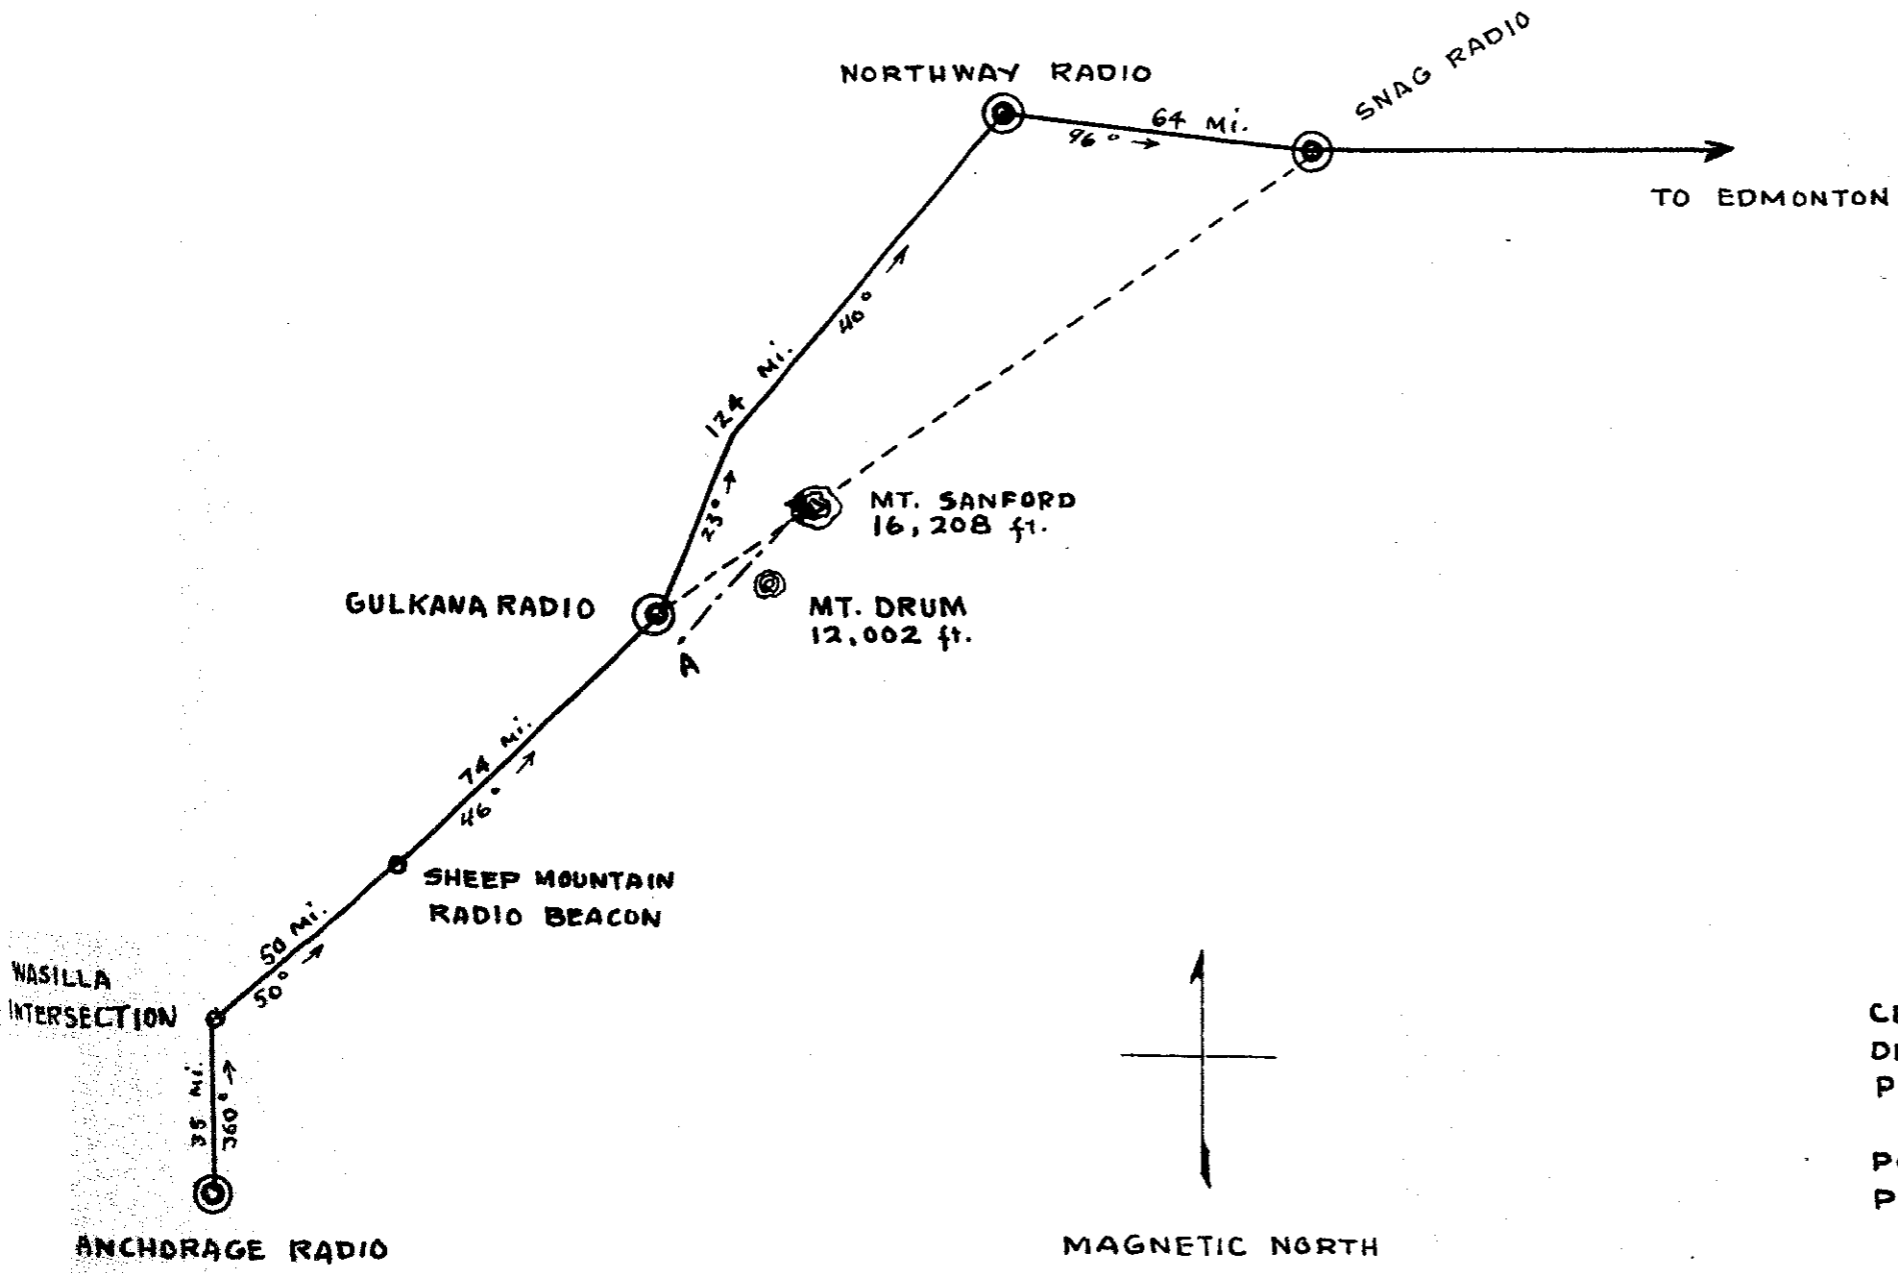
CHART OF AIRWAY FROM ANCHORAGE TO SNAG

Since the aircraft was observed to fly easterly from Gulkana, at which time it was 4 miles south of the Gulkana radio range station, it appears that the flight was not following the airway, but was flying directly from Gulkana to Snag. It is probable that the pilot, relying on good visibility, felt confident that he would see Mt. Sanford and be able to safely circumnavigate it. Though no clouds were reported, the top of Mt. Sanford could very well have been capped by a thin layer of clouds. Such a layer of clouds would not only have tended to obscure the mountain but may have acted as a reflector for the aurora borealis which was observed to be particularly brilliant the night of this flight.

It is concluded, therefore, that the flight flew south of the airways for the purpose of flying the straight line course from Gulkana to Snag, intending to circumnavigate Mt. Sanford; and since Mt. Sanford was not discernible either because of clouds, the aurora borealis, or both, the aircraft crashed into the mountain.

8. The aircraft crashed approximately 42 miles 51 degrees from the Gulkana radio range station on Mt. Sanford at its cruising altitude of 11,000 feet, and 23 miles southeast of the center line of the airway as described above.

CENTER LINE OF AIRWAY
 DIRECT COURSE GULKANA TO SNAG
 POINT "A" - AIRCRAFT OBSERVED FLYING
 EASTERLY FROM THIS POINT.
 POINT "X" - APPROXIMATE POINT OF CONTACT.
 PROBABLE COURSE OF AIRCRAFT.
