**AVIATION INVESTIGATION REPORT
A14W0181**

SEVERE ICING ENCOUNTER AND FORCED LANDING

**AIR TINDI LTD.
CESSNA 208B, C-FKAY
YELLOWKNIFE, NORTHWEST TERRITORIES, 18 NM W
20 NOVEMBER 2014**

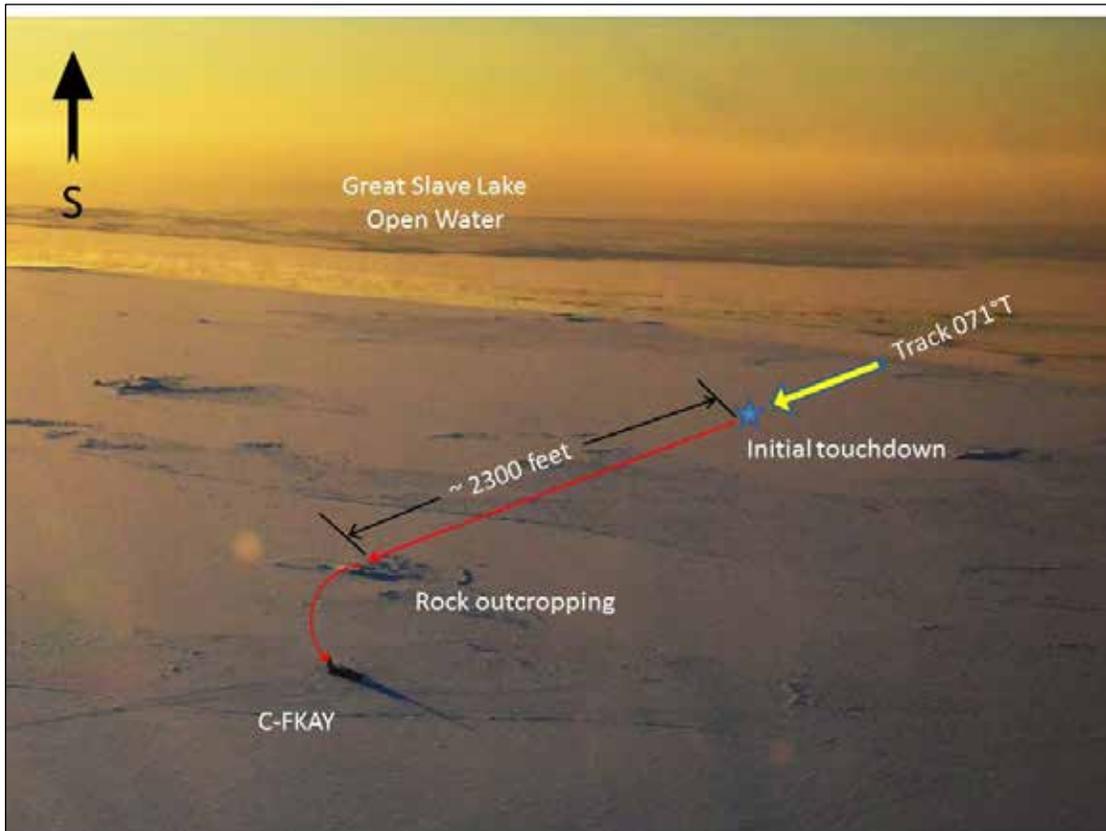
While still in darkness, DA223 contacted the frozen surface of Great Slave Lake at 0721, and continued moving for 2300 feet before it struck a rock outcropping with the nose and left main landing gear. The aircraft came to rest approximately 600 feet from the outcropping and 2900 feet from the initial touchdown point (Figure 1). There were no injuries to the occupants, but the aircraft was severely damaged. There was no post-impact fire.

Figure 1. Aerial view, looking south, of the accident site on the North Arm of Great Slave Lake

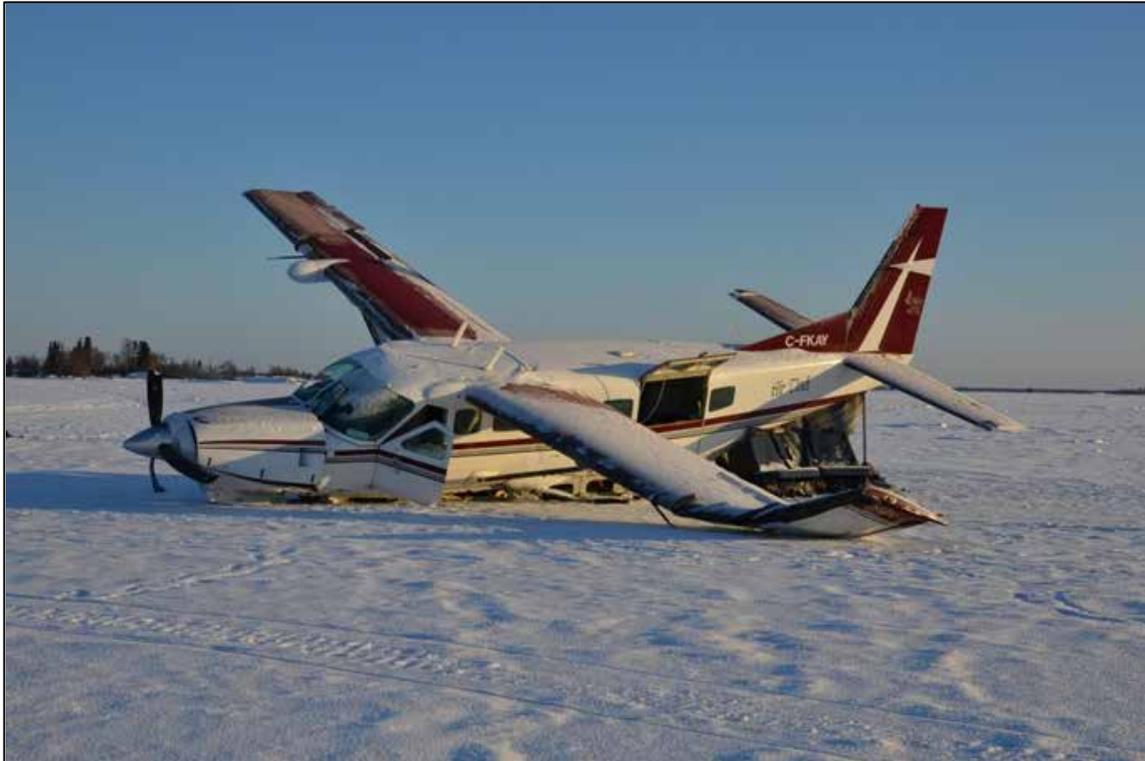
The aircraft suffered extensive damage to the left wing, left main landing gear, nose landing gear, and propeller (Photo 1). The right windscreen was broken, and the remaining portion of the nose gear assembly was pushed up into the right side of the cockpit. Flap position was

verified to be in the fully up position, as selected. Almost all remaining fuel was spilled from the left wing, as the structure had been compromised. Fuel from the right wing also cross-fed the spill. The fuel remained on top of the ice and formed slush under the fresh snow. There was no post-impact fire.

Photo 1. C-FKAY after it came to rest on the North Arm of Great Slave Lake

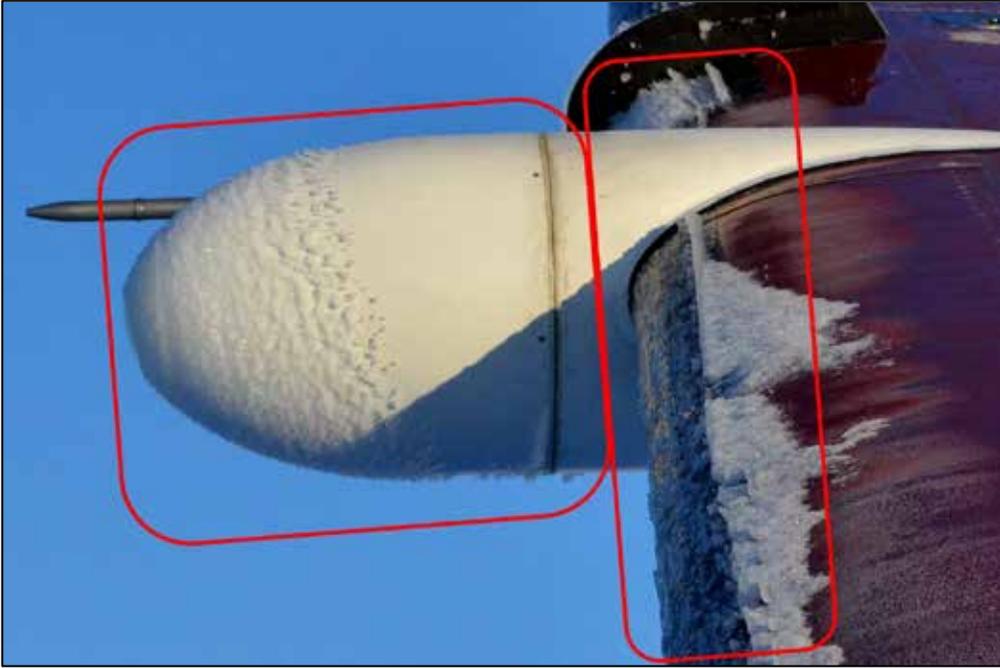
Mixed ice²³ up to 1.5 inches thick was observed on the unprotected surfaces of the aircraft (Photo 2 and Photo 3). Protected surfaces had residual ice. Ice was also observed aft of the protected surfaces, on the undersides of the wings. The windshields were obscured with ice accretion, except for a small area protected by the electrically heated windshield anti-ice panel. The propeller spinner and radome had mixed ice, extending aft to approximately the midpoint of the components.

Photo 2. Red solid outlines indicate ice accretion from the flight on the radome of the right wing and ice ridges aft of the de-ice boots on the leading edge of the wing

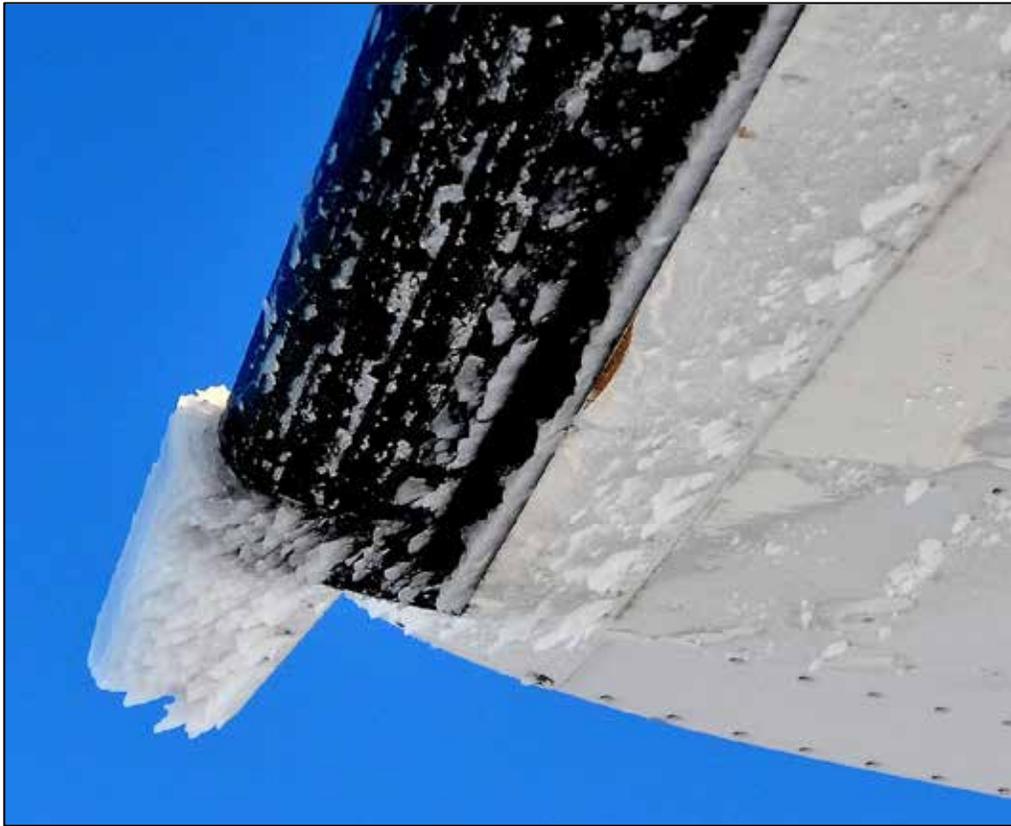
Photo 3. Ice accretion on the outer portion of the right horizontal stabilizer, and beneath and aft of the de-ice boot

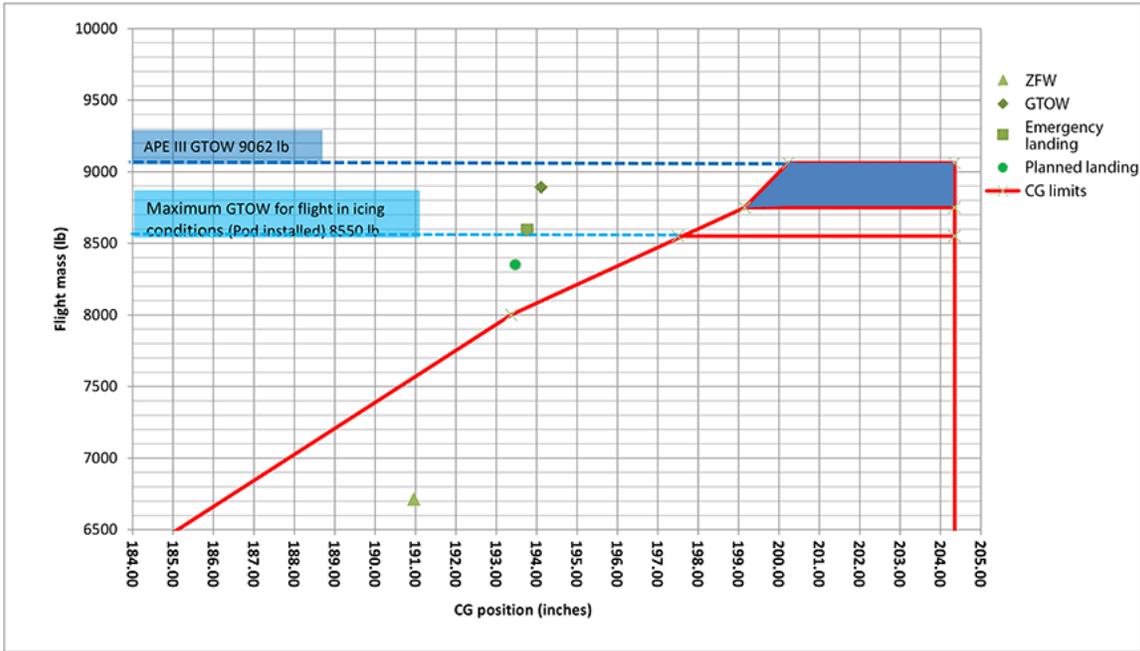
Appendix B – C-FKAY weight-and-balance calculations

Passenger weights were a mix of actual and standard, and passenger seat locations were later determined through interviews. The aircraft had departed at a gross take-off weight of 8892 pounds, which was 342 pounds above the maximum certified take-off weight for flight into known icing conditions.

The Cessna 208B certification for flight into known icing conditions limits the maximum gross take-off weight to 8550 pounds. This limit ensures that aircraft performance meets the requirement of United States *Federal Aviation Regulations* (FARs) 23.1419. As a direct result of previous accidents, many airworthiness directives have been issued to increase awareness of the risks associated with flight in icing conditions. The pilot had not considered the icing conditions for the weight calculation because they had not appeared in a pilot report (although they had been forecast in a GFA); consequently, the aircraft departed 342 pounds over the certified maximum weight for known icing conditions. Increased weight results in an increased stall speed and degraded climb performance.

Inadequate awareness of aircraft limitations in icing conditions and incomplete weight-and-balance calculations led to the aircraft being dispatched in an overweight state for the forecast icing conditions.

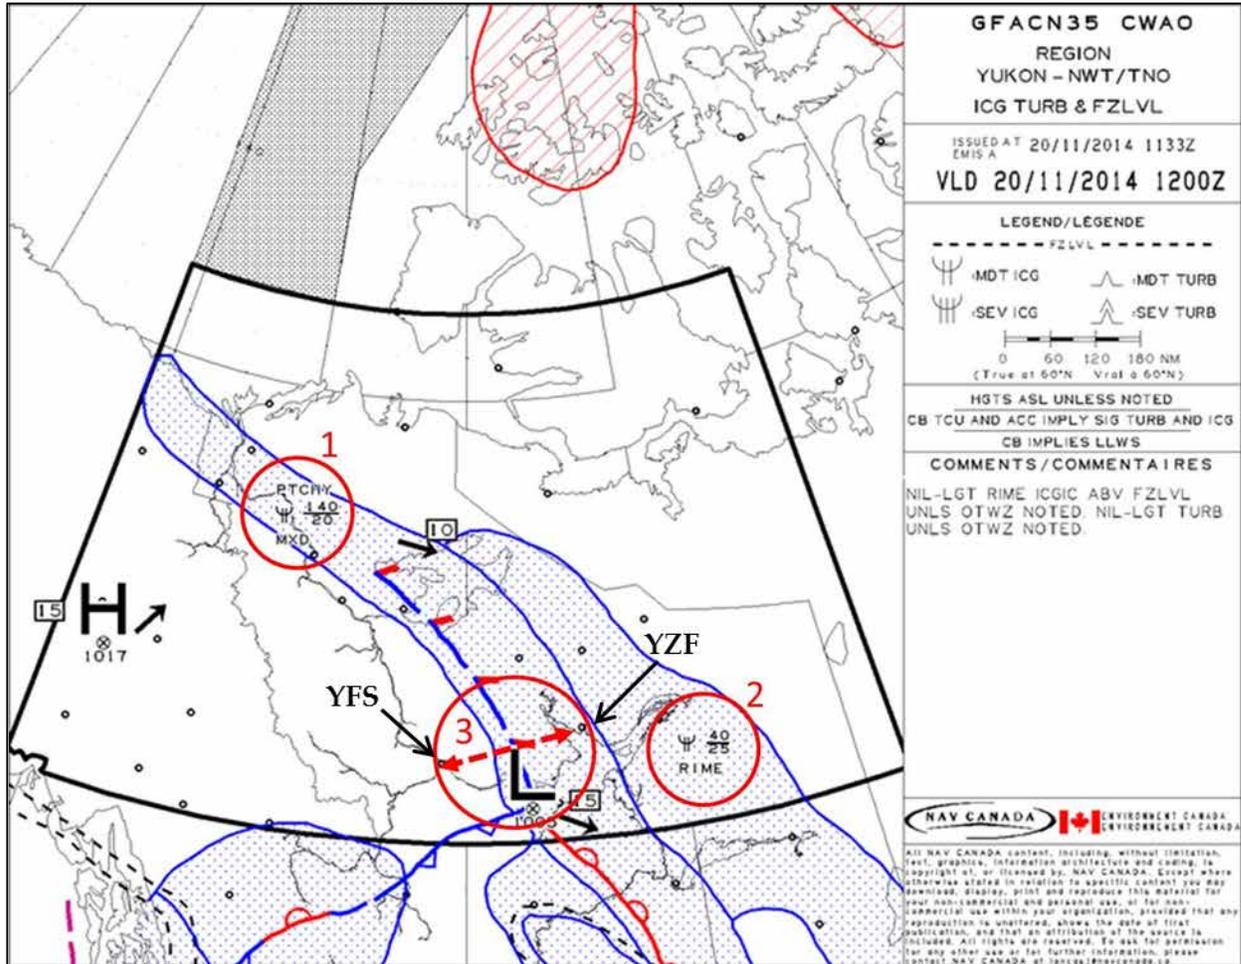
Appendix D – Graphical area forecast: Icing and turbulence

The GFA used by the pilot indicated mixed moderate in-flight icing from 2000 feet to 14 000 feet above sea level (asl) for the flight-planned route. However, the pilot misread the GFA and assumed that icing conditions were moderate rime from 2500 to 4000 feet, as depicted for the area east of Yellowknife. As well, there was a general belief among company pilots that the GFAs for the region were overly conservative and that their accuracy was unreliable in regard to forecast icing conditions. This belief led to the minimization of the information available and a lack of vigilance in its use.

This lack of vigilance resulted in an abbreviated weather analysis, which led to an incomplete picture concerning where the icing conditions were. Specifically, the pilot thought that, by climbing, the aircraft would exit the icing conditions by 4000 feet asl, whereas the conditions were forecast to occur at up to 14 000 feet asl.

- 1 Symbol for patchy moderate mixed ice forecast between 2000 and 14 000 feet asl
- 2 Symbol for moderate rime ice forecast between 2500 and 4000 feet asl
- 3 Route of flight

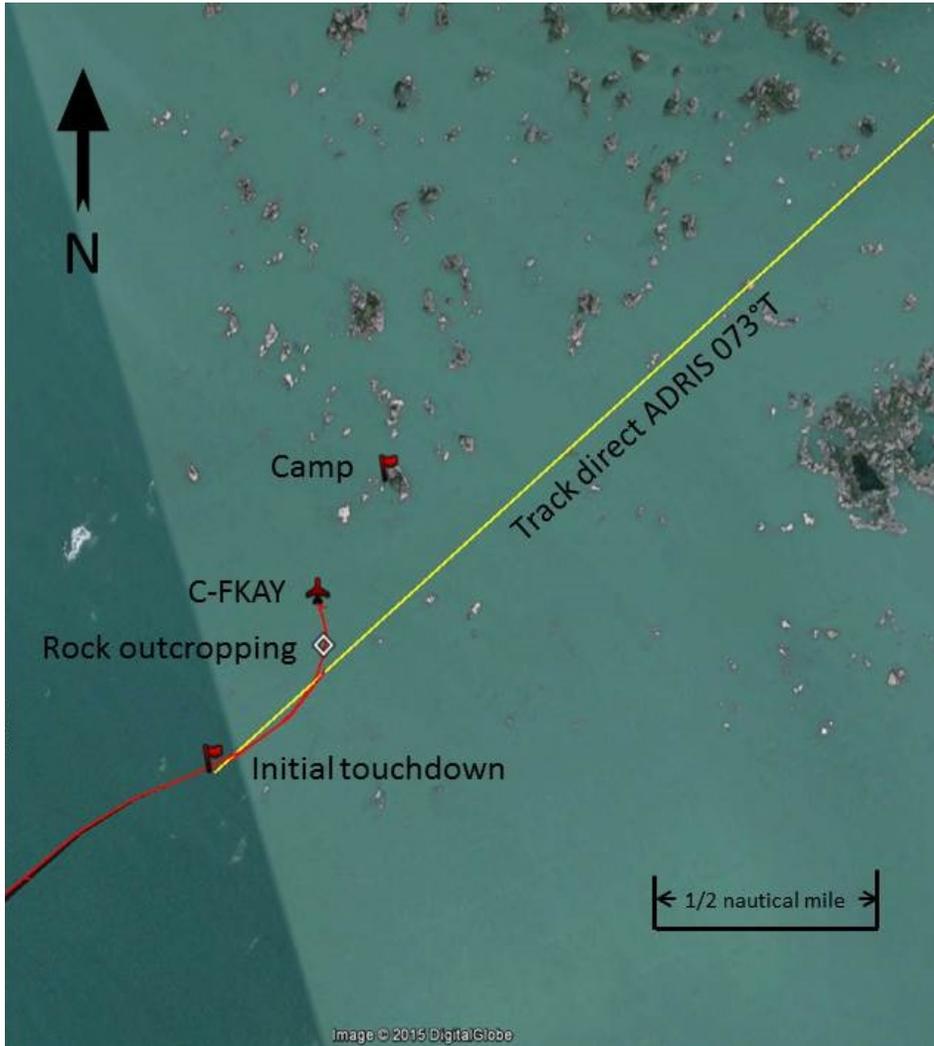
Appendix H – Occurrence site

The initial touchdown was on the snow-covered frozen surface of Great Slave Lake on a track of 075°T, approximately 1600 feet north of open water. The aircraft continued, with 3 separate wheel contacts, before settling onto the surface. At approximately 2350 feet from the initial contact, the aircraft struck a rock outcropping, resulting in separation of the nose and the left main landing gear from the airframe. Damage to the belly cargo pod resulted in discharge of some of its contents. The aircraft slid to the left and came to rest on the cargo pod and left wing, approximately 600 feet beyond the outcropping. The area was surrounded by several outcroppings that increased in size and number toward the shoreline along the original extended flight-path trajectory (Appendix H).

The pilot was aware of Cessna's requirement to immediately exit any in-flight icing conditions greater than a light accretion rate. He continued flight, attempting to climb out of the icing conditions, in the belief that icing would end as he flew outside of the altitudes where it was forecast. The amount of time spent in the moderate to severe icing conditions had a detrimental effect on the performance of the aircraft. Based on SKYTRAC data and the initial recognition of the ice encounter at 6000 feet, it was calculated that the aircraft continued flight for approximately 15 minutes before the decision was made to return to Yellowknife Airport (CYZF). The total flight time in icing conditions was 30 minutes, terminating on Great Slave Lake (Appendix H).
