CIVIL AERONAUTICS BOARD  
ACCIDENT INVESTIGATION REPORT

NORTHWEST AIRLINES, INC. - MARTIN 202, NEAR BUTTE, MONTANA,  
NOVEMBER 7, 1950The Accident

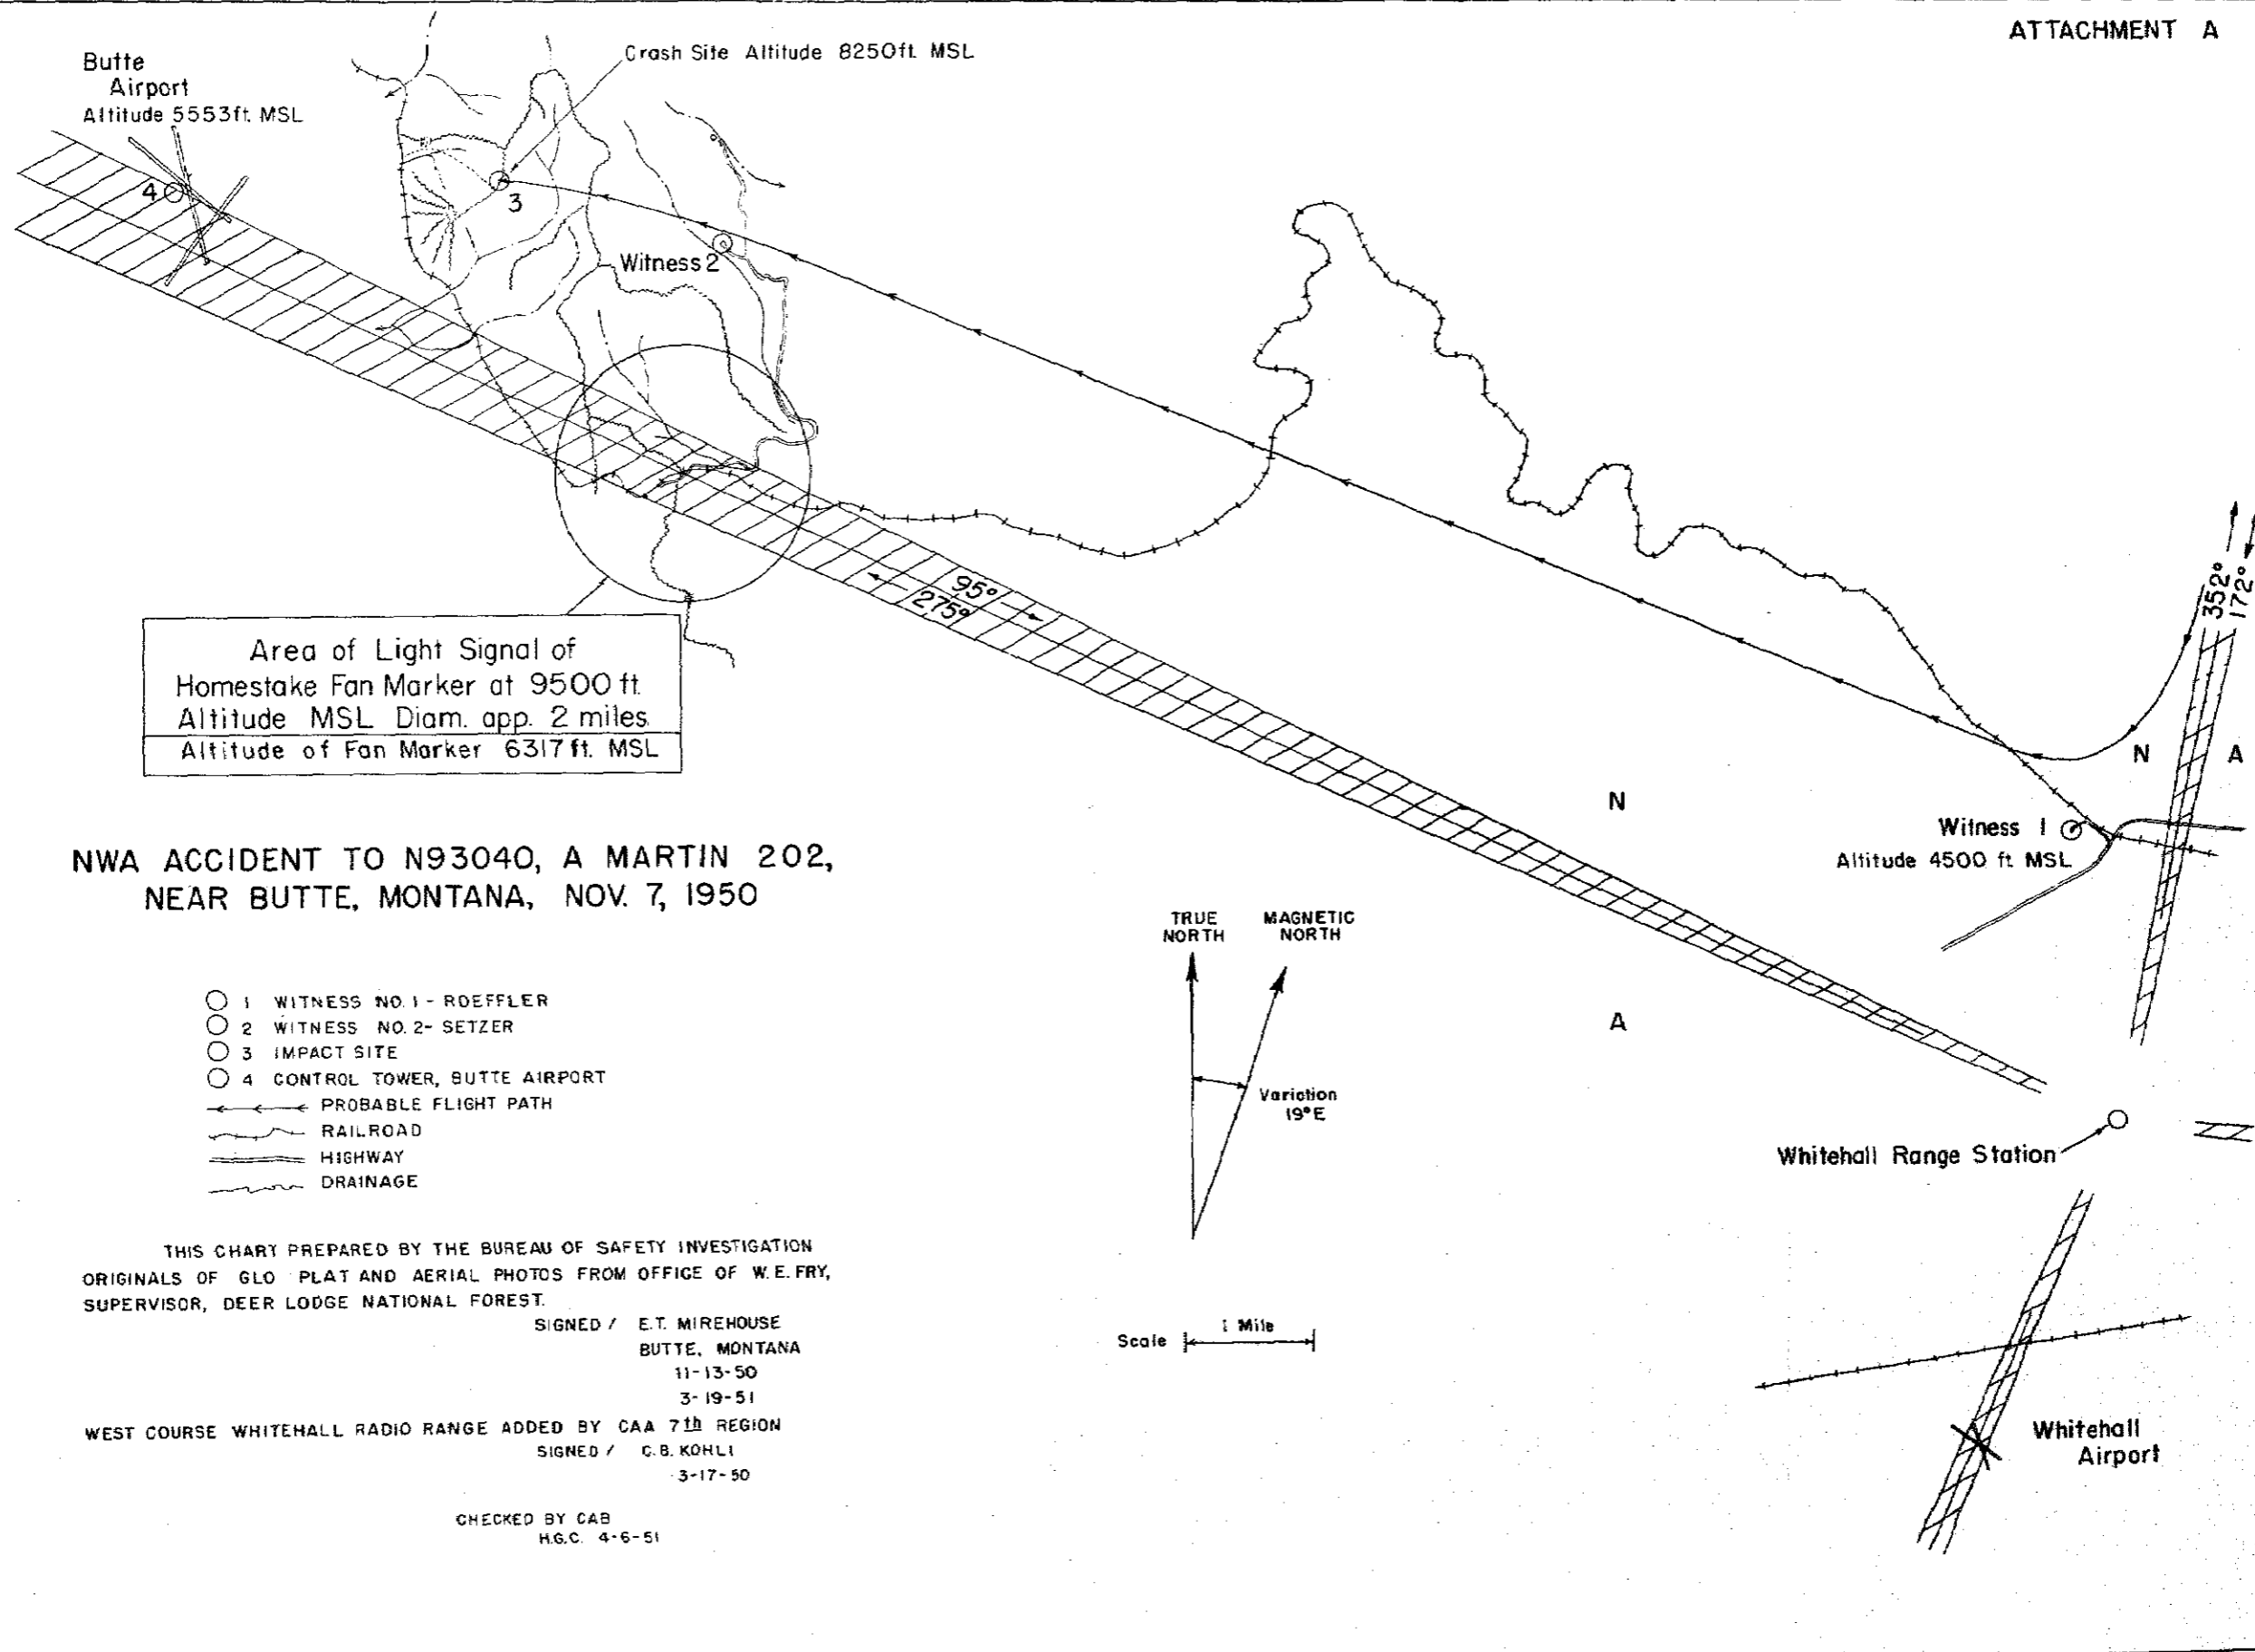
**NWA ACCIDENT TO N93040, A MARTIN 202,  
NEAR BUTTE, MONTANA, NOV. 7, 1950**

One witness, a rancher who lives approximately 13 miles east southeast of the accident site, was in his house located about 2-1/2 miles north of the Whitehall Range Station. His position is shown on Attachment A as Witness No. 1 (Roffler). Mr. Roffler returned from milking his cows and upon entering the house noted the time was about 0805 or 0810. From the bathroom window he saw the aircraft about one-half mile to the north of his house and saw it continue on a straight course in a northwesterly direction toward a mountain until it disappeared from his view as it entered a storm. He habitually checked the time each morning at the conclusion of these chores to insure getting his two daughters ready for the school bus which generally arrived about 0820.

The other witness was outside her home in the mountains, located about two miles east of the crash site and about two miles north of the Homestake Fan Marker. Her position is shown on Attachment A as witness No. 2 (Setzer). Mrs. Setzer testified that she came into the house to hear the 0800 news broadcast but the clock indicated 0810, so she went back out to finish her work. She further stated that some minutes later she heard the aircraft come from the east, pass north of her home, continue to the west and then heard the crash. Falling snow and low clouds prevented her from seeing the aircraft.

Attachment A places these witnesses at their proper positions relative to one another, to the west leg of the Whitehall Range, the Homestake Fan Marker, the site of the crash and the Butte Airport. It seems obvious that the flight came southbound down the north leg of the Whitehall Range as it should have done and then, according to witness No. 1 (Roffler) who saw the aircraft approximately one-half mile northwest of his home heading in a northwesterly direction, turned right on approximately the correct heading for Butte while still some three miles short of the range station. The weather forecasts indicated there would be occasional vertical visibility between snow showers and clouds, and this was verified by the flight's last message at 0814, stating that it had vertical visibility at 10,500 feet. Under these conditions, it seems probable that the pilot anticipated finding suitable weather for the last few miles to allow him to go through Homestake Pass visually.

If we accept the probable flight path as it appears on Attachment A, the flight nearly paralleled the west leg of the Whitehall Range and would definitely have passed appreciably to the north of where it would have received the visual signal of the Homestake Fan Marker. The flight may or may not, depending upon how the control was set, have received the aural indication of the fan marker. The direction of flight at the time of impact was estimated to be 309 degrees true or 290 degrees magnetic.

Accordingly, the Board concludes that the final few miles prior to the crash were flown visually under conditions of intermittent and alternating instrument and visual flight and appreciably to the right (north) side of both the west leg of the Whitehall Range leg and the Homestake Fan Marker, and that the aircraft struck the ridge during a local snowstorm.
