### REPORT OF AF AIRCRAFT ACCIDENT

4. DATE OF ACCIDENT  
**26 Feb 54**

1. AIRCRAFT No. **52-3894 A**

2. TYPE, MODEL, SERIES AND BLOCK No. **C-119G**

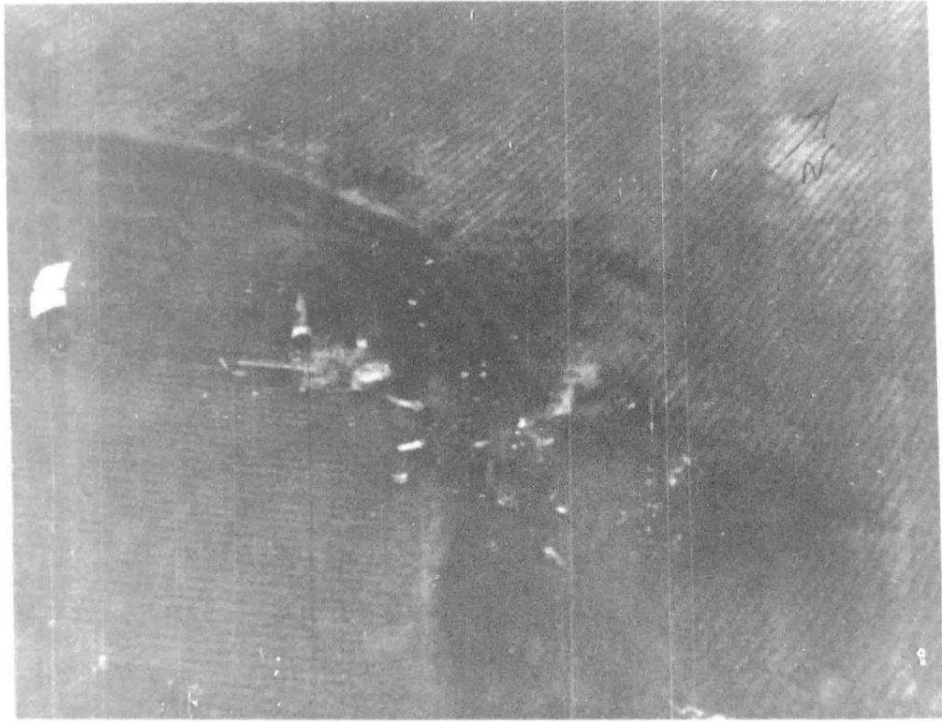
Aerial view looking N.E.

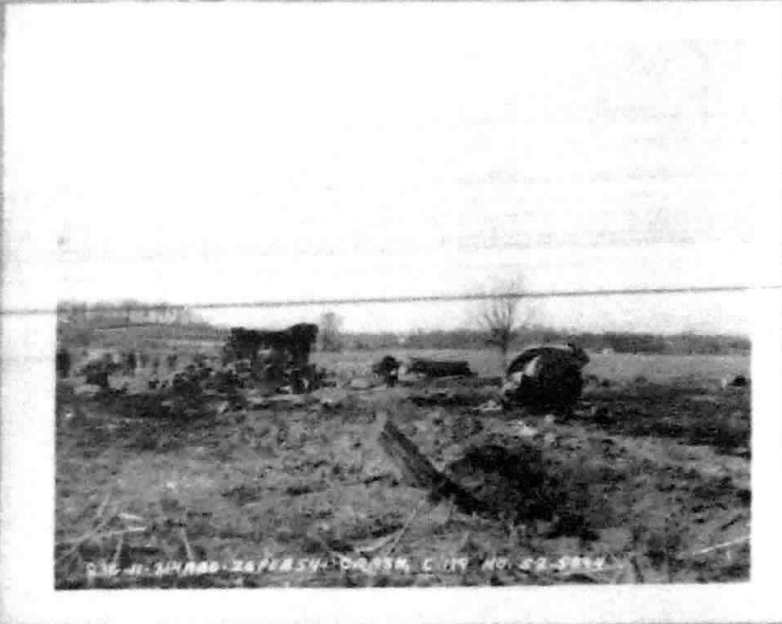
View of 1st impact pt.  
looking west

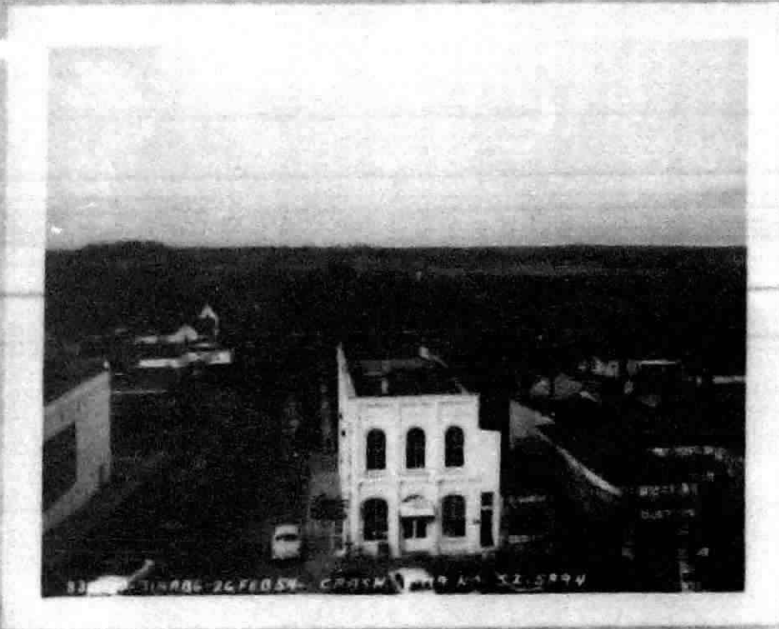
Section of top right wing  
Top of "Tea Room", facing  
west. Position 4 on map.

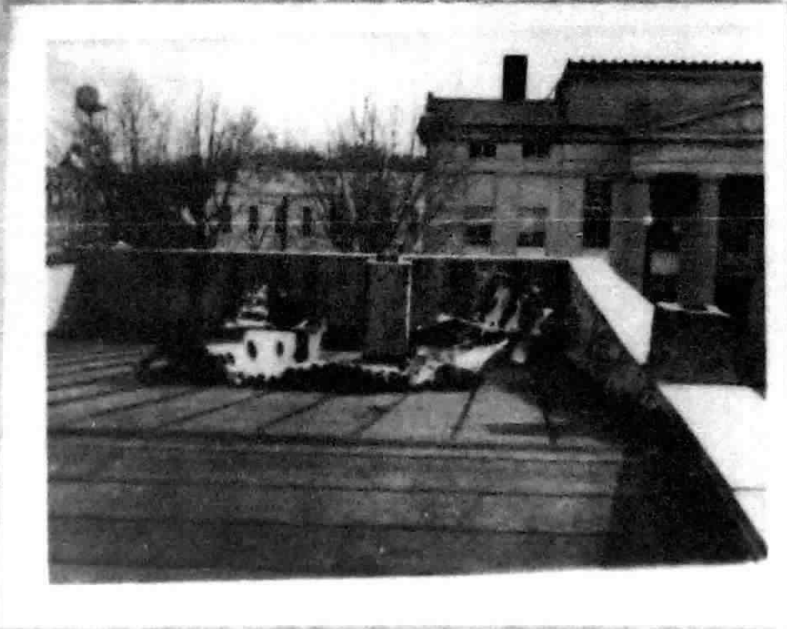
Close up of right wing  
section

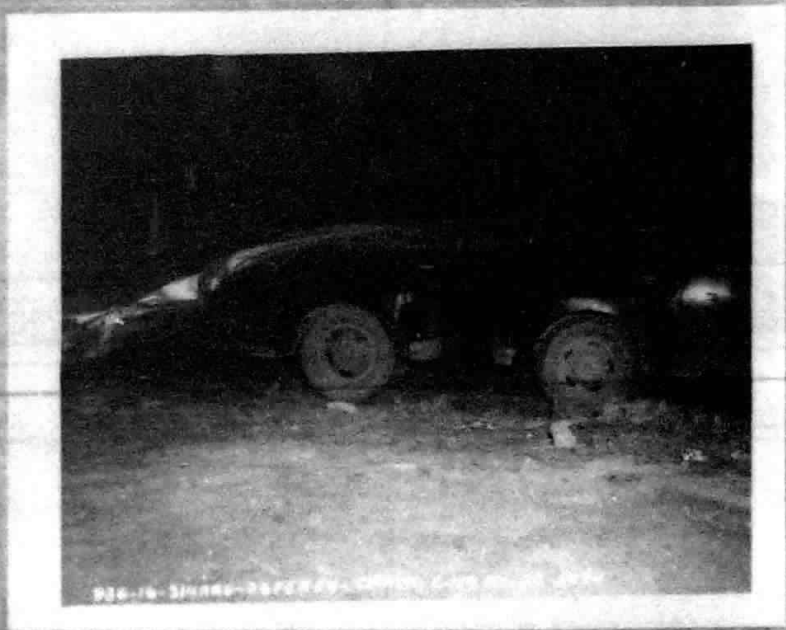
Horizontal stabiliser  
leading edge of surface sho  
showing. Pos 10 on map

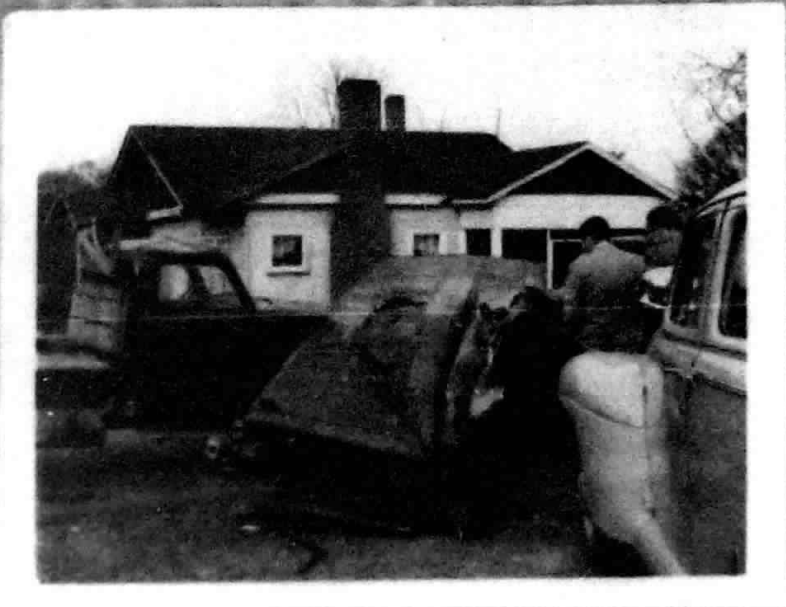
Right side of Horizontal  
stabiliser

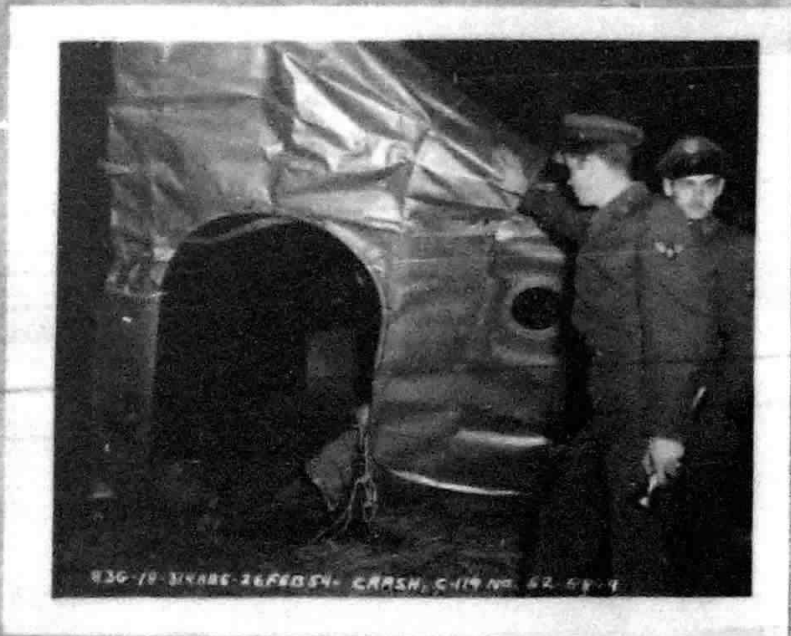
Left clan shell door.  
Pos. 13 on map

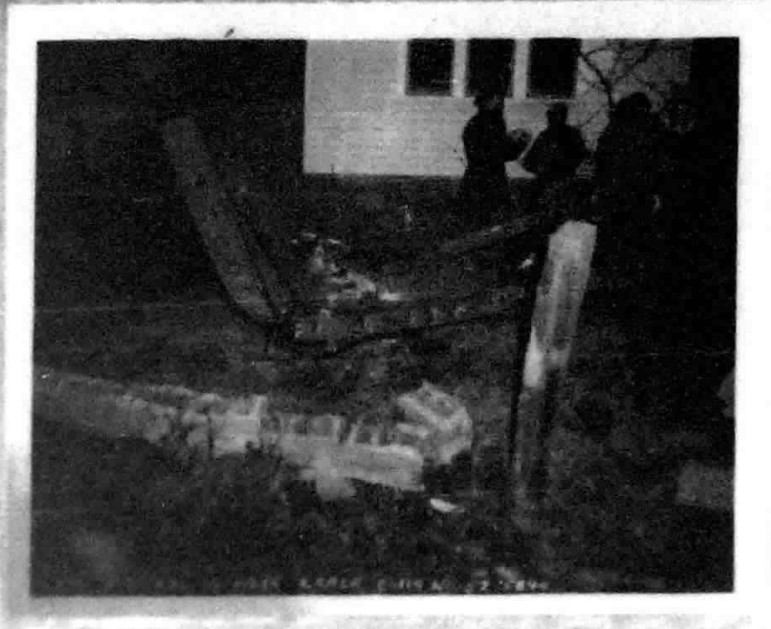
Left clan shell door in  
position where it was  
found.

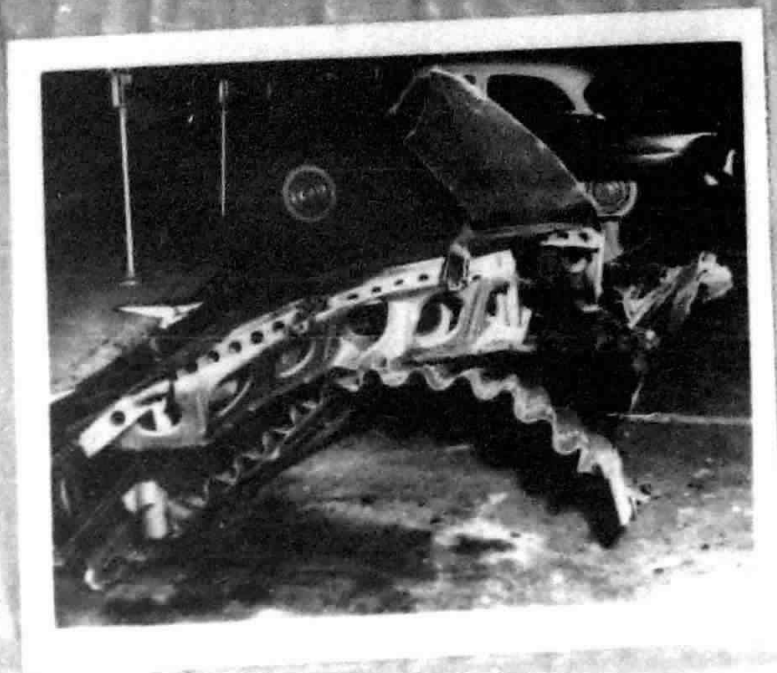
Section of right wing  
from tip inboard 16 feet.  
Pos. 2 on map.

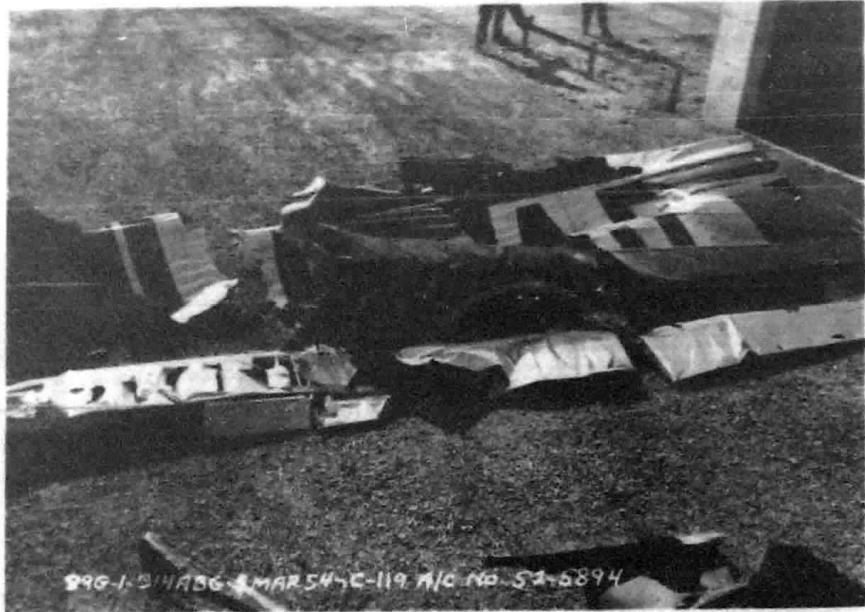
1. The wing indicated that an extremely high torsional moment had been applied.
2. Evidence of high positive bending was also indicated by the deformations that had occurred, that is, compression buckling of the upper surface corrugation.
3. The wing failed, apparently simultaneously, in four separate and distinct places in what was probably a combined condition of high torque and bending.
4. No evidence of fatigue was apparent in the portion of the right wing which could be pieced together. All fittings and spar caps examined on the right wing indicated tension and/or tension and shear type failures with clean breaks.
5. A spot check of skin and spar web thicknesses indicated conformance with blueprint requirements.

Trailing edge of reconstructed right outboard wing

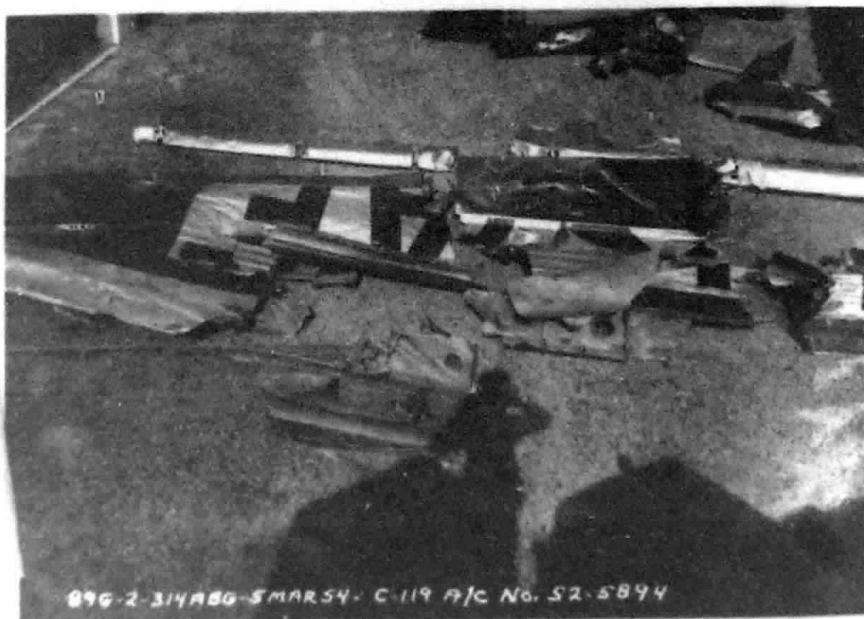
Leading edge of reconstructed right outboard wing.
