No 27Aerovías Nacionales de Colombia (Avianca), Constellation aircraft crashed
9 kilometres west of Lajes Airport, Azores, 9 August 1954. DGCA Portugal
Accident ReportCircumstances

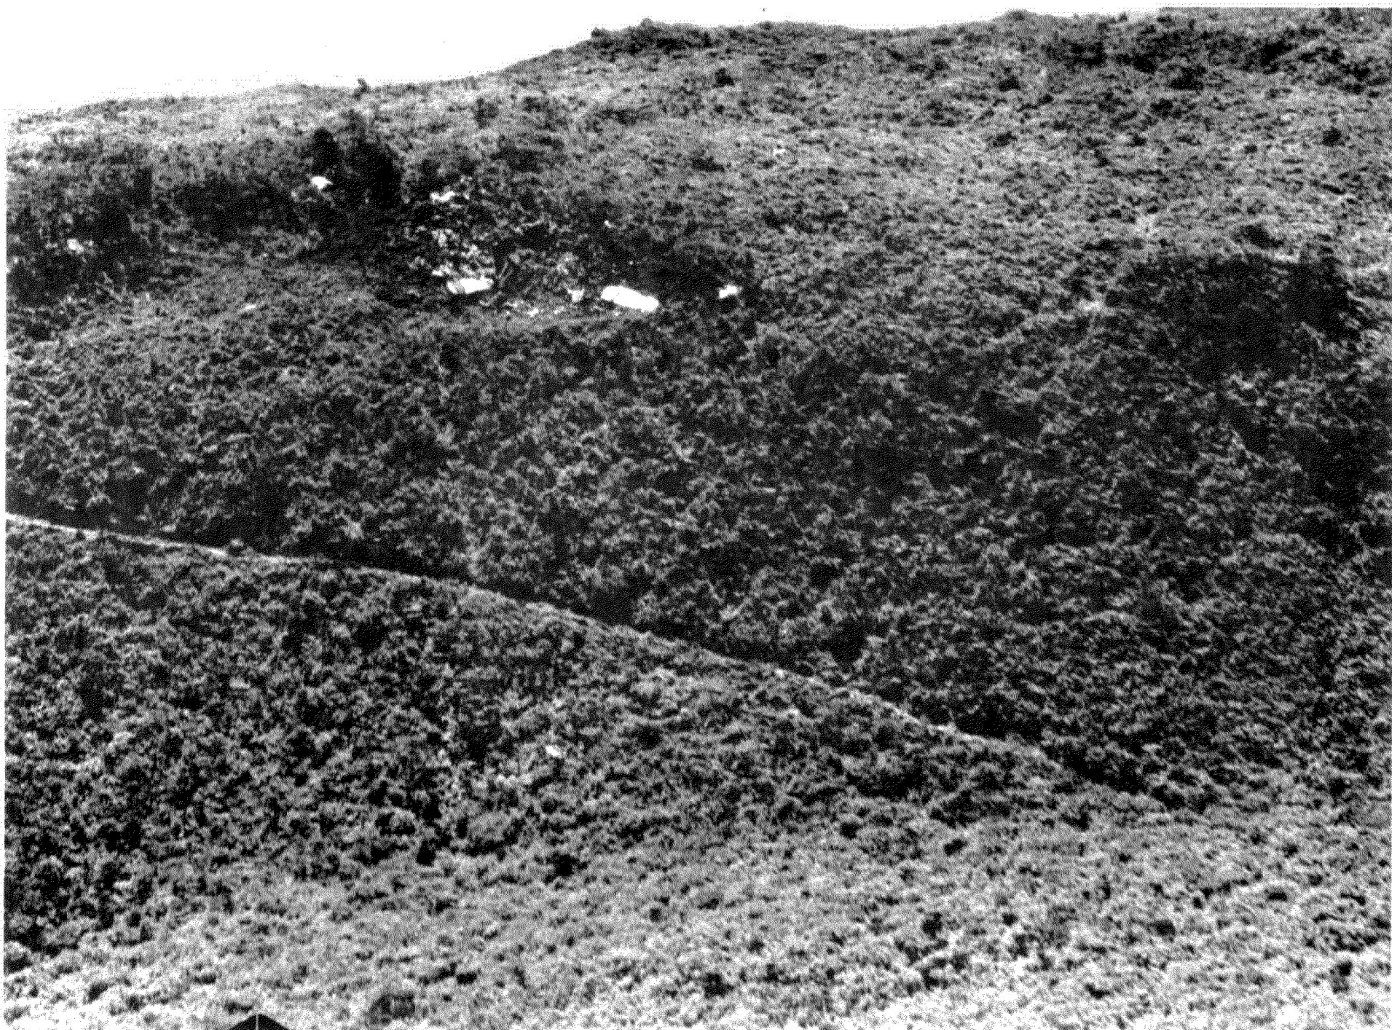
Figure 28

The wreckage was found near the Monte do Boi, in the vicinity of Caldeira de Agualva, 9 000 metres west-south-west of Lajes Airport at an elevation of 620 metres at the crest of a slope of approximately 20%.

The chart at fig. 29 shows the scene of the crash and a horizontal projection of the track assumed to have been flown by the aircraft. The photograph at fig. 28 shows the scene of the accident, part of the wreckage being just distinguishable and the remainder scattered beyond the crest of the mountain. Not only did the marks on the ground indicate a violent impact, but all the evidence led to the belief that the pilot did not see the obstacle in his path.

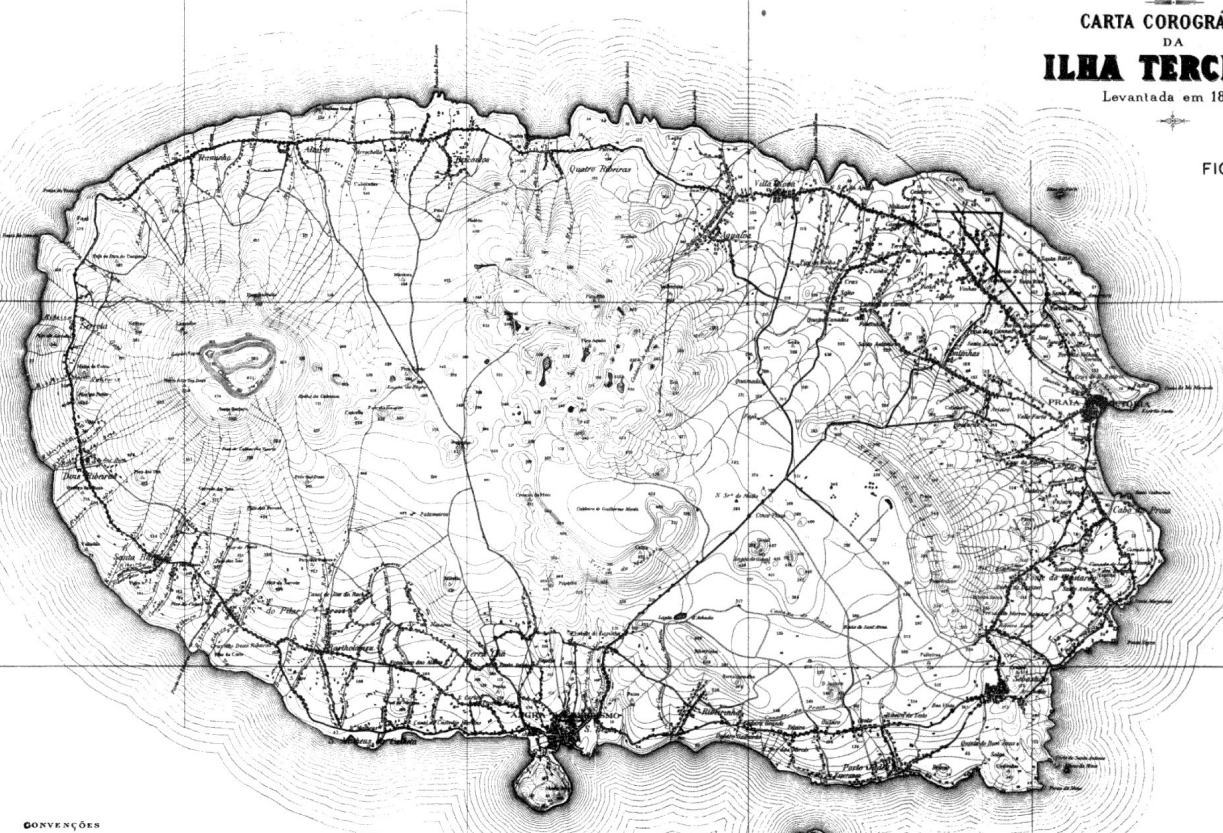
FIG.- 29

In view of the nature of the terrain, it was difficult to believe that the aircraft could have come down at this point without first hitting some other high ground. It was, therefore, possible to plot its presumed track, prior to the crash, by drawing a line over the only possible point lower than the crash scene. It was thus determined that the aircraft flew on a heading of approximately 205° (magnetic) at an altitude lower than the elevation of the point where it eventually crashed.

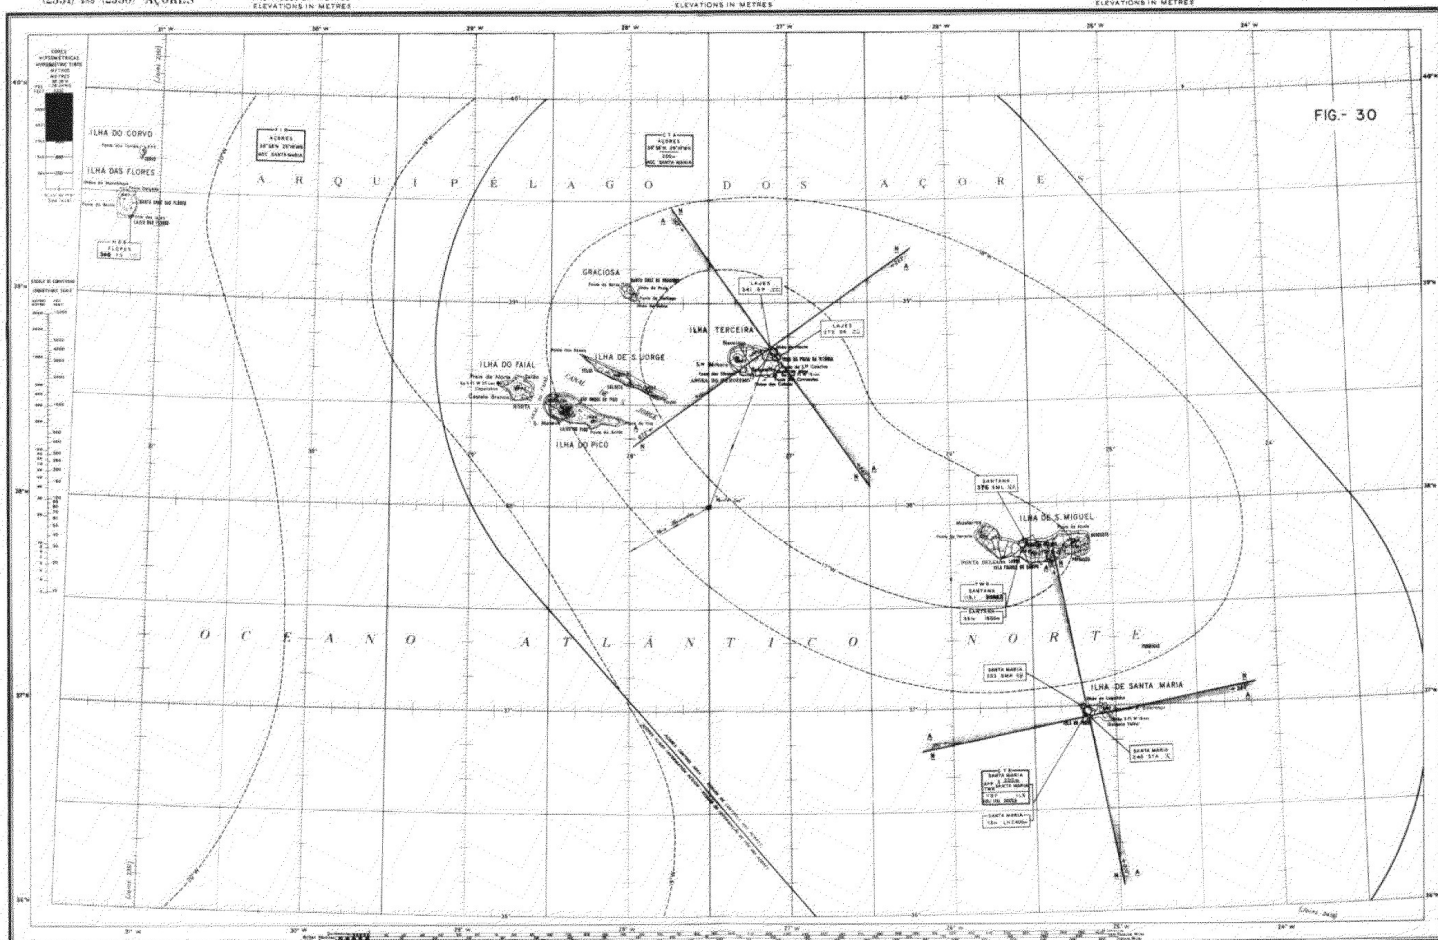
Fig. 30

The point known as "Ponto Sul" is shown on the reproduced 1:1 000 000 chart at Fig. 30. Examination of this chart will immediately explain the reason for the adoption in the Azores control area of the standard procedure whereby aircraft are required to fly over this point before proceeding towards Bermuda, in order to avoid the high ground on Terceira, S. Jorge, Pico and Faial Islands.
