Scottish Airlines (Prestwick) Limited, Avro York, G-ANSY, crashed at Zurrieq, Malta on 18 February 1956. Report of Court of Inquiry appointed by His Excellency the Governor of Malta.

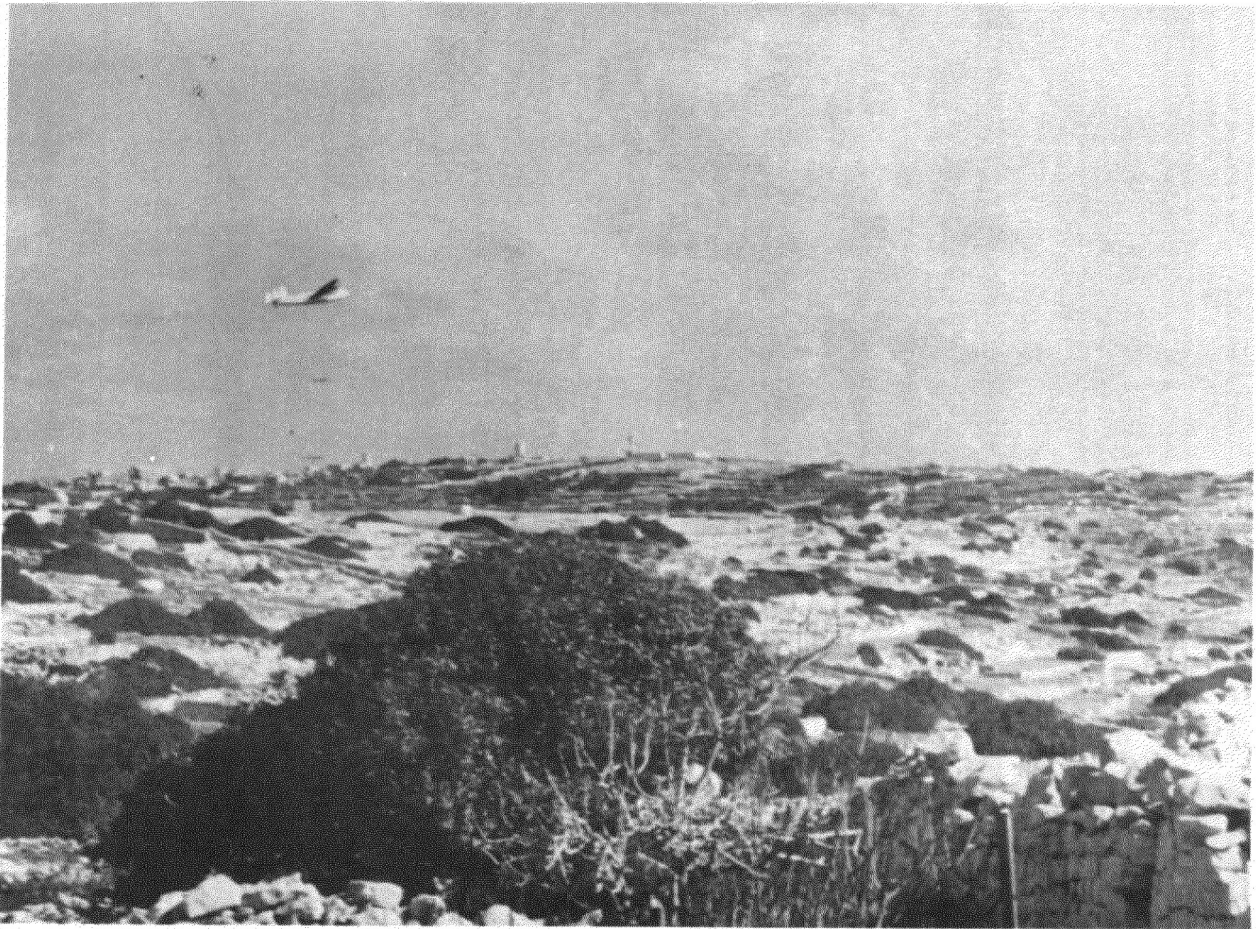
Figure 8

BEFORE - This photo was taken just a few moments before Avro-York, G-ANSY, crashed into the ground on the cliffs near Zurrieq, Malta, on 18 February 1956.

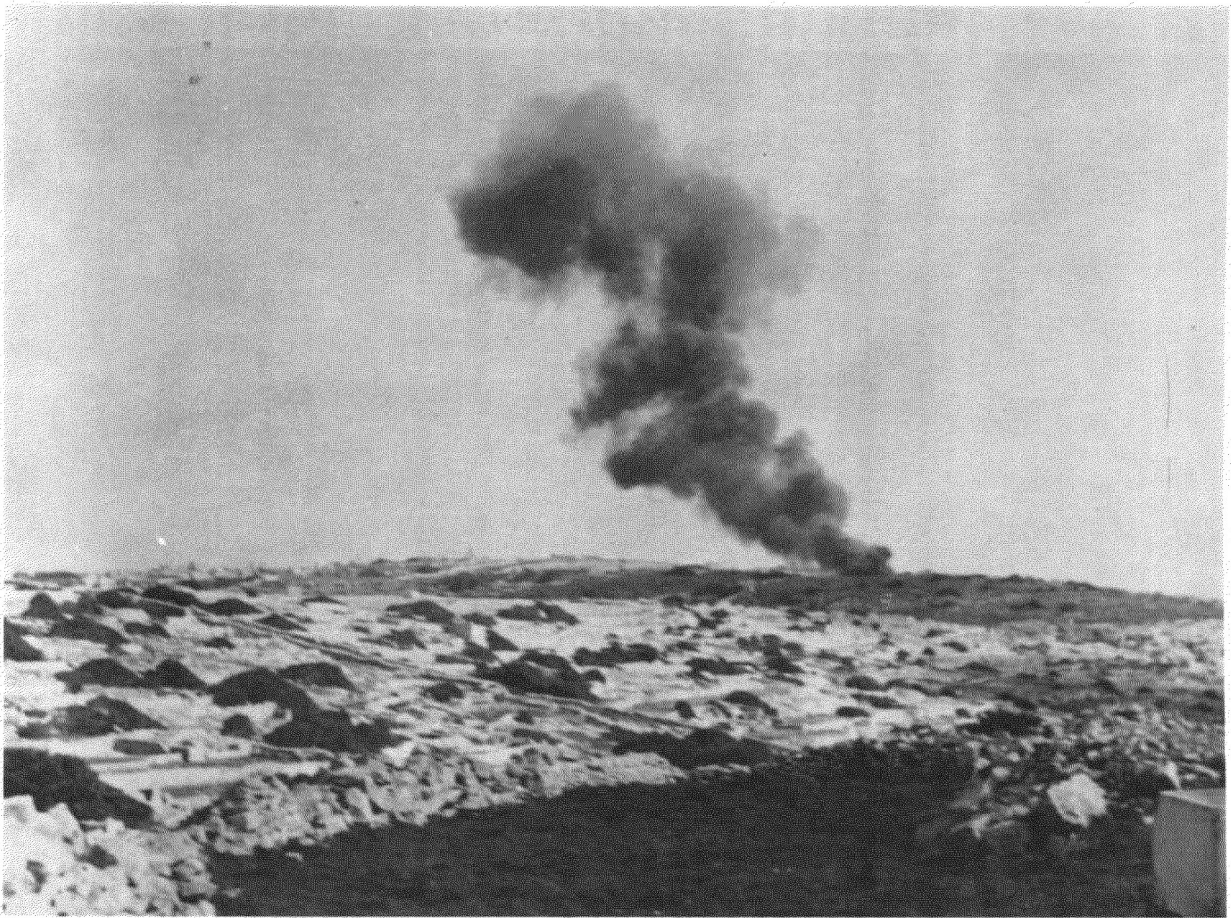
Figure 9

AFTER - The same Avro-York a few minutes later.
It nose-dived into the ground and blew up
on impact killing all 50 persons aboard.

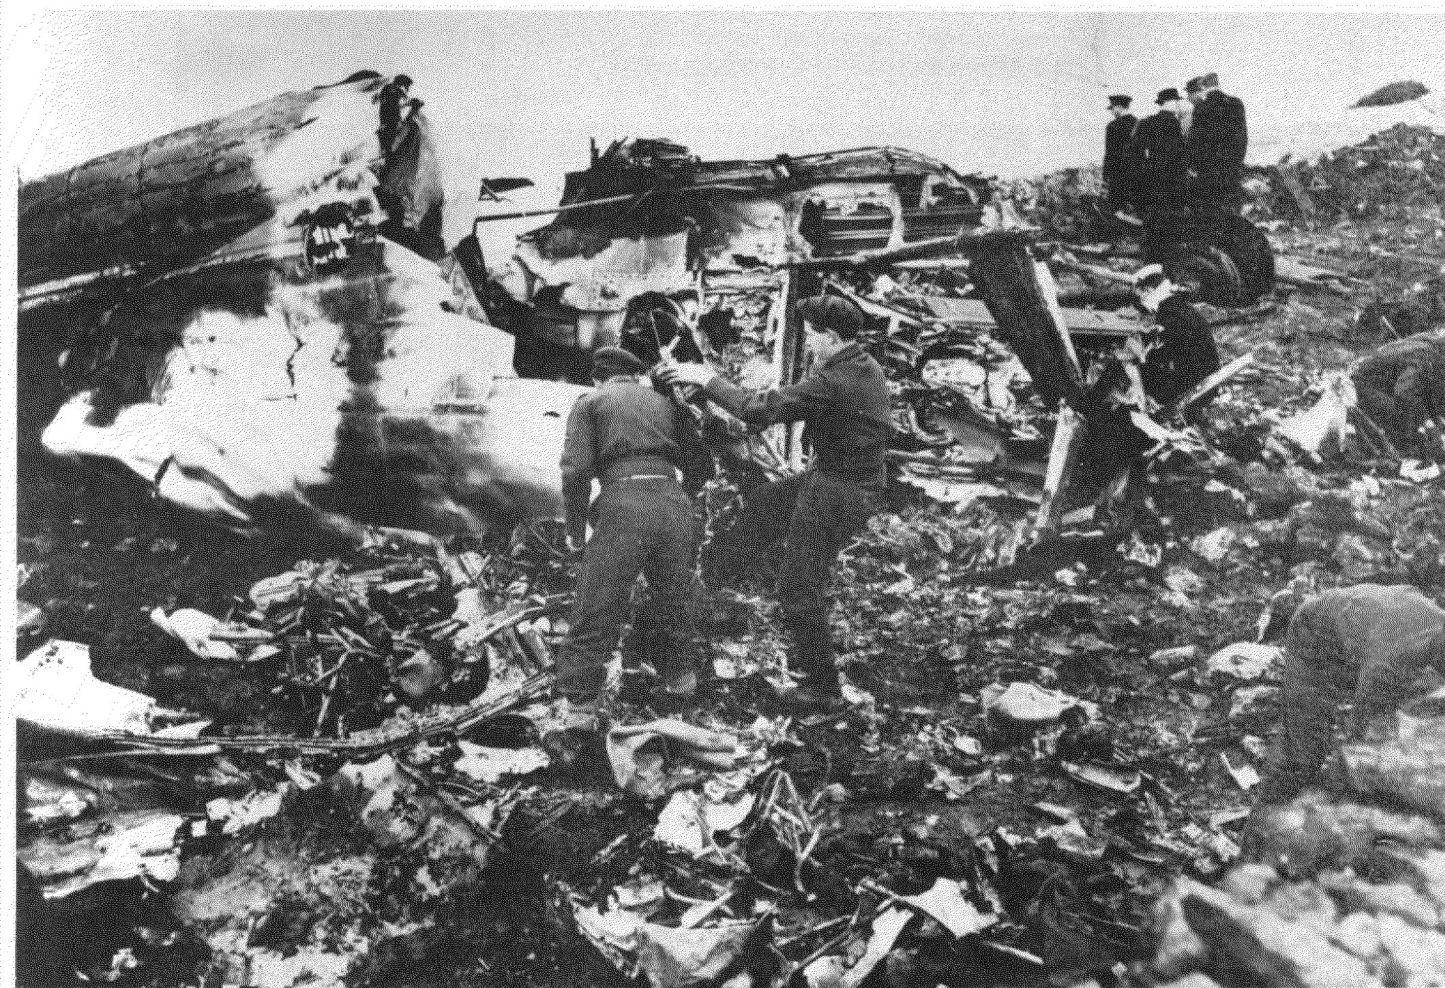
Figure 10
General view of wreckage area of Avro-York, G-ANSY
