No. 48

Vickers Viscount, G-AOYF, crashed on landing at Jan Smuts Airport, Johannesburg, South Africa, on 20 October 1957. Report released by the Department of Transport, Union of South Africa.

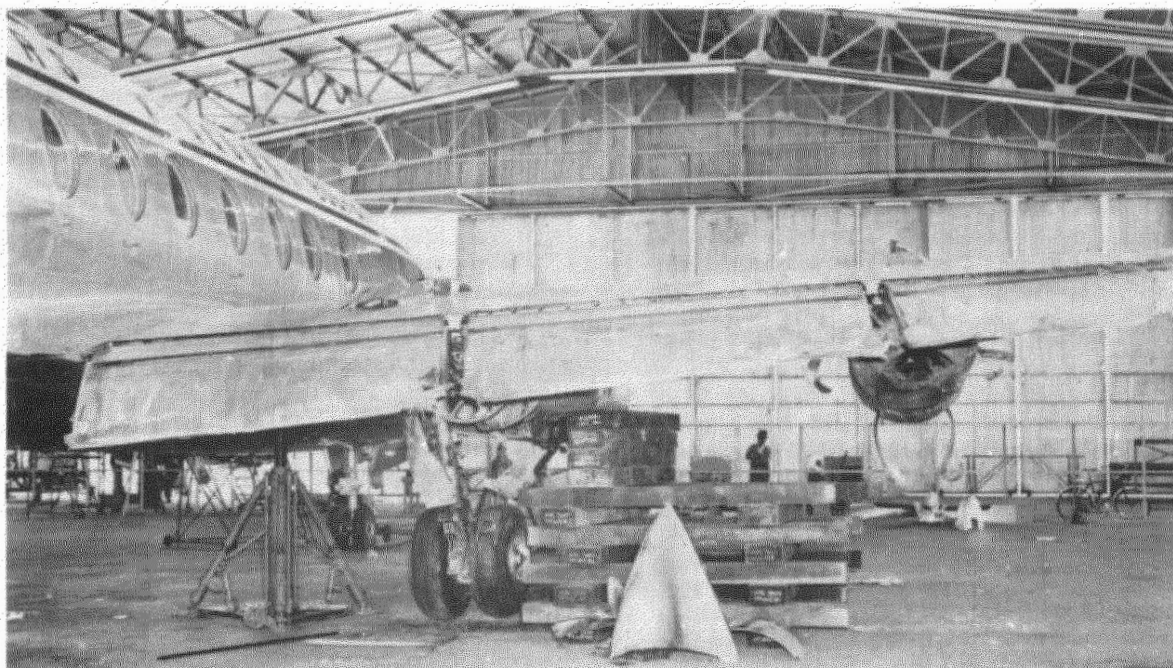
FIGURE 26

Special attention was paid to the possibility of the starboard bogie being defective before the initial touchdown. No evidence of any faulty material, malfunctioning or defects was found. The backstay to which the jack was attached was sheared away from the trailing edge member. The jack, oleo leg, and radius rod, as well as the downlock, were satisfactory. The area above the wheel bay and ahead of the trailing edge member had been forced upwards and numerous rivets sheared. A bolted repair in the outer diaphragm of the wheel bay was satisfactory. The skin below this repair was damaged. The outer tire had burst, and the running surface was worn flat. The cross shaft for the leg had sheared away a portion of the metal structure above the bearing. (The piece of sheared metal was found 73 yards beyond the point of initial touchdown.) As a result of this and heavy loading in the diaphragms, the cross shaft slipped out of its outer bearing.

The misjudged roundout resulted in a heavy landing which caused the starboard undercarriage to collapse.

GENERAL VIEWS OF THE STARBOARD SIDE OF G-AOYF WHICH WAS DAMAGED WHEN IT MADE A HEAVY LANDING AT JAN SMUTS AIRPORT, JOHANNESBURG, SOUTH AFRICA ON 20 OCTOBER 1957
