No. 17

KLM, Lockheed Electra L-188C, PH-LLM, accident near Cairo Airport, United Arab Republic on 12 June 1961. This summary is based on a translation of the report, dated 6 March 1963, of the Aircraft Accident Investigation Board The Netherlands.

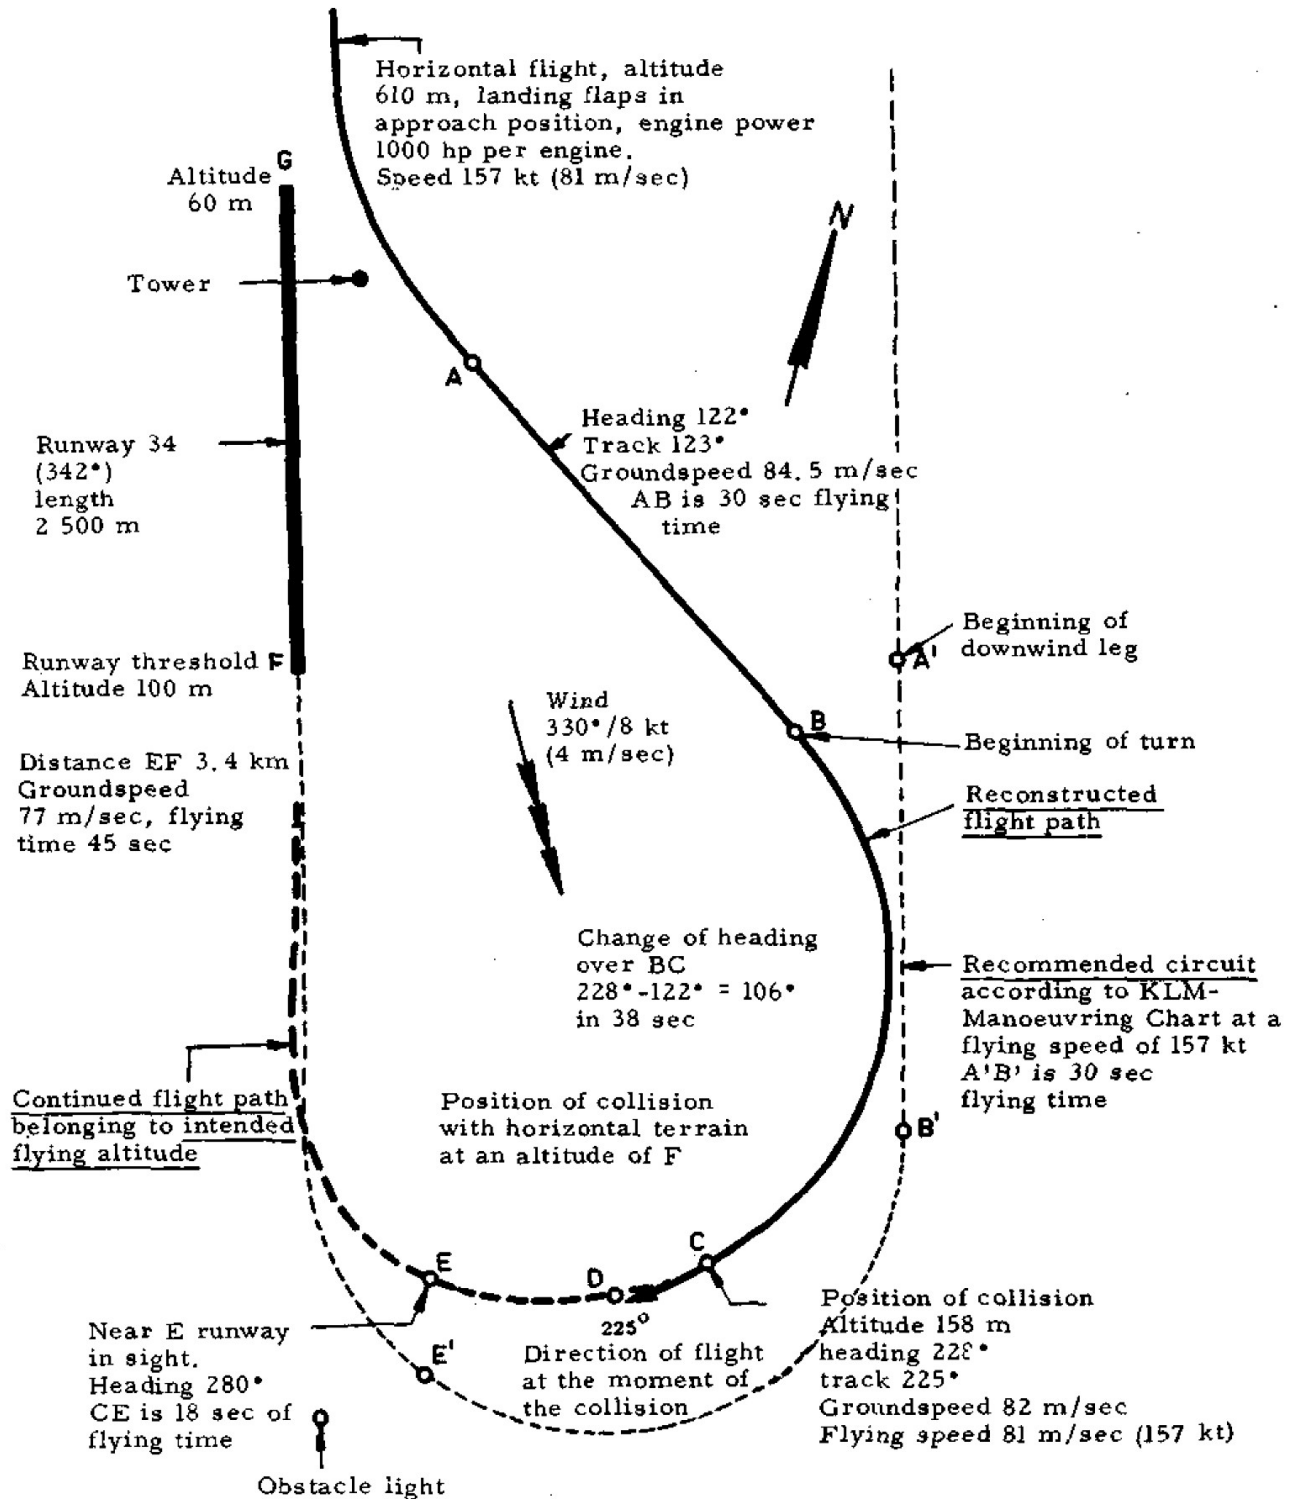
FIGURE 5

Reconstruction of the flight path (see Figures 5 and 6)

From the marks on the ground it was inferred that at impact the aircraft was on a 225° heading, the angle of bank was 22° and the ground speed was 159 kt. The flaps were in the approach position, and the landing gear was down. The wind was 330°/8 kt.

This data gives a flying speed and a heading at time of impact of 81 m/sec and 228° respectively. From the angle of bank at this flying speed follows a rate of turn of 2.80° per second, so that the duration of a turn of 180° was 64 seconds, which is in accordance with the duration of the normal

procedure, which takes 60 seconds. From the speed and the bank a radius of 1 650 m in front of the runway and in respect of the air can be inferred. Assuming that speed and bank were kept the same during the turn and taking due account of the wind, it follows from this radius, from the heading at the moment of impact, and from the probable point where the downwind leg of the circuit was commenced that on the track prior to the turn the track was 123° and the heading 122°. This heading differs 40° from the direction of runway 16, the opposite of runway 34, which concurs with the statement of the pilot-in-command that he changed his heading about 45° to the left, after he reached the airport.

The change of heading between the beginning of the circuit until the moment of the crash was $228^\circ - 122^\circ = 106^\circ$, at the rate of turn as reconstructed, reached in 38 seconds.

If the aircraft had not lost height, it would have come right in front of the runway when continuing the circuit. This shows that the pilot-in-command flew the circuit correctly.

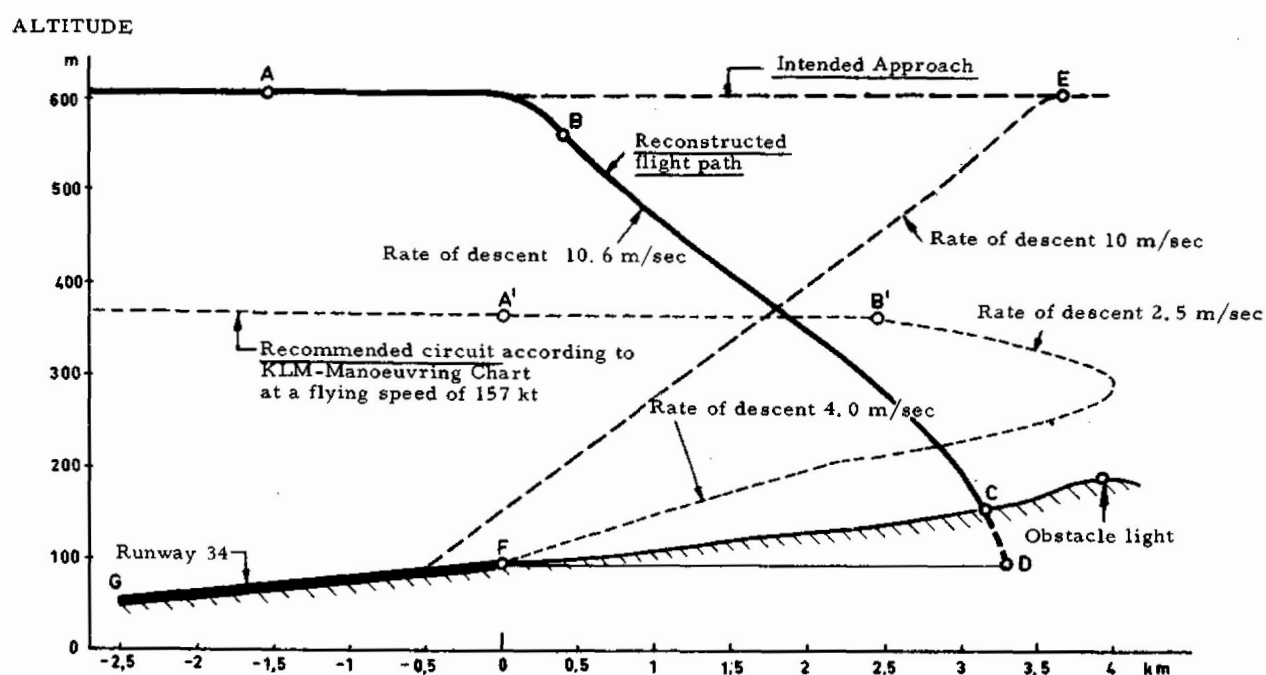
FIGURE 6

The difference in height between the aircraft's altitude on the downwind leg (2 000 ft) and that at the point of the crash (520 ft) is 450 m, so that it must have been descending for 42 seconds. As the turn took 38 seconds, it can be concluded that the power reduction and the lowering of the landing gear must have taken place about simultaneously with the initiating of the right-hand turn.

If the accident area had been at the same altitude as the runway threshold the collision would have occurred 6 seconds later, the difference in altitude only being 187 ft (i.e. 57 m). The heading of the aircraft would then have been 245° so that the pilot-in-command would not have had sight of the runway either, and would not have had occasion to take corrective action during these six seconds.
