Aerolineas Argentinas, Caravelle SE-210-VI-N, LV-HGY, accident at Pajas Blancas Airport, Cordoba Province, Argentina on 3 July 1963. Accident Report No. 1905, published in Information Bulletin No. 11 (Aircraft Accidents), September 1965, by the National Directorate of Civil Aviation, Argentina.

ACCIDENT TO CARAVELLE LV-HGY,  
OF AEROLINEAS ARGENTINAS,  
AT PAJAS BLANCAS, ARGENTINA.  
3 July 1963 3 JULY 1963

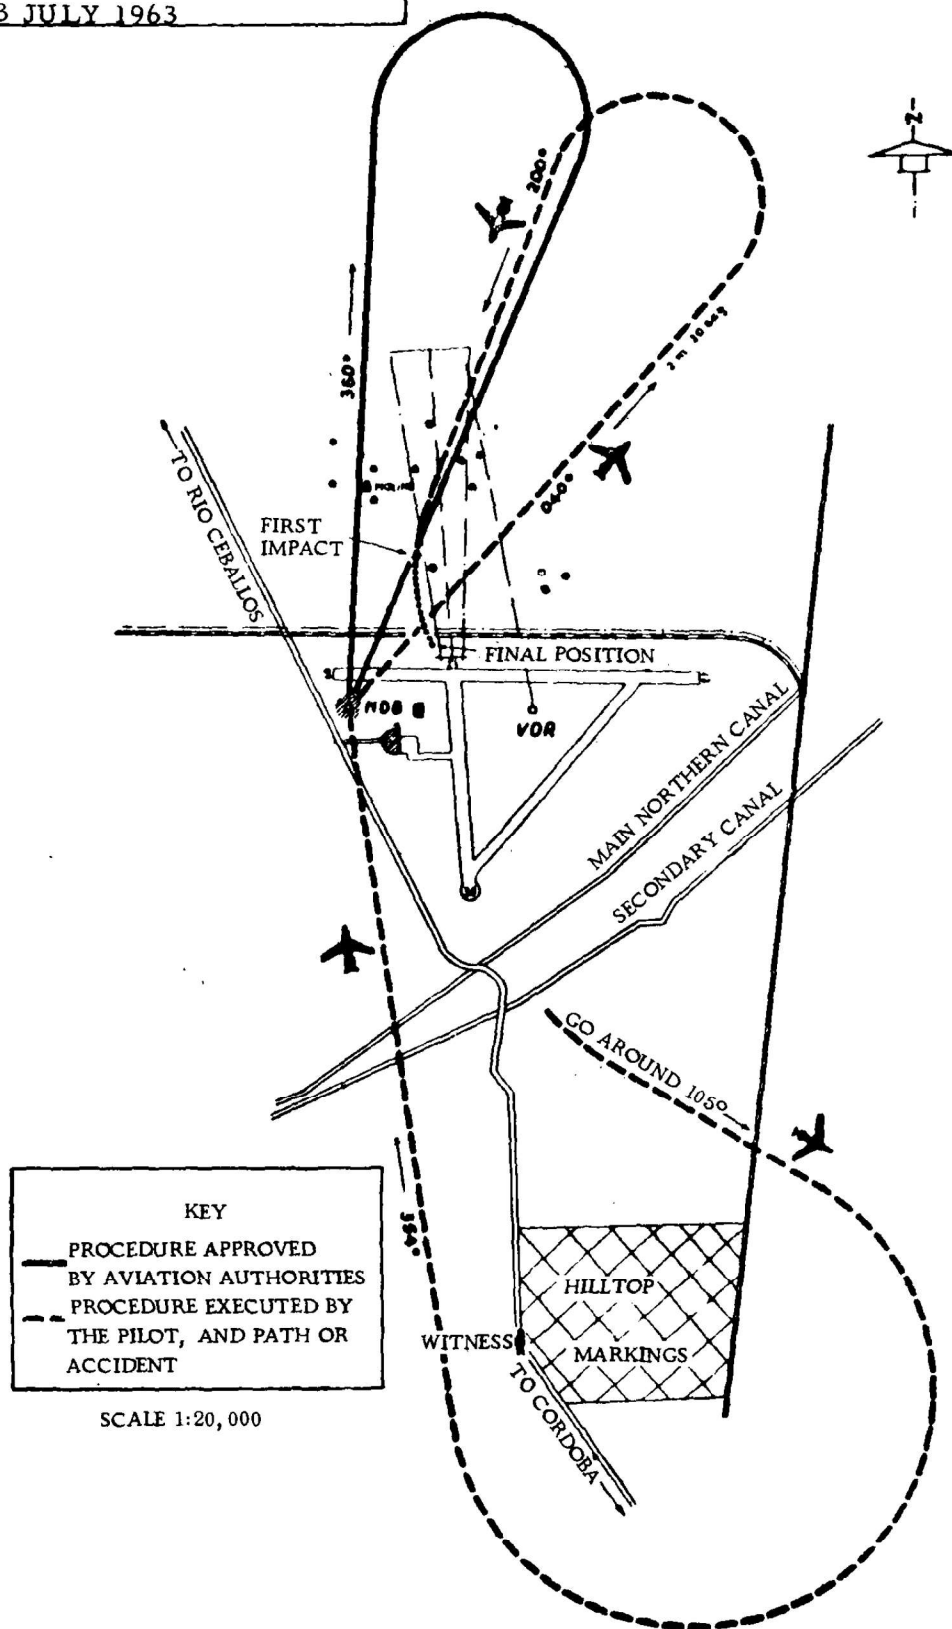
FIGURE 10

At 390 m from initial impact the port wing struck some other trees, the fuel tanks bursted out and fire broke out. The aircraft then came into contact with the General Belgrano Railway tracks, broke its undercarriage, tearing away 25 m of railway rails and finally came to rest 280 m before the threshold of runway 17 (See Figure 10). The accident occurred at 1906 hours.
