British Aircraft Corporation Ltd., BAC 111, Series 200, G-ASHG, accident at Cratt Hill, 1-1/4 miles NNW of Chiclade, Wiltshire, England on 22 October 1963. Accident Report No. EW/C/039, dated November 1964, released by the Ministry of Aviation, United Kingdom. (C.A.P. 219)

ACCIDENT TO BAC 111, G-ASHG, OF BRITISH AIRCRAFT CORP. LTD.,
AT CRAT HILL, WILTSHIRE, ENGLAND. 22 OCTOBER 1963.

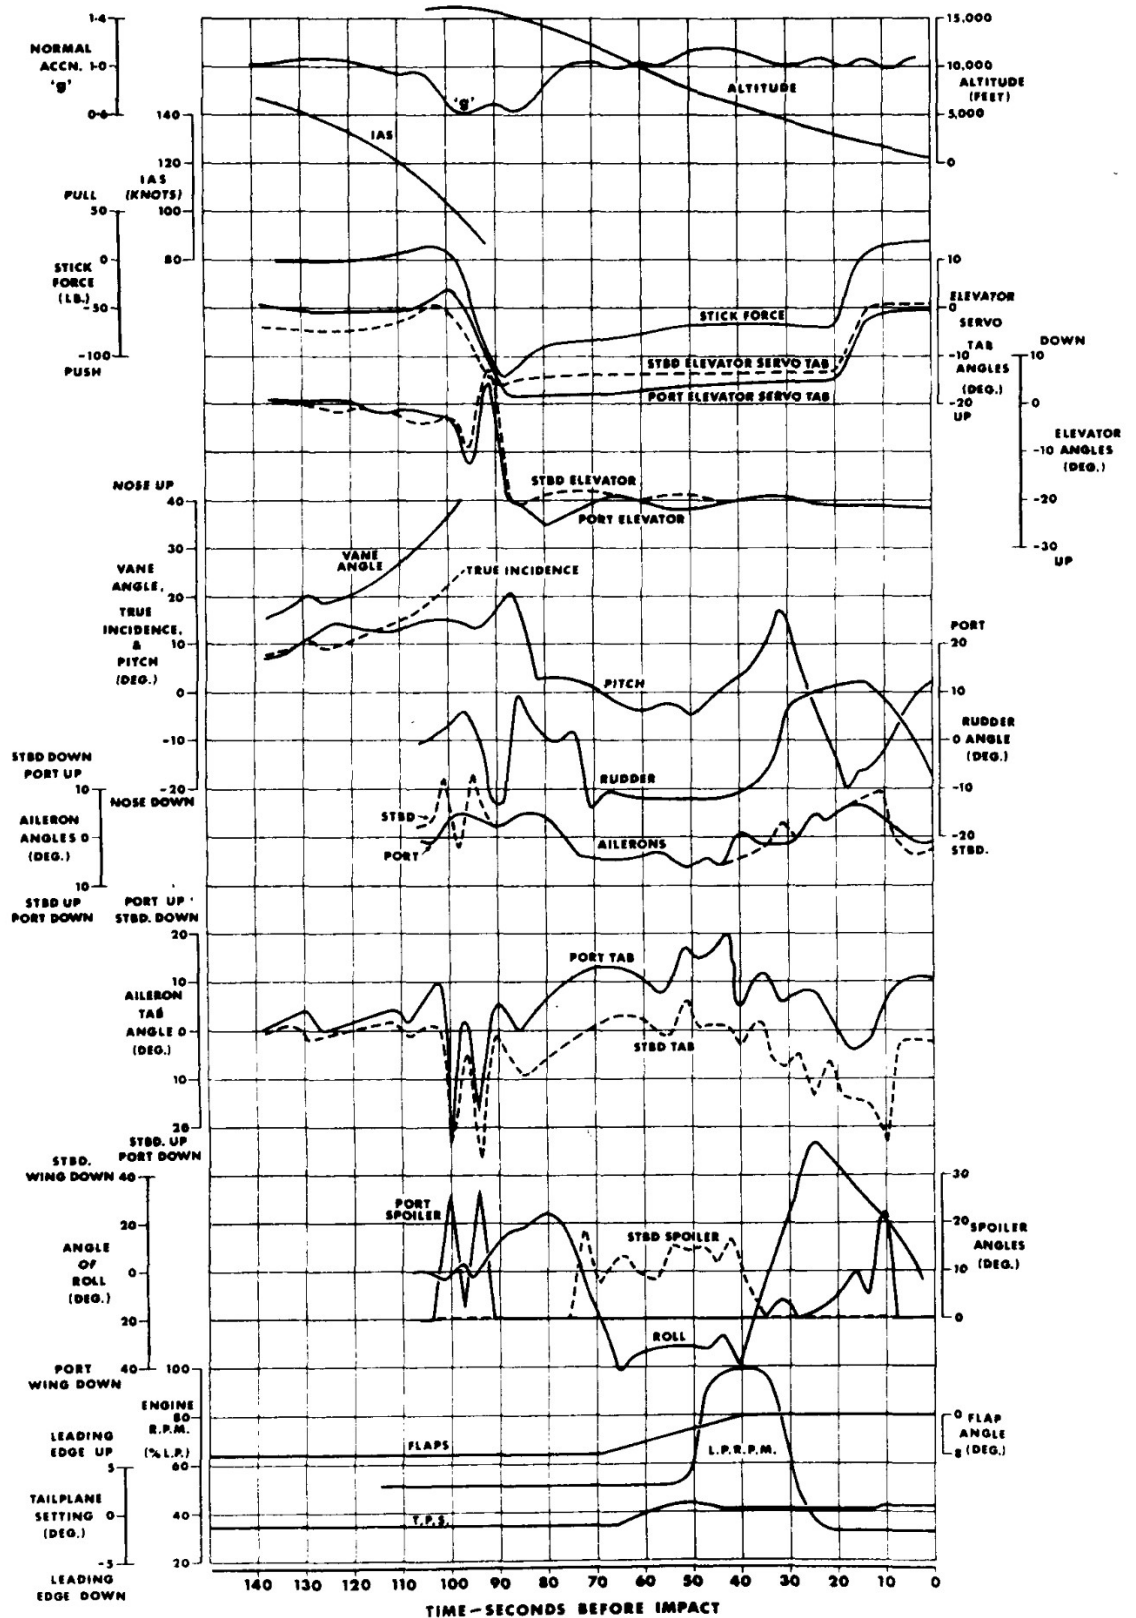
FIGURE 5

The time history in Figure 5 indicates that as the aircraft entered the stall there was a tendency to a wing drop which was corrected by the pilot. Subsequently during the deep stall the aircraft banked successively right, left, then right again. At the high incidence conditions prevailing during the descent the aileron rolling effectiveness would fall off to such an extent that the ailerons become of little value as a roll control. Nevertheless, since the tab, aileron and spoiler movements are consistent, it can be concluded that the pilot was moving his lateral control deliberately; but it should be remembered that some movement of the ailerons would result from the incidences induced by the aircraft's motion and, in the absence of wheel and rudder pedal force records, this tends to obscure the picture. However, the movement of rudder and ailerons is not inconsistent with an attempt by the pilot to regain control by putting the aircraft into an appreciable asymmetric flight condition. At impact minus 50 seconds when the pitch angle was 4° nose-down, full power was applied from both engines and maintained for about 15 seconds. This application of power was accompanied by a rapid pitch-up reaching 17° nose-up; power was then reduced by the pilot apparently to prevent continuation of the pitch-up.

TIME HISTORY FOR THE 140 SECONDS BEFORE
GROUND IMPACT BASED ON FLIGHT RECORDER DATA

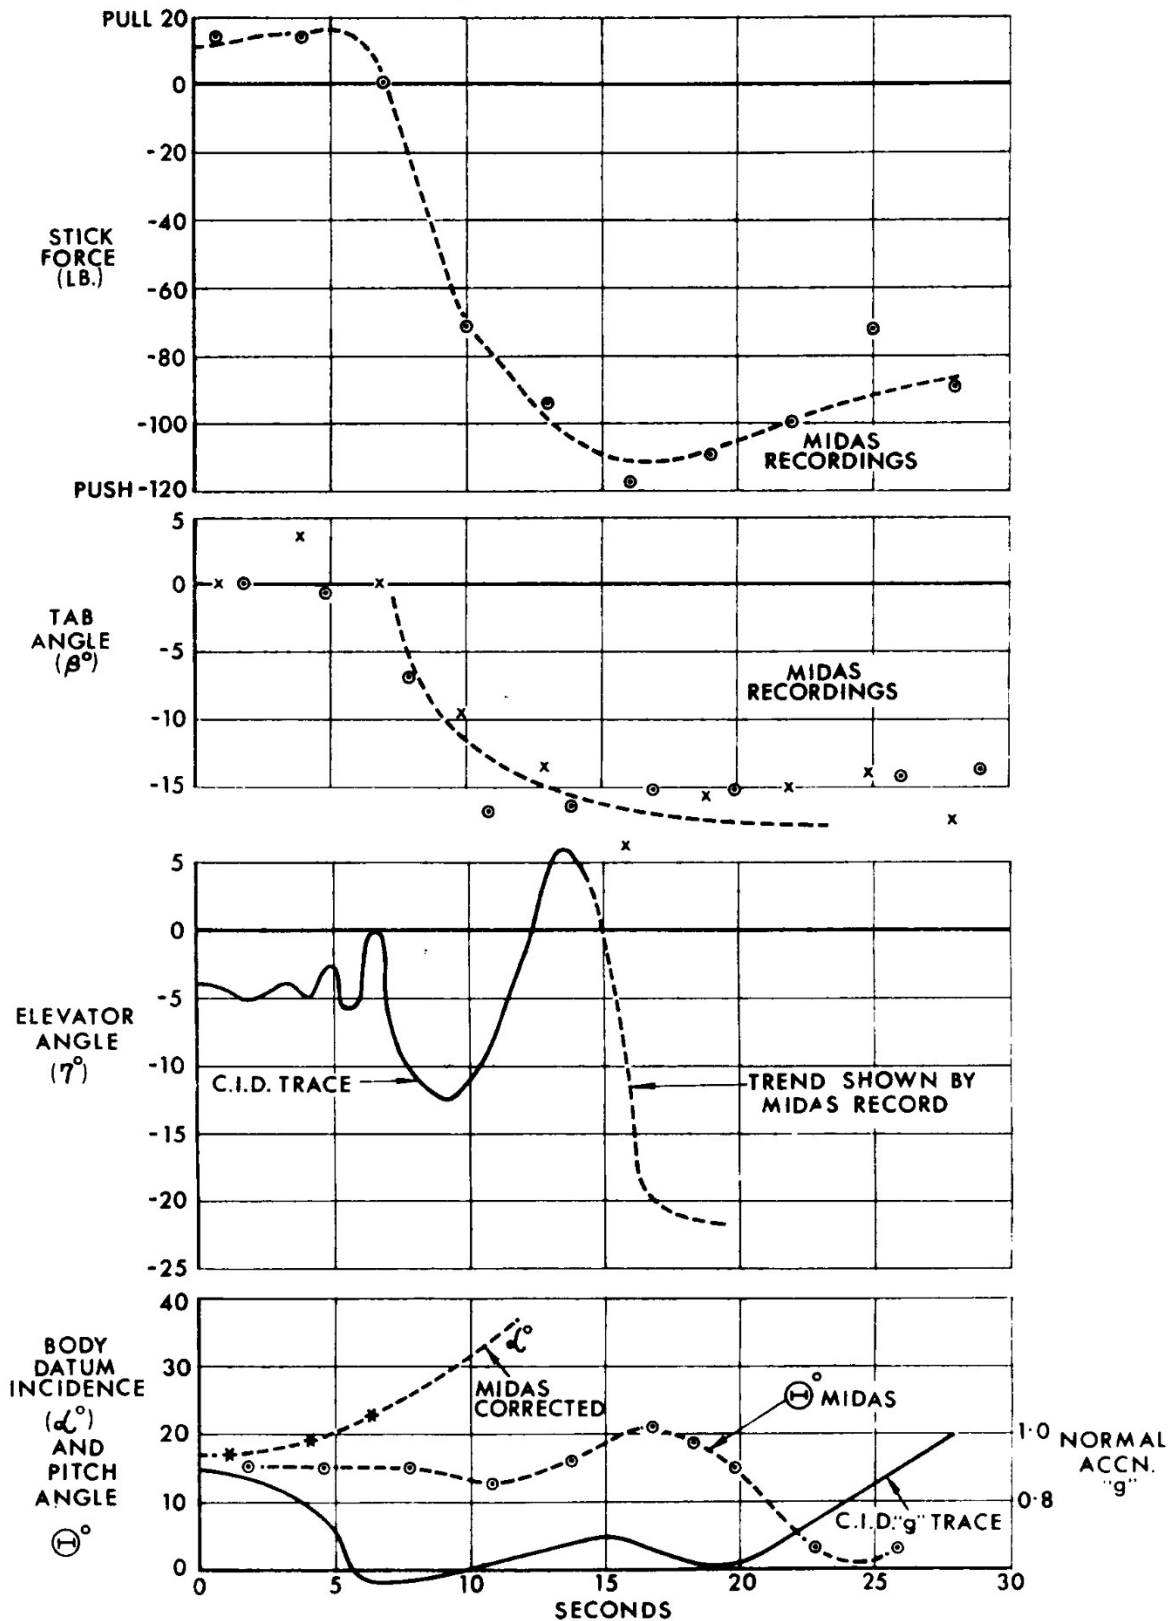
FIGURE 6

In analysing the flight recorder traces of the final stall in the light of the results of the theoretical considerations discussed in paragraph 1.15 it must be emphasized that the recordings are open to a certain amount of variation in interpretation, largely because the sampling rate of the elevator stick force and the servo-tab angles was once every three seconds: further, the incidence recording stopped at 25°. A continuous trace of the all-important elevator angle was, however, available. A time-history for the 140 seconds before ground impact based on Midas recorder data supplemented by that from the CID recorder is shown in Figure 5. Relevant portions of this have been plotted to a time base with a zero for an incidence of the order of 16° to 17°, as shown in Figure 6.

The attempt by the pilot to recover is shown by the change in direction of elevator movement at around 9 seconds on the time scale (see Figure 6). A number of things may have prompted this action and it is by no means clear what, for example, was the tab position or the stick force just previous to this. He may have been faced with an unexpected up-elevator position or he may have been alerted by the incidence meter. Whatever was the exact sequence of events it is certain that incidence would have continued to increase during the recovery attempt. According to the analysis of the hinge moment data an incidence of about 40° or more was reached, since it will be seen that at about 13-14 seconds the elevator "up-floats" to reach a fully up position shortly after.

DATA OBTAINED FROM MIDAS AND C.I.D.
FLIGHT RECORDERS AT THE STALL
