No. 20

Swissair SE-210 Caravelle HB-ICV, accident at Dürrenäsch
(near Zurich/Kloten Airport), Switzerland on 4 September 1963.

Report, dated 10 March 1965, released by the Swiss
Accident Investigation Commission

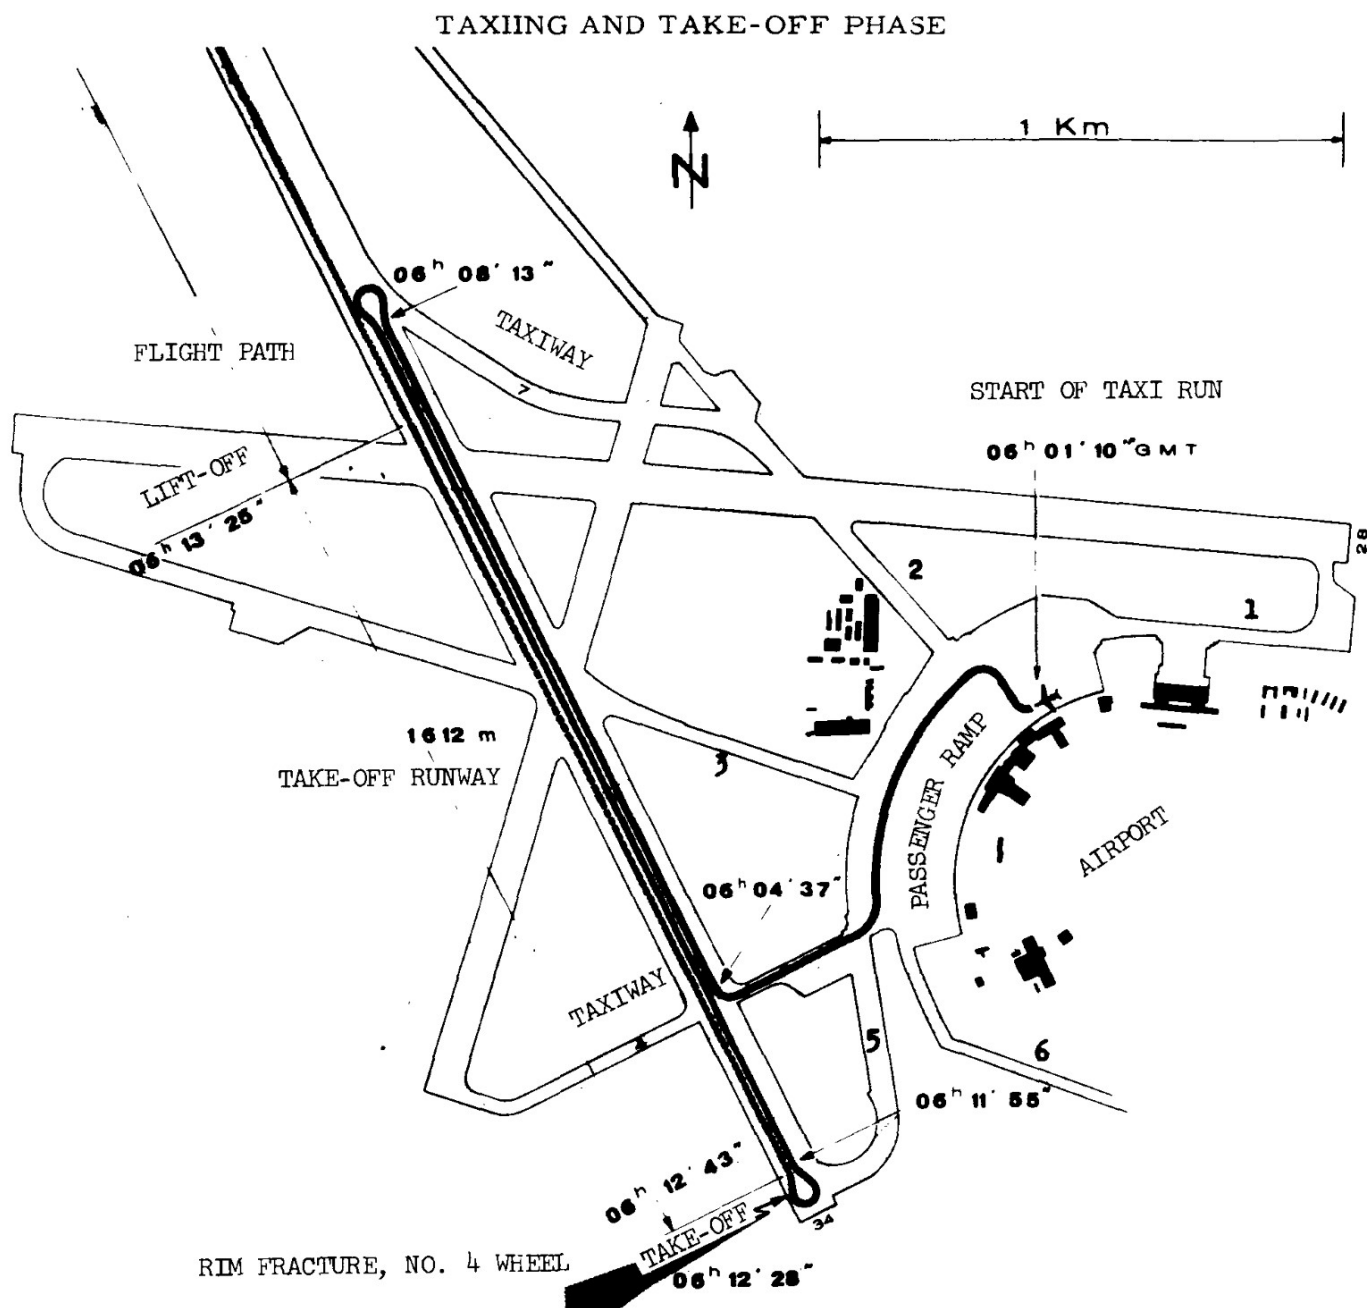
FIGURE 19

ACCIDENT TO SE-210, CARAVELLE HB-ICV,
OF SWISSAIR, AT DÜRENÄSH, SWITZERLAND.
4 SEPTEMBER 1963

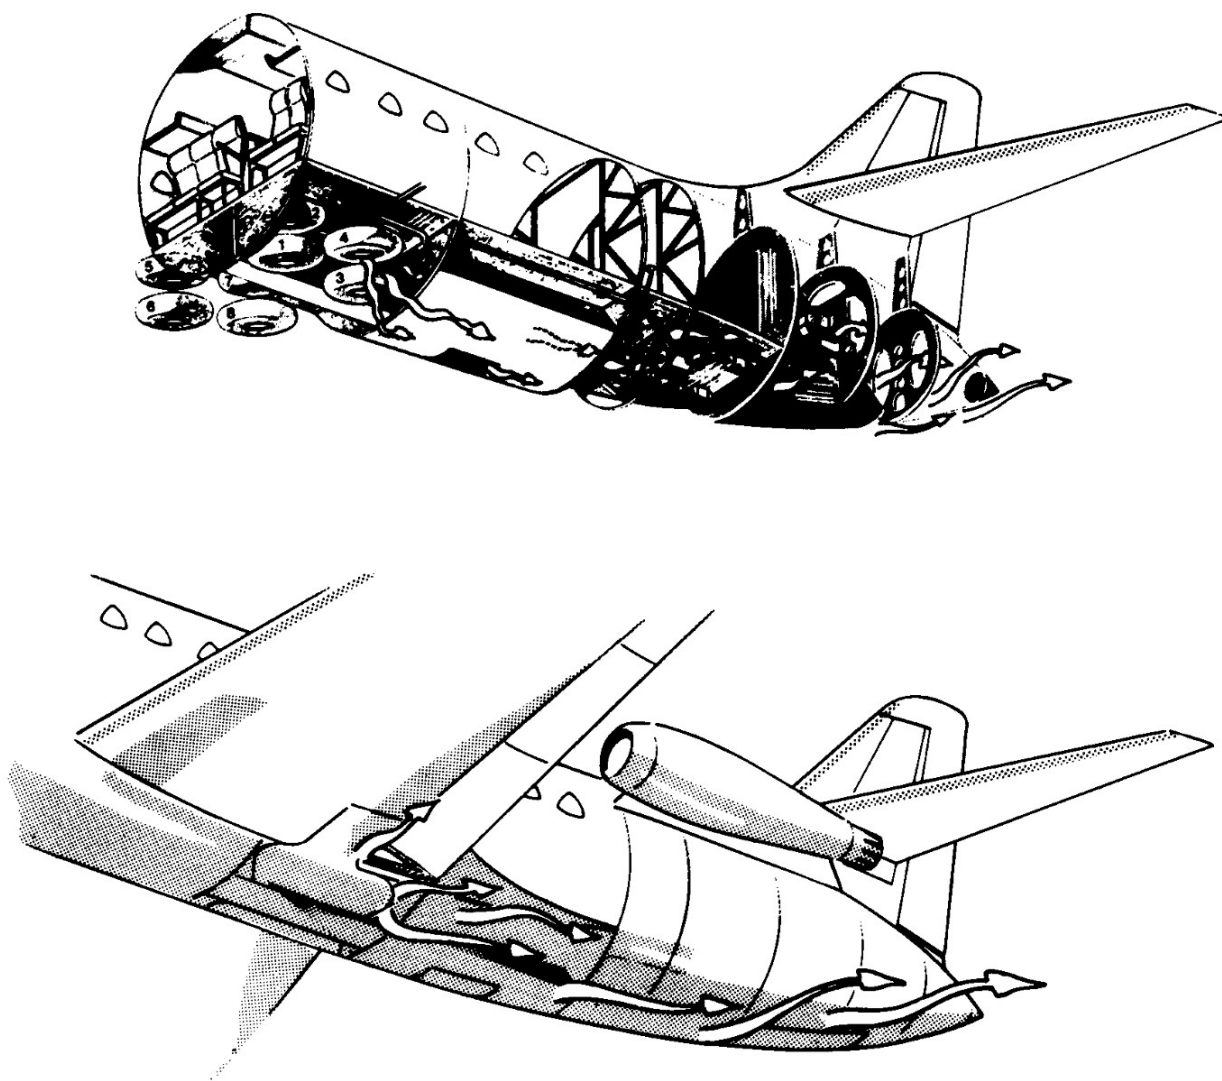
FIGURE 20

The fracture of the rim might have damaged fuel lines and the leaking fuel might have become ignited on the overheated brake parts. The neighbouring fuel lines might also have been damaged by the fracture or might have melted due to the fire. The overheating due to the heat from the brakes and the fire also burst Nos. 1 and 2 wheels. This caused further damages which must have led to further spreading of the fire. Subsequently, the fire -- fed by fuel -- spread from the left landing gear shaft to both the outside and inside of the fuselage and also affected the rear of the fuselage and the tail unit.

Another possibility was that the fire which resulted from the fracture of No. 4 wheel on the runway, had not been quite extinguished when the landing gear was retracted. Following lift-off and immediately prior to retraction, the fire might have been fed by hydraulic oil leaking from the wheels or might have become re-ignited after having been temporarily extinguished. Such a fire might first have spread to the tires and then to the wheel rim of No. 3 wheel. Because of the air current prevailing in the landing gear shaft during flight No. 3 wheel must have been especially exposed to the effects of the burning gases from No. 4 wheel which was located just above it. Also the deformation of the rim fragments from No. 3 wheel could hardly be explained without prior effects of burning with localized, concentrated increases in temperature. It therefore appeared more likely that the fracture of No. 3 wheel was a consequence of the fracture of No. 4 wheel (See Figure 20).

PRESUMED PATH OF THE FIRE
