No. 23

The Flying Tiger Line Inc., L-1049H, N 6915C, accident at San Francisco International Airport, San Francisco, California, U.S.A., on 24 December 1964. Civil Aeronautics Board (U.S.A.) Aircraft Accident Report, File No. 1-0064, released 8 June 1966

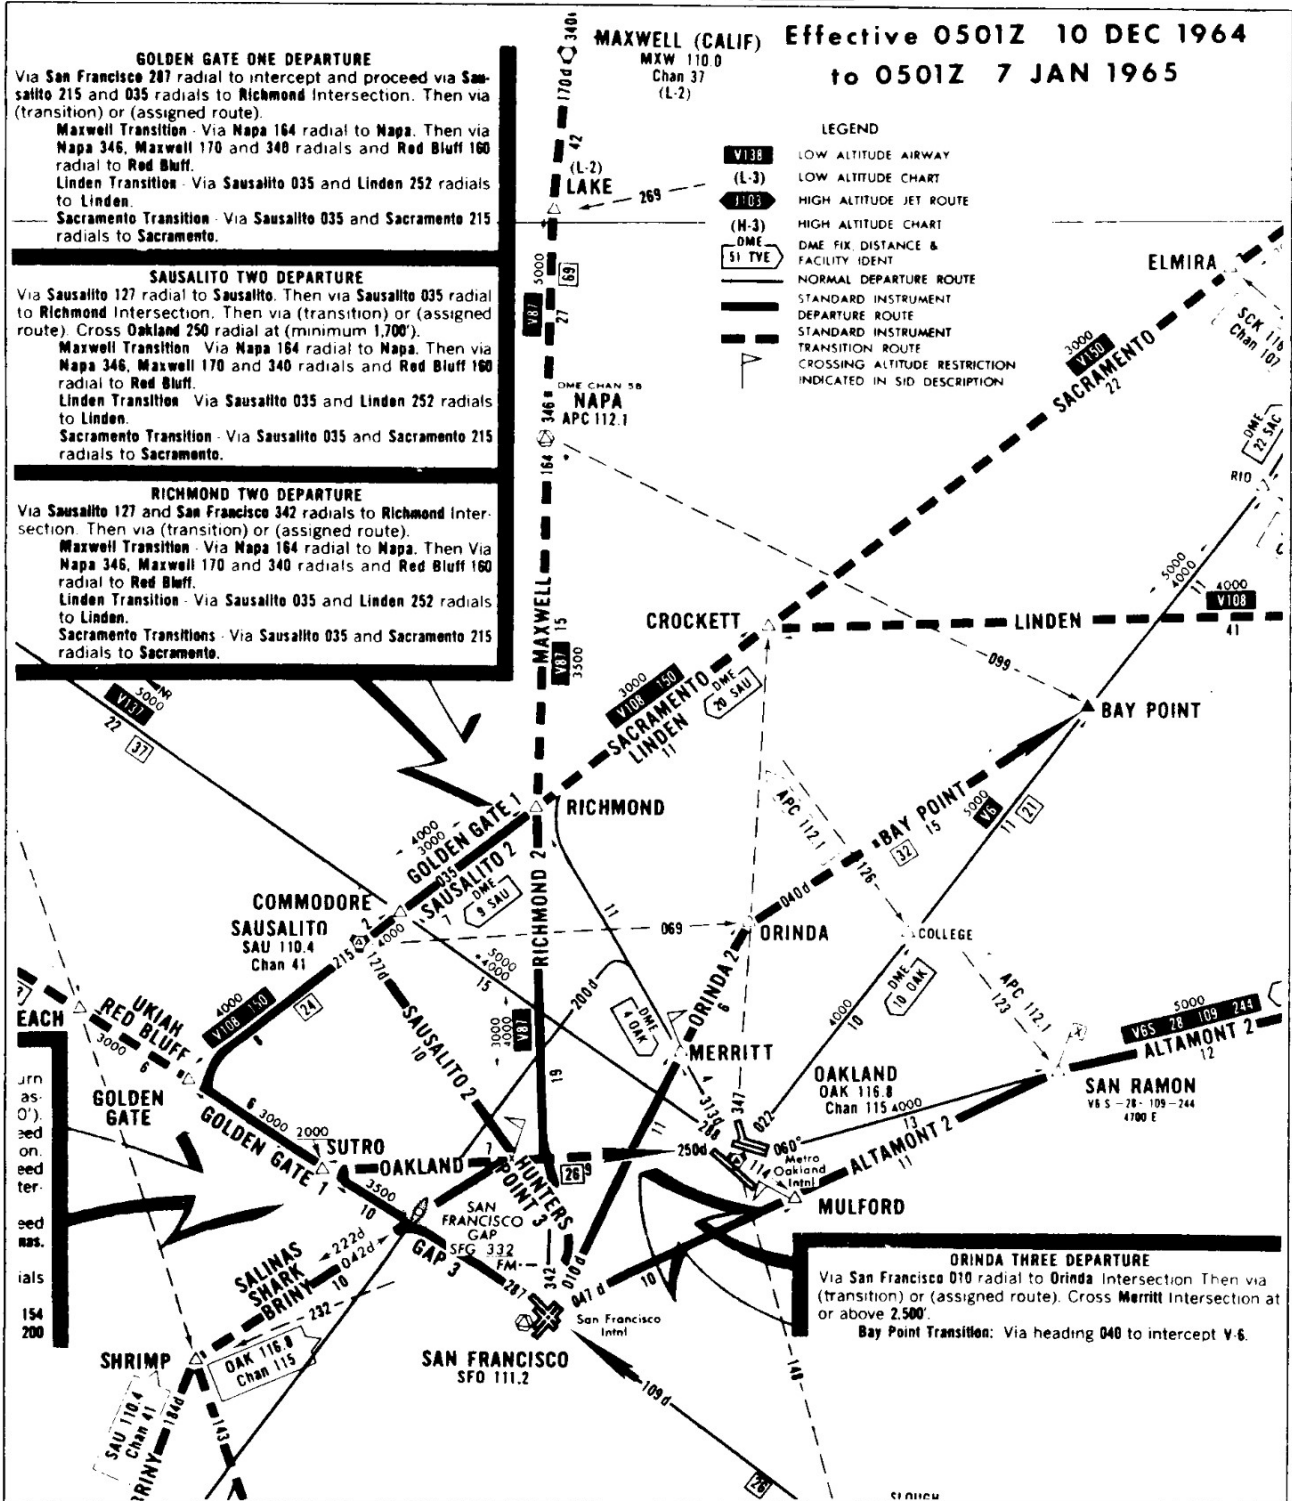
FIGURE 23-1

* Radar vectoring could not be provided an aircraft departing runway 28 via the Golden Gate Standard Instrument Departure until the aircraft reached an altitude of 1 500 ft. This was because standard obstruction clearance from the terrain, both vertical and lateral, could not be achieved in so far as criteria, as existing on 24 December 1964, were concerned. Lateral clearance from obstructing terrain is so critical that there is no space available in which to vector an aircraft safely below 1 500 ft. (See Figure 23-1).

The investigation of this accident revealed that the lateral and horizontal terrain clearance for a runway 28 departure at San Francisco could be marginal for an aircraft operating in this environment. With respect to the radar procedures utilized, radar vectoring is not provided during this instrument departure until the aircraft reaches 1 500 ft. This is because standard vertical and lateral obstruction clearance from the adjacent terrain cannot be achieved in so far as present criteria are concerned. The lateral clearance from obstructing terrain is so critical that there is no available space in which to vector an aircraft safely until it has reached an altitude of 1 500 ft.

4.2 New standard instrument departure (SID) procedures for San Francisco were issued and became effective on 22 July 1965. A note, to the effect that a minimum climb rate of 250 ft per mile up to 2,000 ft was required on certain SIDs, was included on the appropriate chart.

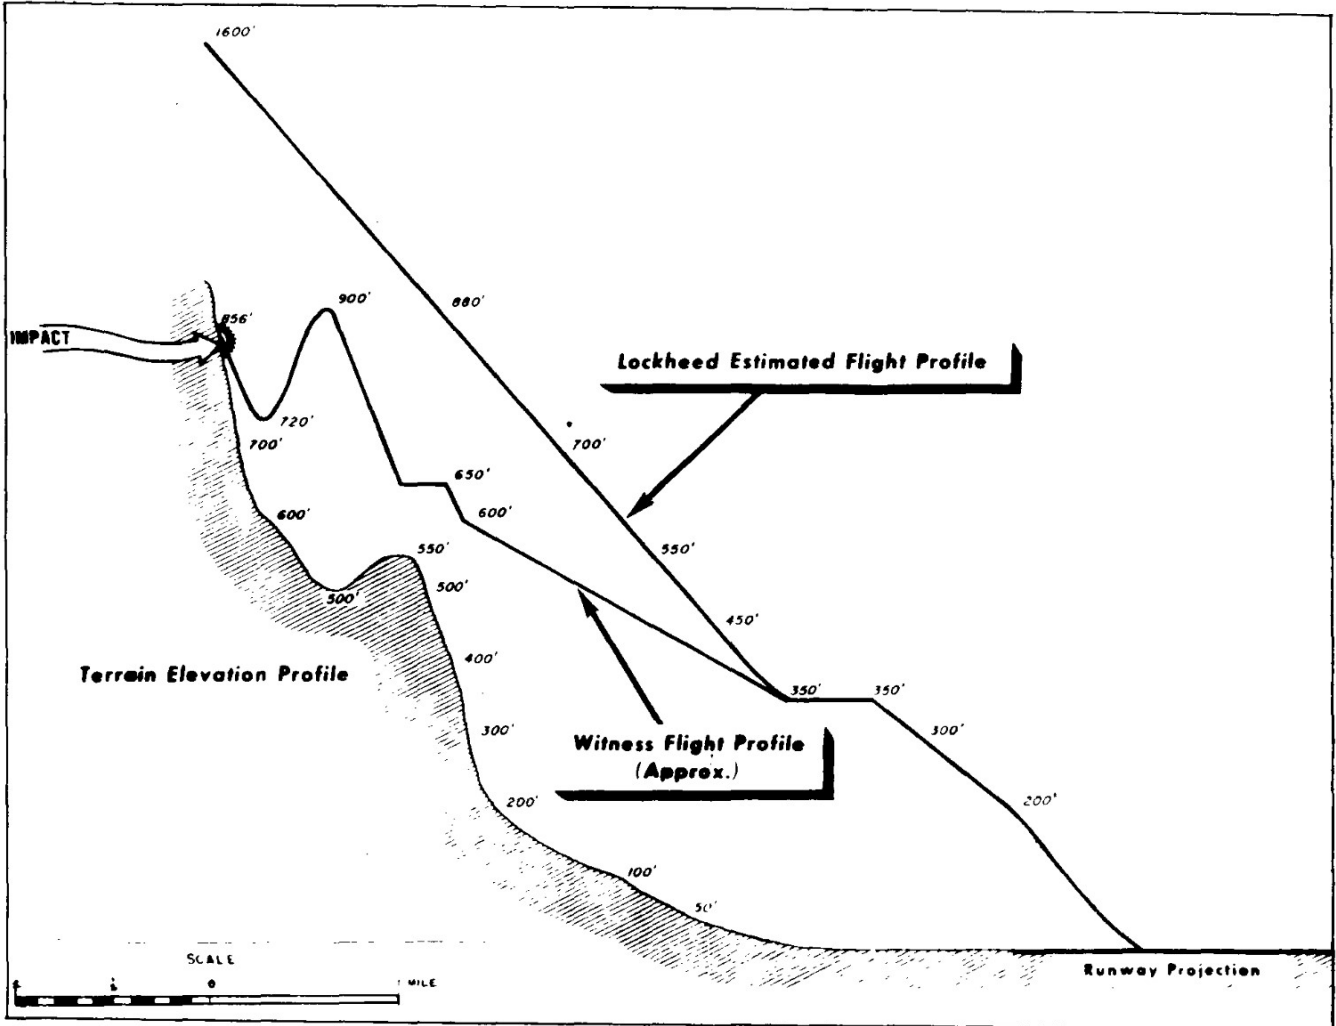
FIGURE 23-3

Performance figures of the manufacturer indicated that this aircraft's rate of climb should have been in excess of 800 ft/min from lift-off. The chief pilot of the airline at San Francisco stated that in his experience similarly loaded L-1049H aircraft will normally climb between 400-500 ft/min on departures from runway 28 at SFO. While no minimum rate of climb per mile was established for runway 28 departures at the time of the accident, the FAA has since specified that 250 ft/mile is the minimum acceptable. (See Figure 23-3)

As far as can be determined the flight was initially climbing at approximately 250 ft per mile minimum rate of climb and would have undoubtedly made a safe climb-out had it remained on the appropriate standard instrument departure route. However, after the aircraft left the prescribed departure route, it entered an area of rising terrain where downdraught activity and moderate to severe turbulence affected the climb capability of the aircraft sufficiently to prevent terrain clearance. The deviation to the left was not detected in time to avert impact with the hill.
