# AIRCRAFT ACCIDENT REPORT

EASTERN AIR LINES, INC., DC-7B, N849D  
IN THE ATLANTIC OCEAN 6.5 NAUTICAL MILES  
SOUTH-SOUTHWEST OF JONES BEACH  
LONG ISLAND, NEW YORK  
FEBRUARY 8, 1965

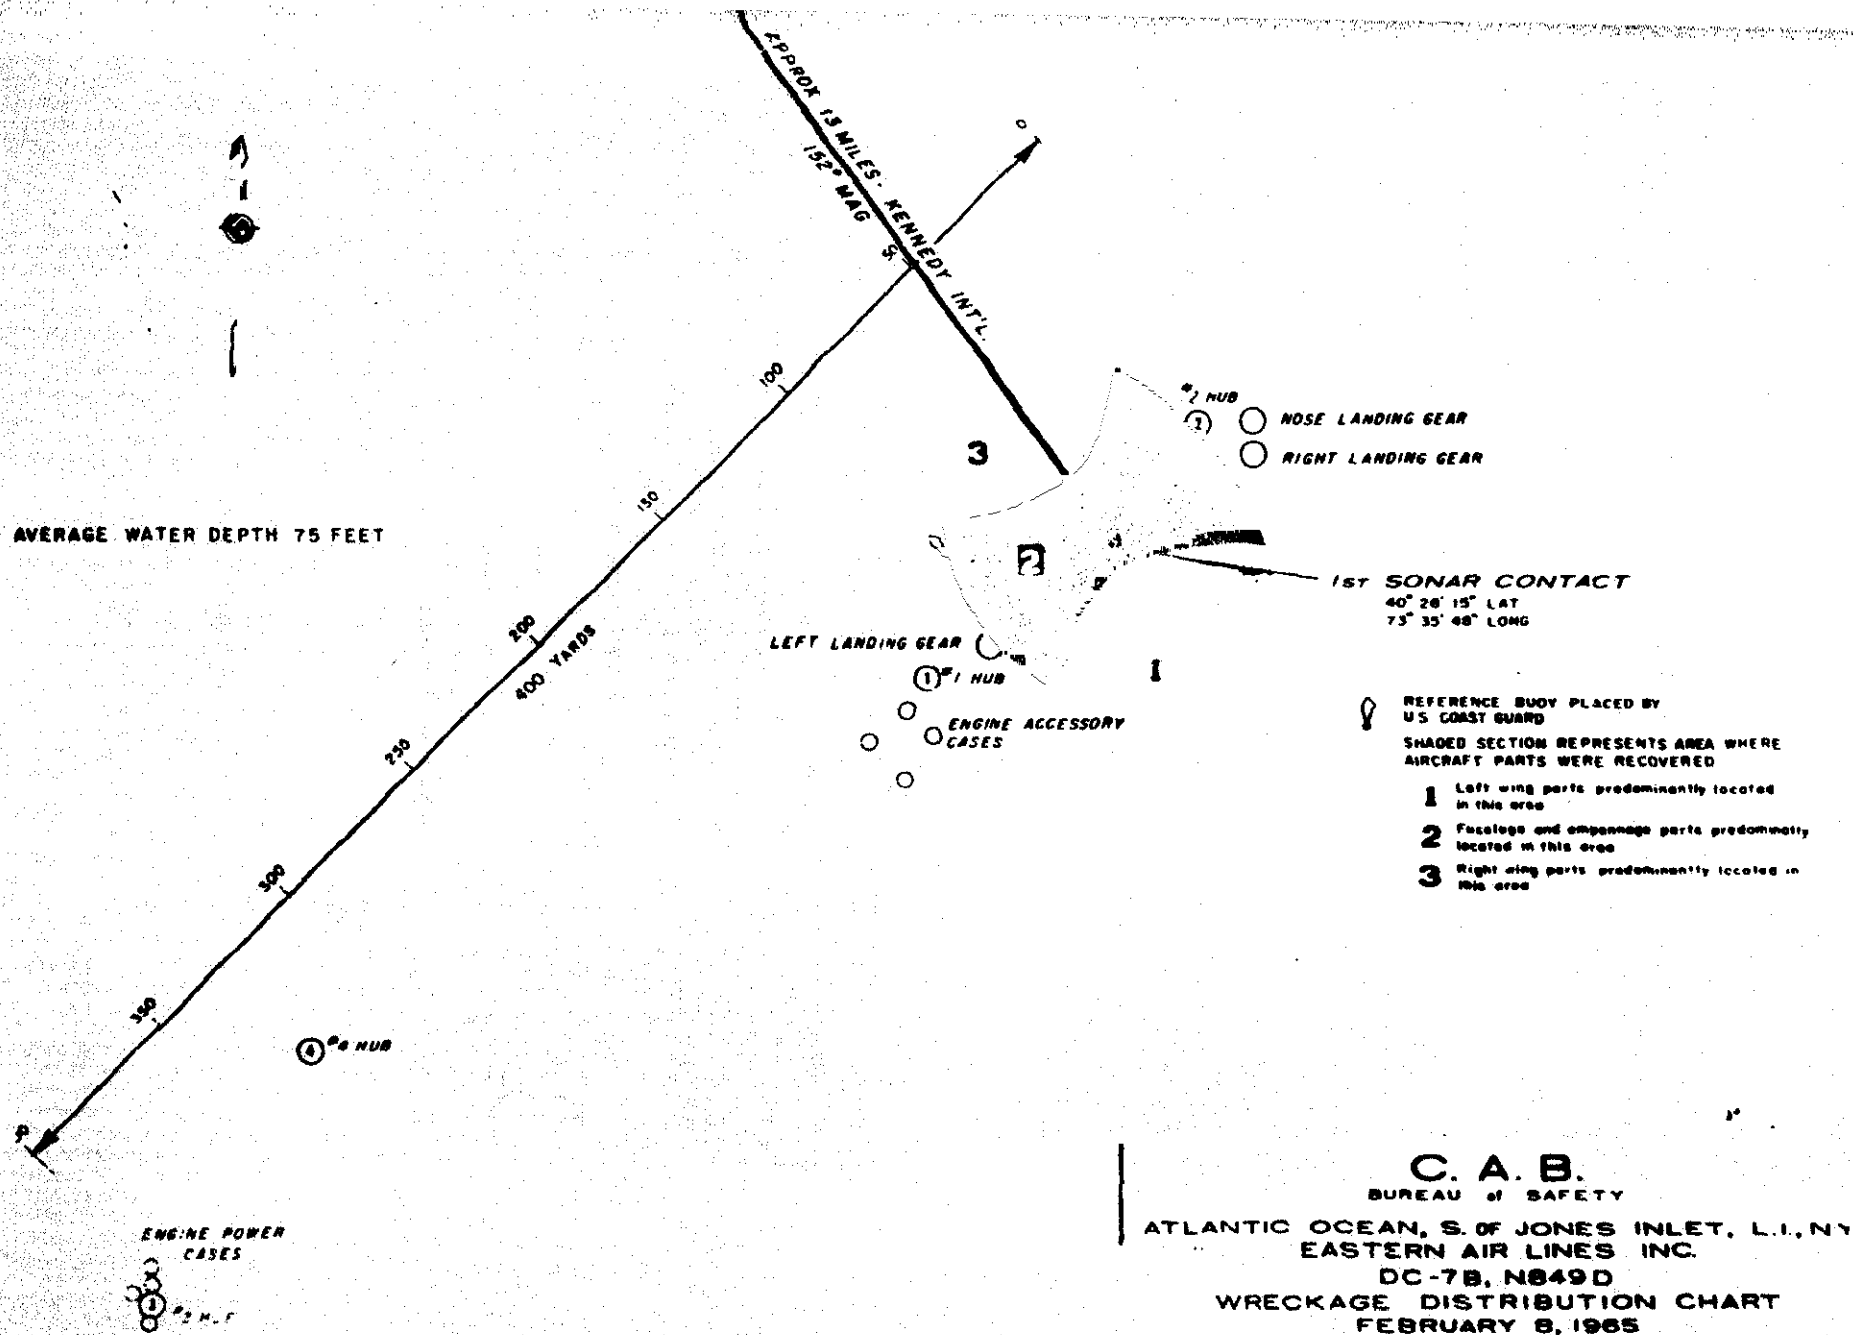
**C. A. B.**  
BUREAU OF SAFETY  
ATLANTIC OCEAN, S. OF JONES INLET, L.I., NY  
EASTERN AIR LINES INC.  
DC-7B, N849D  
WRECKAGE DISTRIBUTION CHART  
FEBRUARY 8, 1965

Over 60 percent of the aircraft was recovered, including portions of all major components. The investigation revealed no evidence which would indicate failure or malfunction of the aircraft's powerplants, systems, or structural components prior to impact.

All the control surfaces including trim tabs were recovered, damaged but with no indication of pre-impact malfunction or failure. All of the control cables recovered exhibited complete separation and all strands were necked down at the separation points.
