No. 13

British United (C.I.) Airways, Douglas Dakota C-47, G-ANTB, accident near Jersey Airport, Channel Islands, on 14 April 1965. Civil Accident Report No. EW/C/097, dated January 1966, released by the Ministry of Aviation, United Kingdom, C.A.P. 256

ACCIDENT TO DOUGLAS DAKOTA C-47, G-ANTB, OF BRITISH UNITED
(C.I.) AIRWAYS, NEAR JERSEY AIRPORT, CHANNEL ISLANDS,
14 APRIL 1965

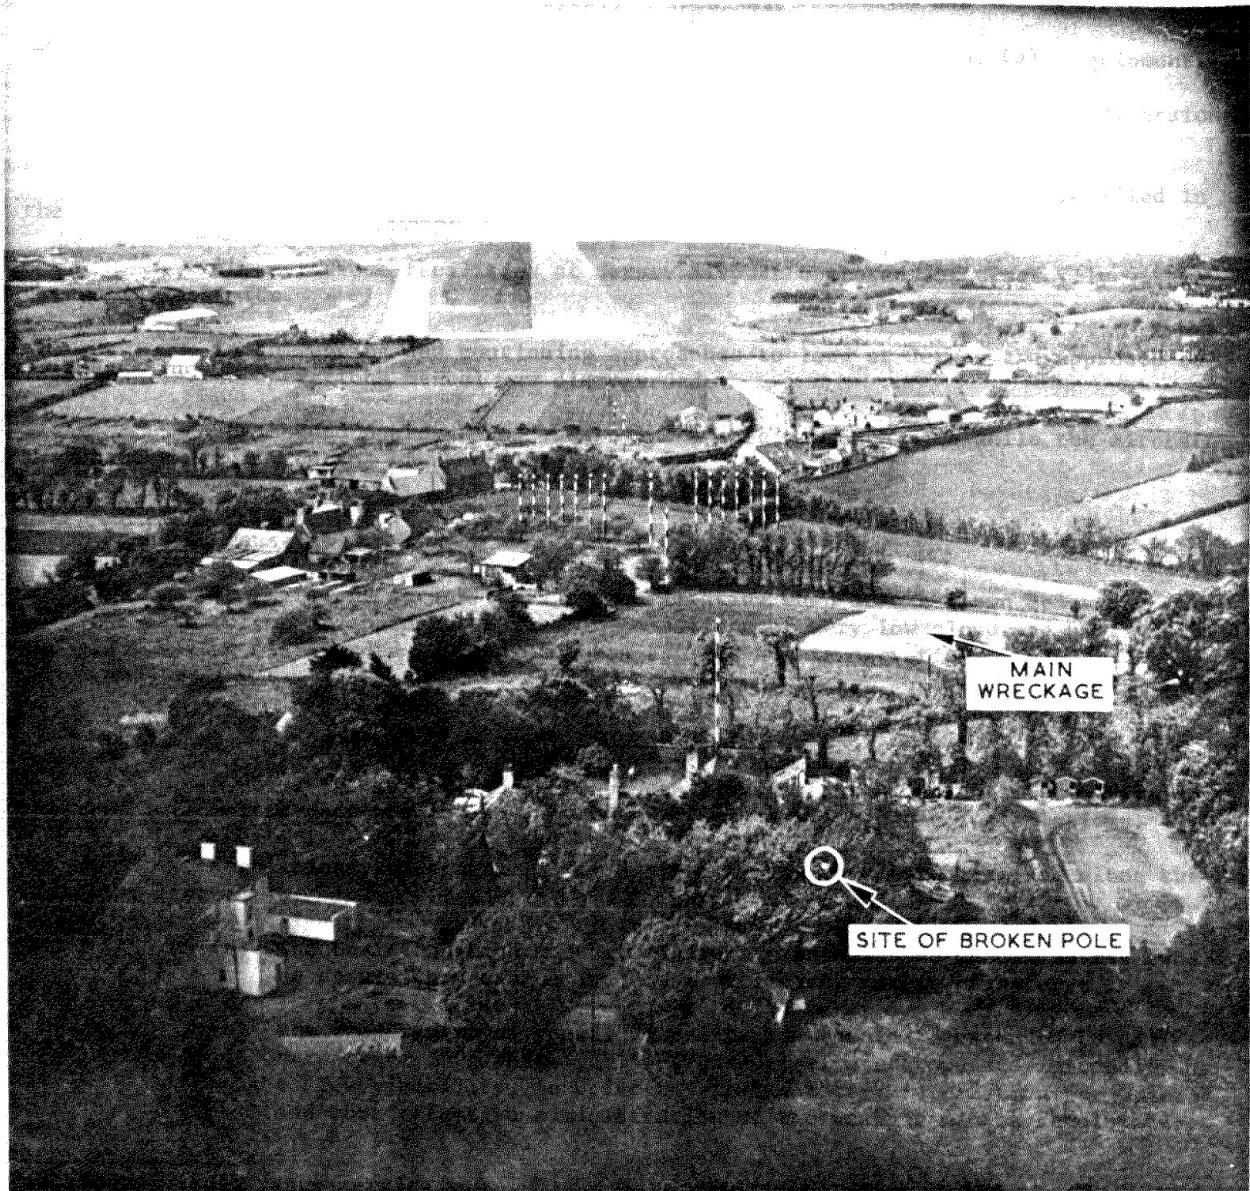
Fig. 13-1

Subsequently, it was established that the aircraft had hit with its starboard wing the outermost approach light pole, which was 3 000 ft from the runway threshold, at a height 58 ft above runway level. After climbing slightly, it rolled to an inverted attitude, at which time the starboard wing folded rearwards and separated as the aircraft dived to the ground, still inverted. It crashed at about 1806:27 hours.

Approach to Runway 27, Jersey Airport
