No. 9

British European Airways Corporation, Trident Series 1, G-ARPY,
accident 1 mile SSW of Felthorpe, near Norwich, Norfolk,
United Kingdom, on 3 June 1966. Civil Accident Report EW/C/0130,
dated June 1968, released by the Board of Trade, United Kingdom, C.A.P. 311

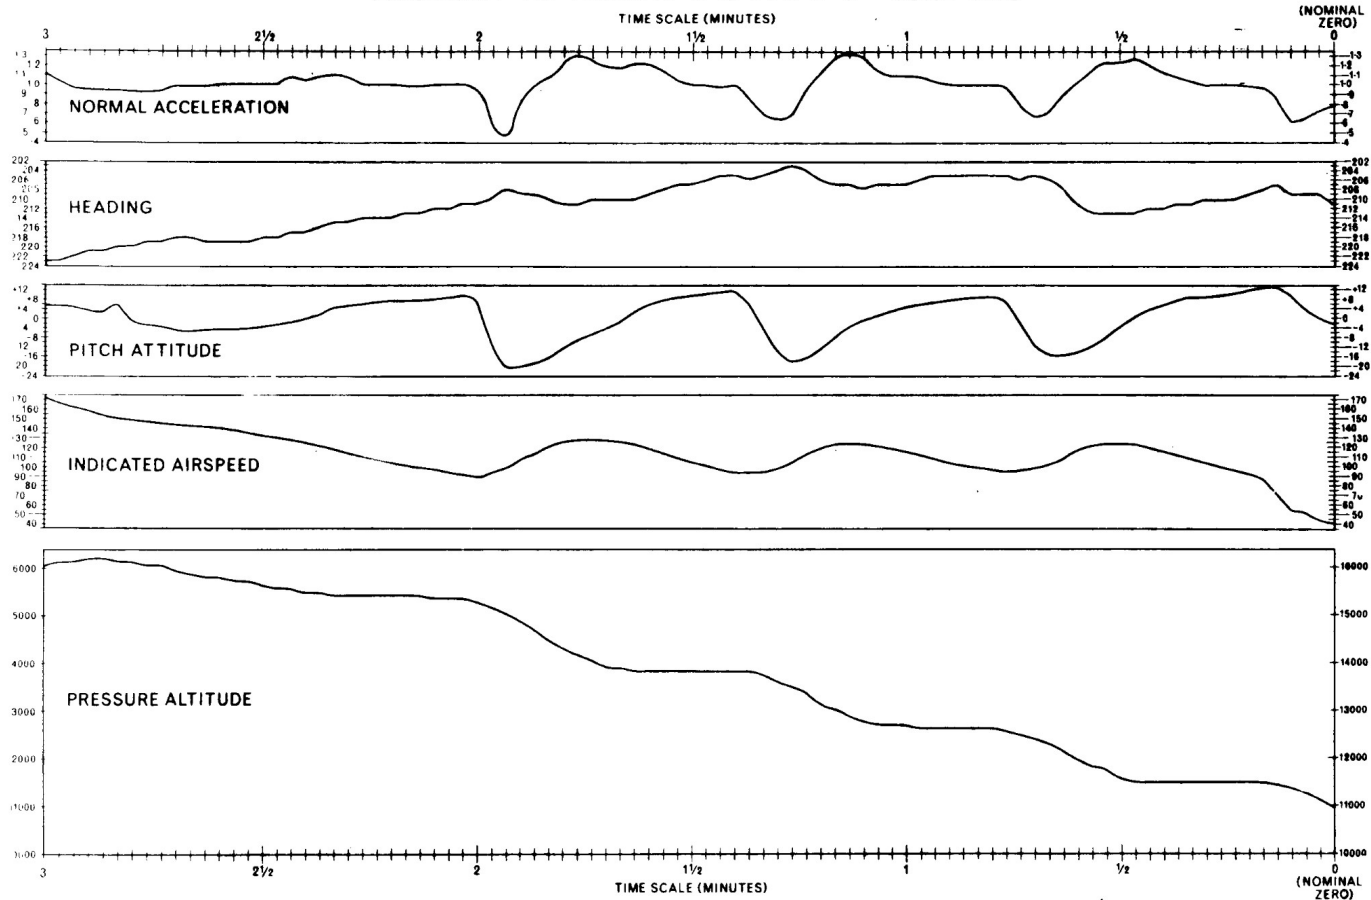
APPENDIX "A"
EW/C/0130
(NOMINAL
ZERO)

The time history of the flight parameters for the last three minutes of recorded flight is contained at Appendix A. The stalling tests begin at a height of 15 700 ft which agrees with the flight engineer's log. At this time the aircraft was in almost level flight at a speed of 130 kt. A gradual nose-up pitch accompanies the steady decrease in airspeed towards the stall, while normal acceleration changes very little. This first "stall" which occurs at about two minutes before the end of the record was straightforward and recovery was made with the stick-pusher system fully operative. There followed a second and then a third approach to the stall; these were designed to check the functioning of the duplicated parts of the stick-pusher system. Finally, towards the end of the record, the aircraft levels out at 11 600 ft and the fourth stalling run is started. After the stall the aircraft starts to pitch nosedown and speed falls off rapidly. Then for about 5 seconds the nosedown pitching motion ceases indicating that the aircraft was tending towards a superstalled condition. At the same time the heading changes, the aircraft turning to port at the rate of 8° per second.

The rate of decay of airspeed during this last stalling run averaged at about 1½ kt per second - but the rate was increasing towards the end of the run.

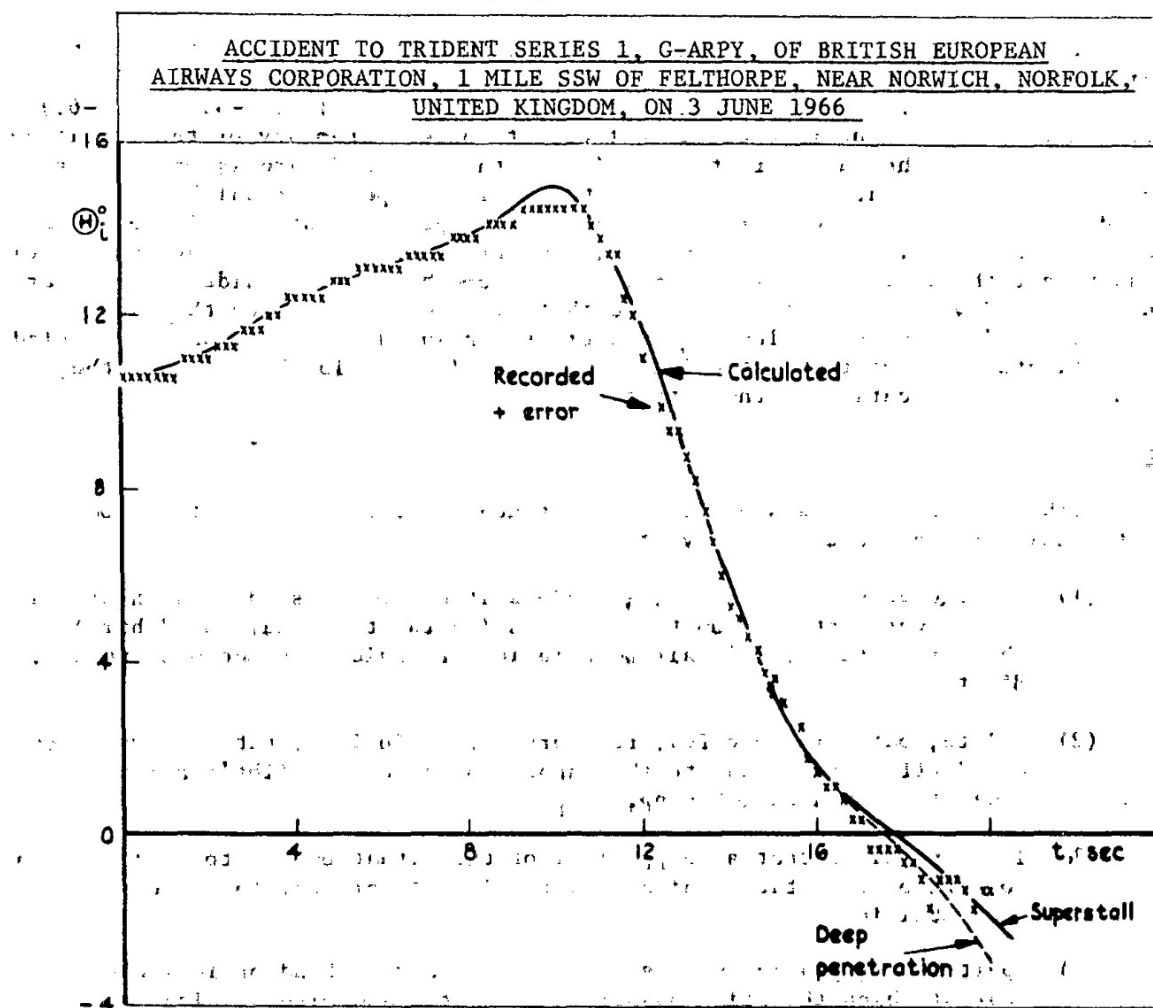
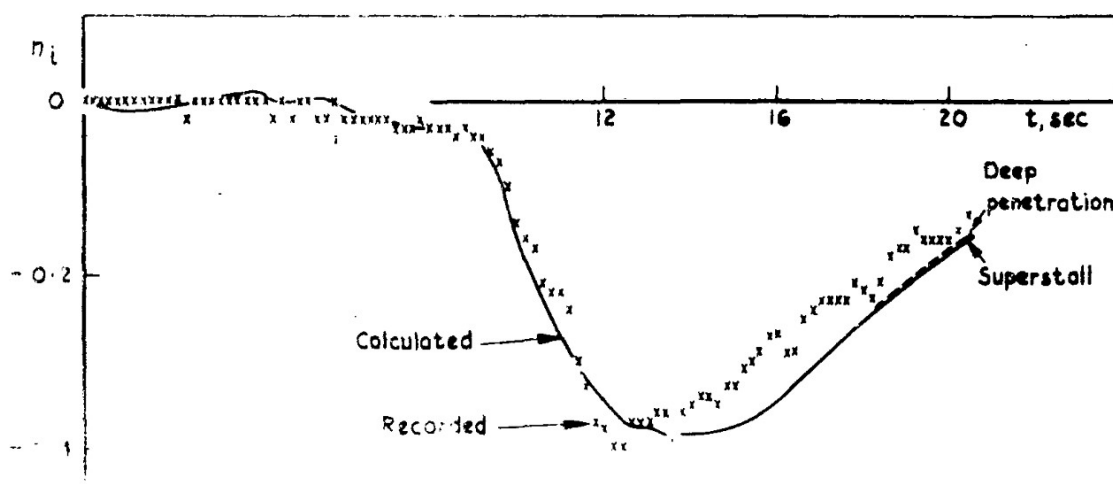
Fig. 9-1 - Pitch attitude (angle of inclination), θ_i , and indicated normal acceleration a_z .

As indicated earlier the assumed elevator input (elevator is used to denote longitudinal control, which in this case was an all-moving tail plane with geared flap) for the first stage of the calculating that is in the approach to the stall, has the form $n_T = n_{T\text{trim}} + \Delta n_T$. The increment over the trimmed value is subject to adjustment, on a step-wise basis, so as to maintain good correlation with the observed pitch attitude. Thus the reduced steepness of the θ curve at about 4 sec. (on time scale used here) and again around 6 sec. is reflected in the two small steps in the elevator angle, see figs. 9-1 and 9-3

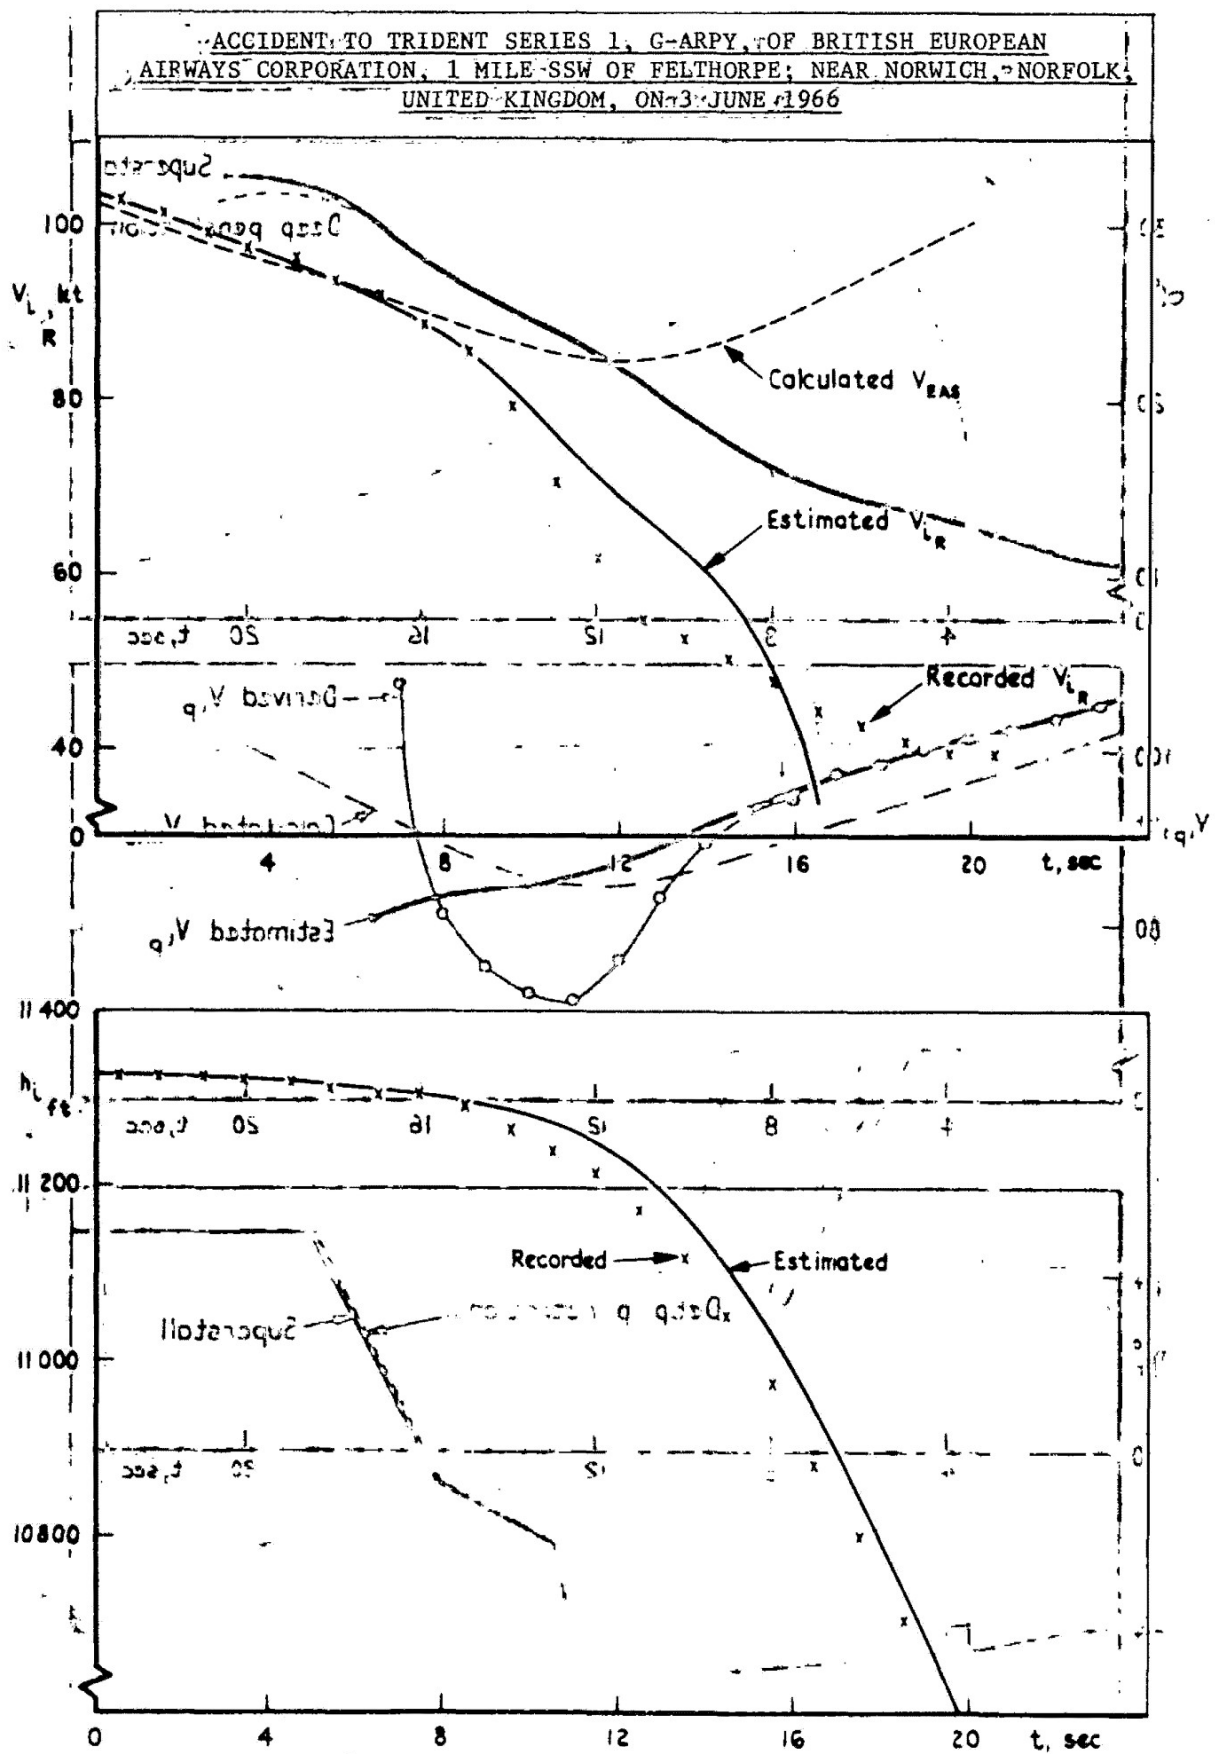
Fig. 9-2 - Recorded indicated velocity V_{tR} and indicated height, h_i

In this way the curves shown in figs. 9-1, 9-2 and 9-3 are obtained. The estimation of both the indicated airspeed showing on the recorder and the indicated airspeed of the pilot's instrument involved large corrections for instrument and position errors.

In fact with the suggested extrapolation of the pitch and static errors beyond an incidence of about 30° (i.e. beyond a time of 16.5 sec) the corrections become meaningless. This may account for the rather poorer correlation of airspeed as compared with all other measured quantities. For these the measured and recorded values agree within acceptably small limits. On this high degree of correlation rests the assertion that notwithstanding its somewhat unrealistic character the calculated input must approximate closely the pilot's action. The only doubt concerns the aerodynamic data used in the calculations and it is scarcely conceivable that these can be materially in error in view of the results.

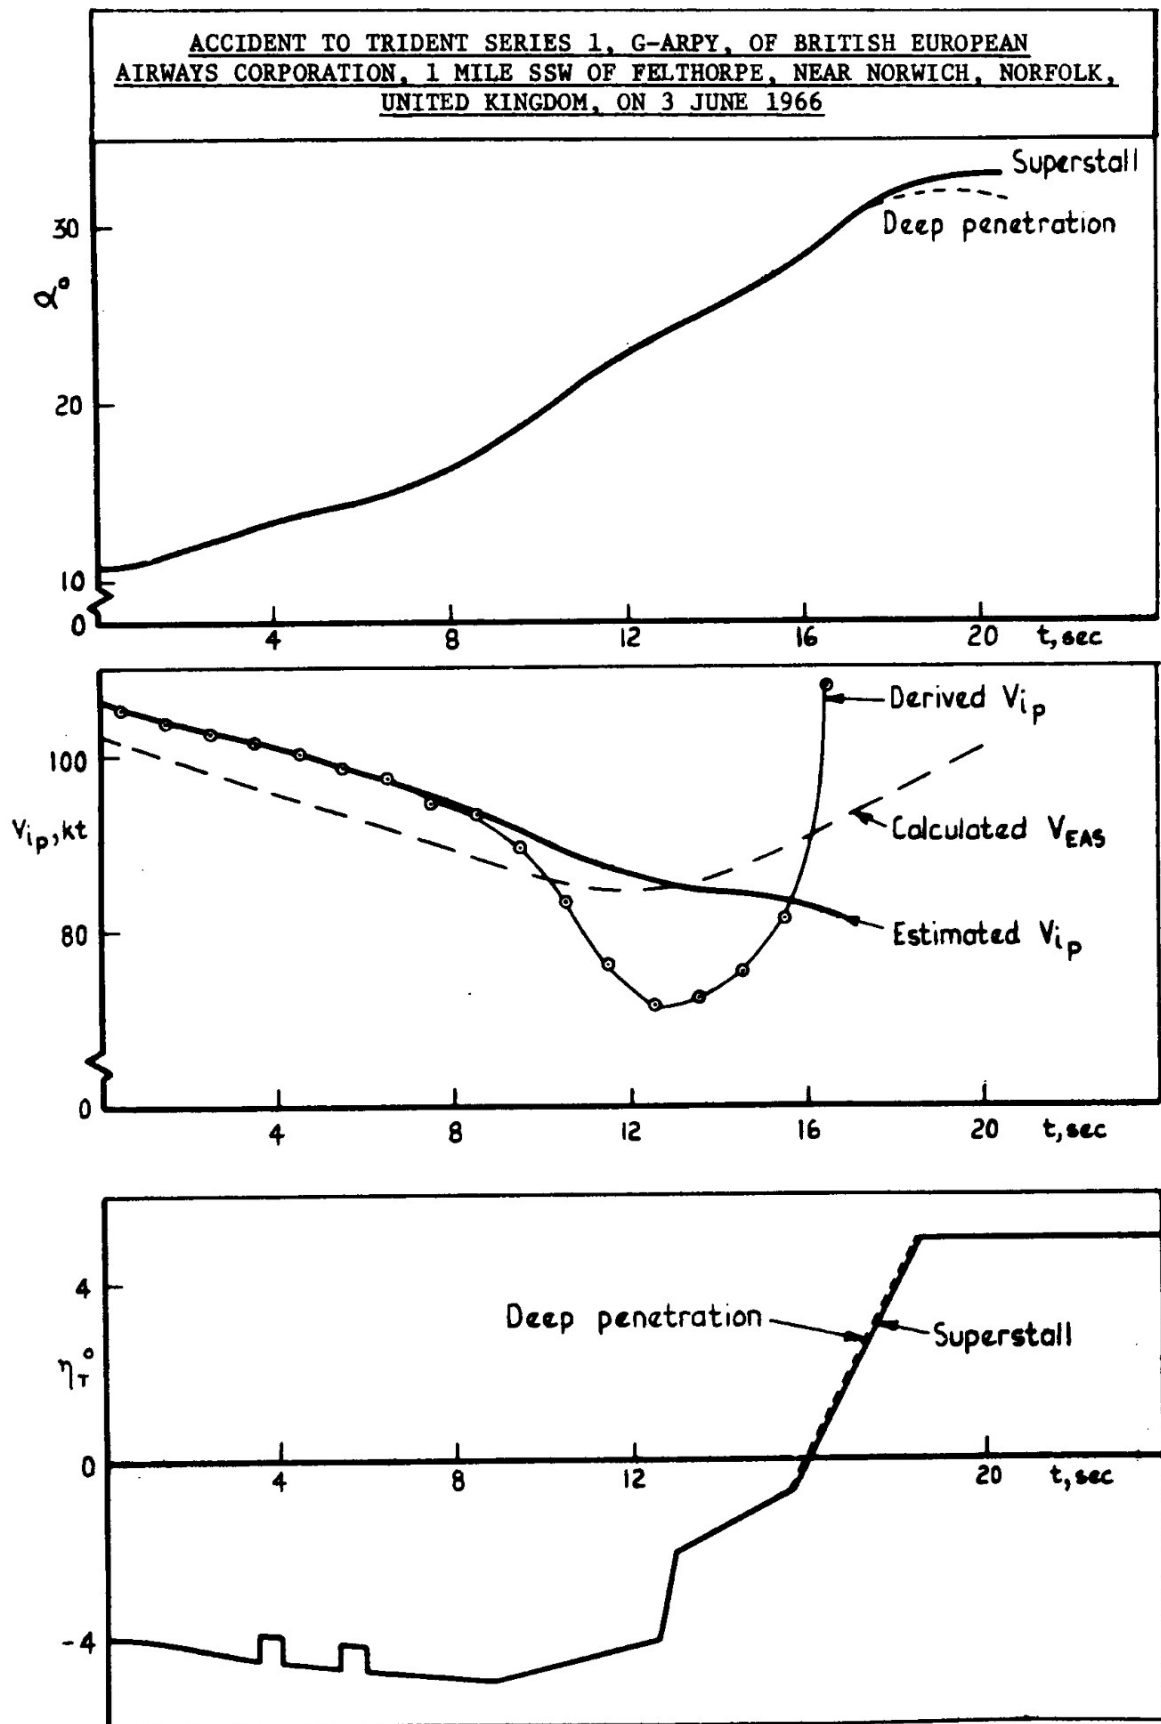
Fig. 9-3 - Angle of incidence, α , velocity indicated to pilot, \dot{v}_{ip} and tailplane angle, η_T

If it is accepted, on the basis of the above argument, that the input history shown in fig. 9-3 closely approximates the tail plane movements made by the pilot then it remains to interpret these as far as it is possible to do so.

It is essential to this part of the investigation to consider what airspeed reading was displayed to the pilot. His instrument is subject to entirely different corrections as compared with those of the recorder equipment, c.f. figs. 9-2 and 9-3. Estimates of the readings of the pilot's airspeed indicator can be obtained in two ways. In the first of these the calculated equivalent airspeed is converted into a pilot's instrument reading. This yields the curve marked 'estimated V_{ip} ' in fig. 9-3. In the second method the recorded airspeed (corrected for instrument error) is multiplied by a factor, which accounts for the different position errors. This gives the curve marked 'derived V_{ip} '. In the range of speeds covered by the 'estimated V_{ip} ' instrument corrections are small and no account is taken of them. Although the values obtained by the two methods are quite different beyond about 10 secs, both curves indicate that a flattening off or even an increase of speed occurs at around 13 secs.

Examination of the behaviour of the various motion parameters shows that having brought the aircraft down to 'stick-pusher' speed, or strictly a somewhat slower speed, the pilot eases the stick forward. During the phase he could have been awaiting the occurrence of the buffet and would have noted the change to a mild nosedown rotation, which results mainly from the inherent pitching moment characteristics of the aircraft and partly from his action. This latter hardly merits being called a recovery action and might rather have been an attempt to hold a given flight condition. A plausible reason for doing so is that the pilot was not convinced that he had achieved the objective of the test, namely to explore the aircraft's behaviour to the buffet or the overriding speed limit.

There is no means of resolving this particular problem, but whatever the reason it would seem that no forcible recovery action was taken till about 12.5 secs on the present time scale. After applying the 'elevator' control at a fairly fast rate in the nosedown sense for about half a second there now seems to follow another interval during which the rate of application of the tail plane is much reduced. This hesitation may be related to the pilot's assessment of the situation, in particular the apparent deceleration, as has been demonstrated, exhibits a marked falling off, if not reversal. It also seems possible that a further apparent drop in speed alerted him to the true situation and resulted in the final push forward of the stick.

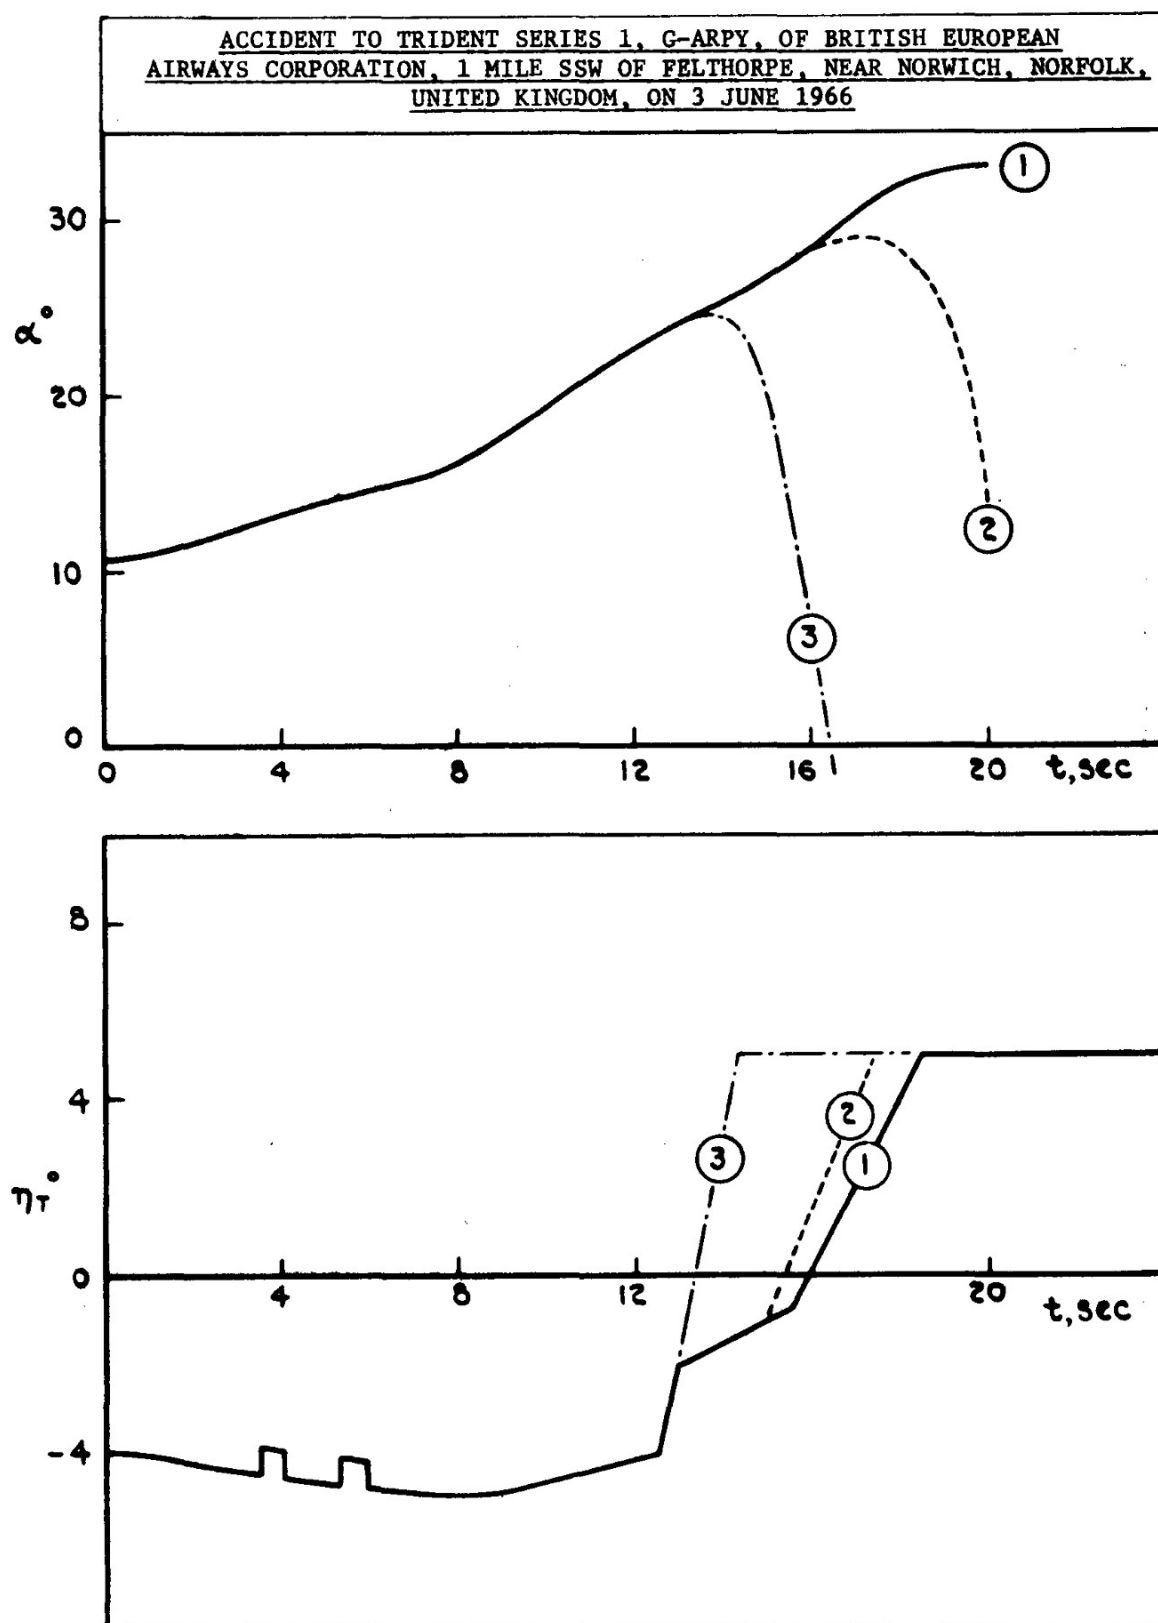
Fig. 9-4 - Effect of different recovery action shown on the angle of attack, α

The effect of such a change in input on the history of the variables recorded is shown in figs. 9-4, 9-5, 9-6. Up to 15 secs the curves marked (1) and (2) are, of course, identical. Beyond this there is some gradual divergence of the curves, but the significance of this could easily be overlooked in a casual examination of the recorded data. It is difficult to see how the pilot could distinguish between these two situations with any certainty. On the other hand it is clear that such differences are significant in terms of the present analysis.

If, however, the angle of attack (2) is available it can be seen from fig. 9-4 that not only are the two cases more readily distinguished but also the maximum value of the angle (29°) indicates how dangerously near the manoeuvre would have been to one from which recovery would have been impossible. This fact would have been much less evident to a pilot using airspeed and altitude angle as his primary cues.
