No. 11

Líneas Aéreas Nacionales S.A. (LANSA), Constellation L-749A, OB-R-771,  
accident on Mount Talaula, Department of Lima, Peru, on 27 April 1966.  
Report, dated 10 June 1966, released by the Directorate General of  
Civil Aeronautics, Peru

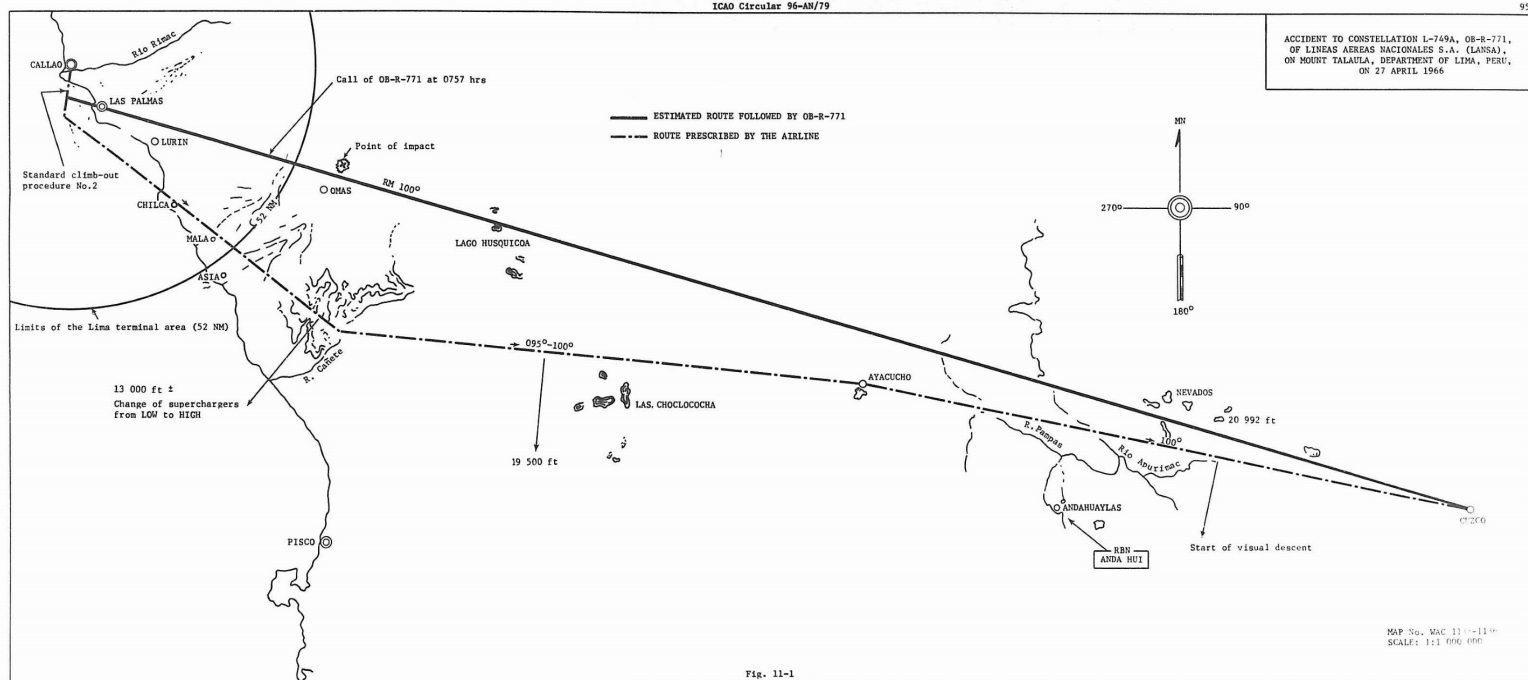
Fig. 11-1

The airline's operation procedure for the route Lima - Cuzco specified that the aircraft should climb on a heading of 190° until reaching a point 9 NM south of the station, then turn 70° to the left climbing along the coast up to the Quebrada de Canete and then turn on to a direct heading to Ayacucho and from there to Cuzco. This procedure was made in order to allow the aircraft to reach a safe altitude before crossing the Andes mountains and placing the engine superchargers in the "HIGH" position (see Figure 11-1).

Three witnesses observed the aircraft flying unusually low over the narrow gap between the villages of San Pedro de Pilas\* (elevation 2 633 m or 8 638 ft) and Tamará (elevation 2 833 m or 9 294 ft) and heading towards Mount Huamantanga. It was deduced from their statements that the aircraft was then flying on a heading of approximately 100° and was operating normally. This appeared to be confirmed by the fact that the aircraft continued its flight in the direction of the peak whereas, should the pilot have been faced with any type of difficulties in the vicinity of San Pedro de Pilas, he would certainly have turned towards the Rio Omas gap, starting between San Pedro de Pilas and Tamará and debouching on the coast near the town of Asia.

By joining Cuzco to San Pedro de Pilas by a straight line a true track of 107°, i.e. a magnetic track of 100° (variation 7°E) was obtained. This corresponded to the general heading of the aircraft and therefore it was believed that the pilot elected to fly a direct route to Cuzco. By continuing this straight line in the direction of Lima, it was found that it intersected the prescribed 190° climbout procedure track in the vicinity of Las Palmas and it was assumed that the pilot turned on to a direct course to Cuzco abeam this town which is 7 NM from Lima, i.e. 2 NM short of the prescribed turning point. The late departure and the fact that the meteorological conditions were exceptionally good along the route may have induced the pilot to take such a decision. However, in view of the fact that the aircraft was heavily loaded, although within permissible limits, its climbing performance was not sufficient to allow it to reach the safety height required over the mountain range along the direct route.
