Empresa Consolidada Cubana de Aviación, Antonov AN-12A, CU-T 827, accident at Texcoco near Mexico City International Airport, on 9 February 1967.  
Report File No. 0023/1-87, dated 21 February 1967, released by the Aircraft Accident Investigation and Inquiry Commission, Directorate General of Civil Aeronautics, Mexico, on 3 March 1967

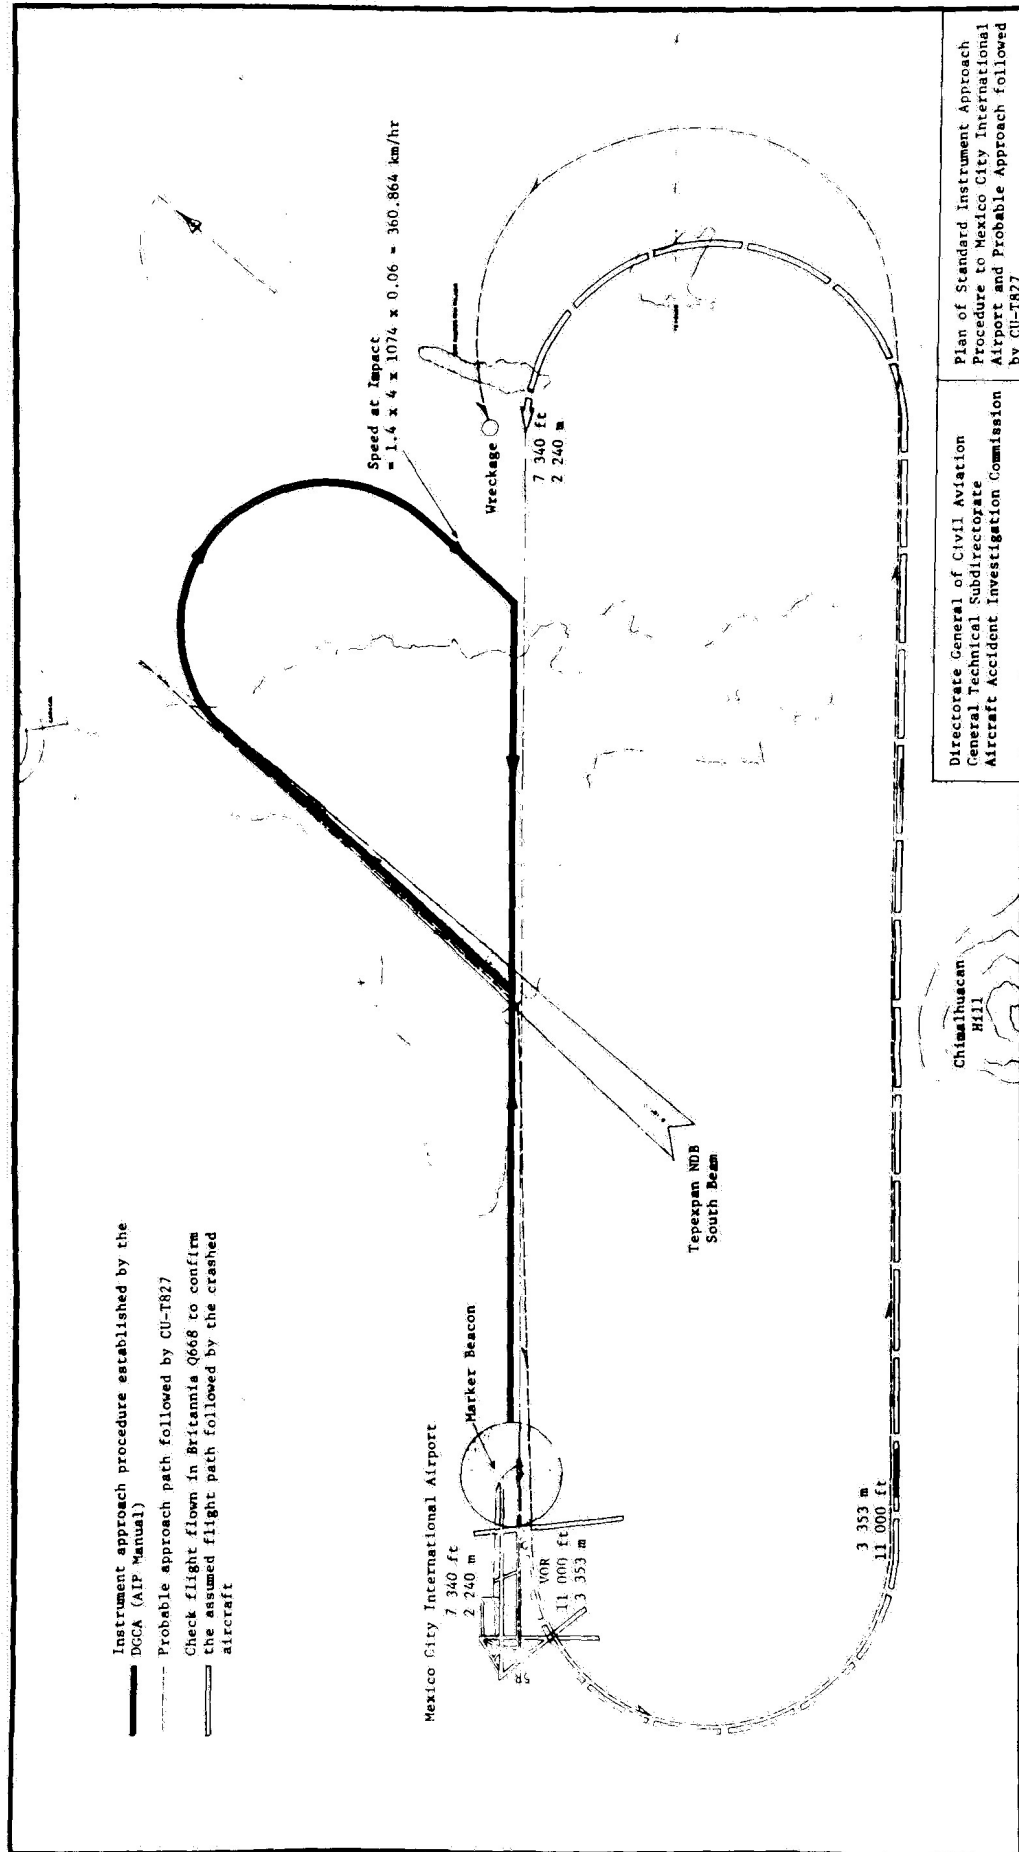
Figure 19-1. Accident to Antonov 12A, CU-T827 of Empresa Consolidada Cubana de  
Aviación near Mexico City International Airport on 9 February 1967
