PART ISUMMARIES OF AIRCRAFT ACCIDENT REPORTS AS PREPARED BY ICAONo. 1

British Midland Airways Limited, Argonaut, G-ALHG accident at Stockport, Cheshire, England, on 4 June 1967. Report, not dated, released by the Board of Trade, United Kingdom. C.A.P. 302 on 22 August 1968

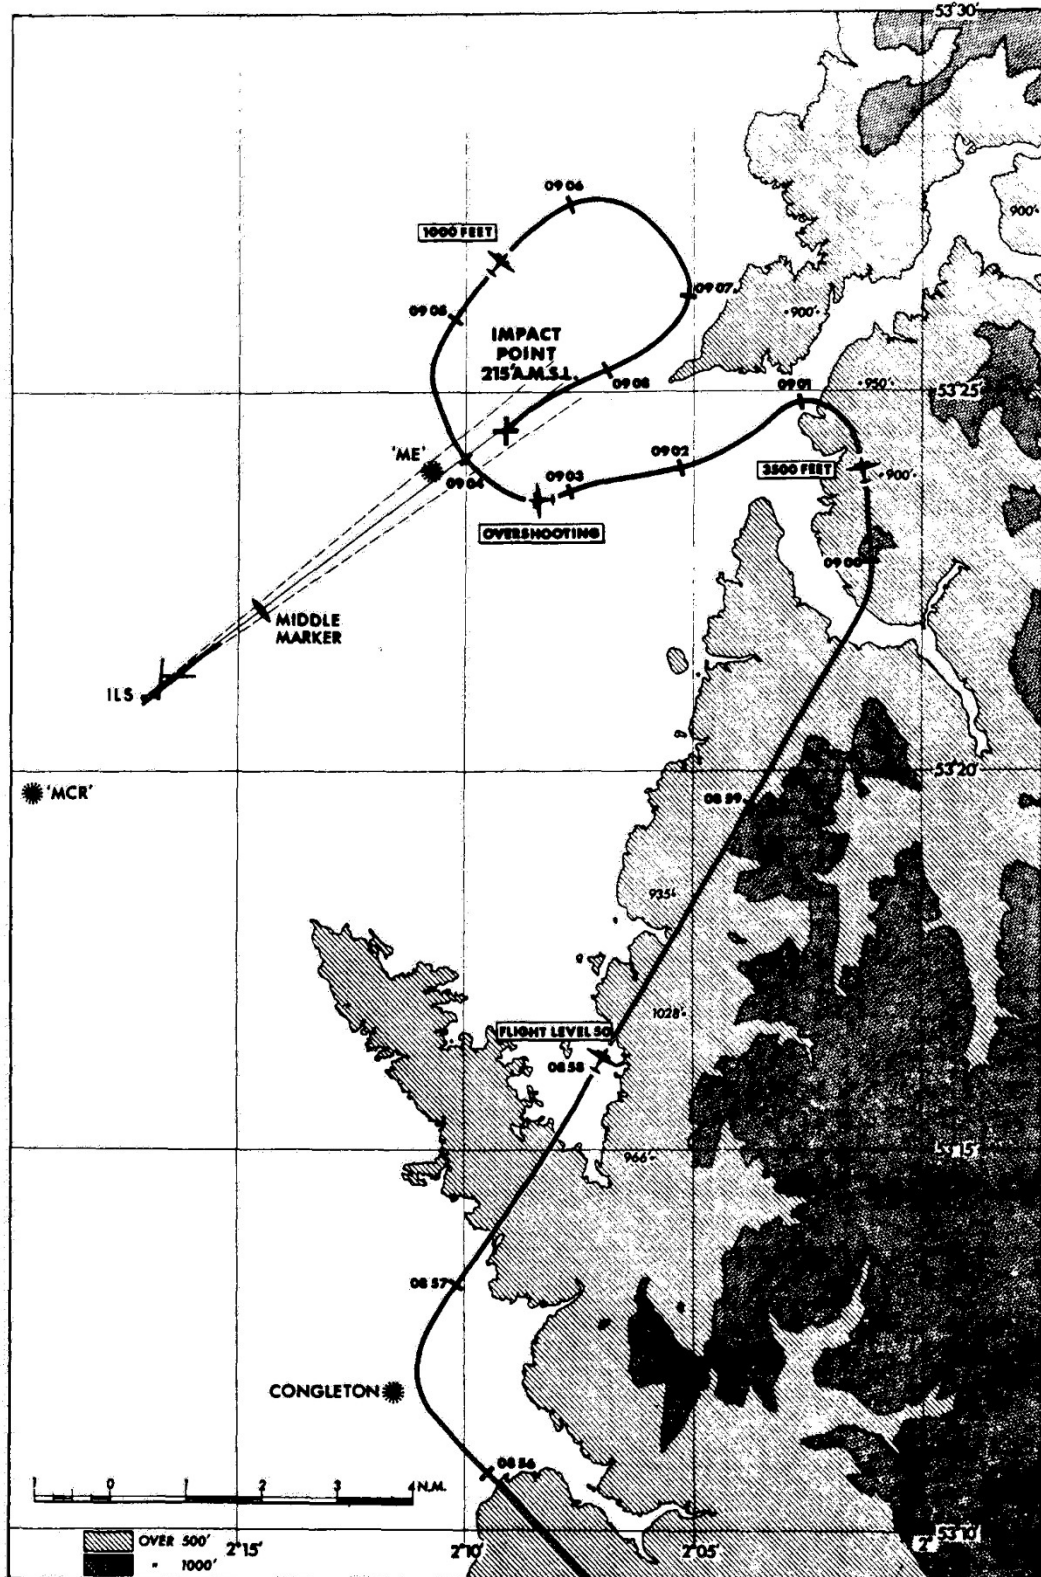
Figure 1-1. Flight Path Diagram

A reconstruction of the last 15 minutes (900 seconds) of the flight was made from the read-out of the recording. Subject to the aircraft track being plotted about half a statute mile to the SE of its actual track this reconstruction conformed closely with the eyewitnesses' evidence (see Fig. 1-1 and 1-2).

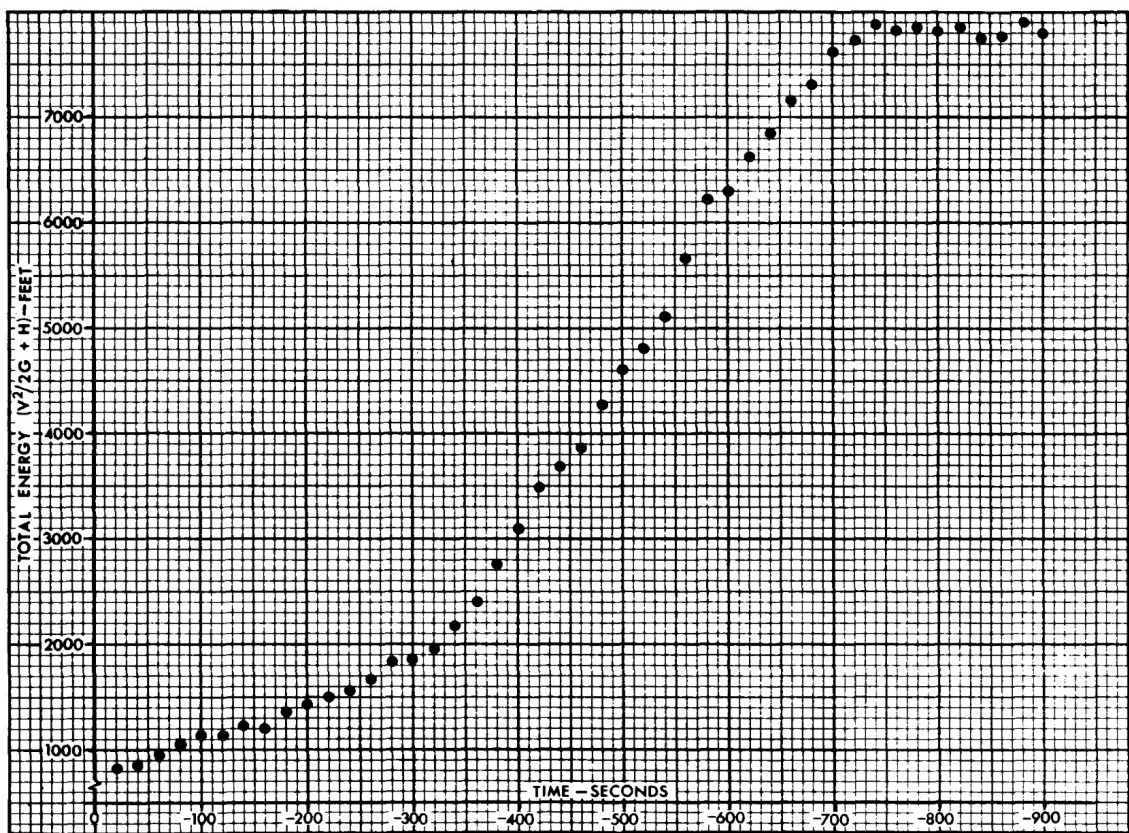
Figure 1-3. Total Energy Plot

A plot of the aircraft total energy derived from the flight recorder speed and height data against time was drawn (see Fig. 1-3). The plot showed that 900 sec before the crash (-900) the total energy level was corresponding to cruising flight at a fairly constant speed and height. After 150 sec (-750) this was followed by a somewhat variable energy loss as height and later speed were reduced in the initial stages of the approach. At -340 sec there was a sharp reduction in the slope of the curve followed by a further reduction at about -215 sec. The period from -550 sec to the crash was plotted on a larger scale in Figures 1-4 and 1-5, and these changes show more clearly on Figure 1-4. Energy continued to be lost at a steady rate without any sustained increase until the end.

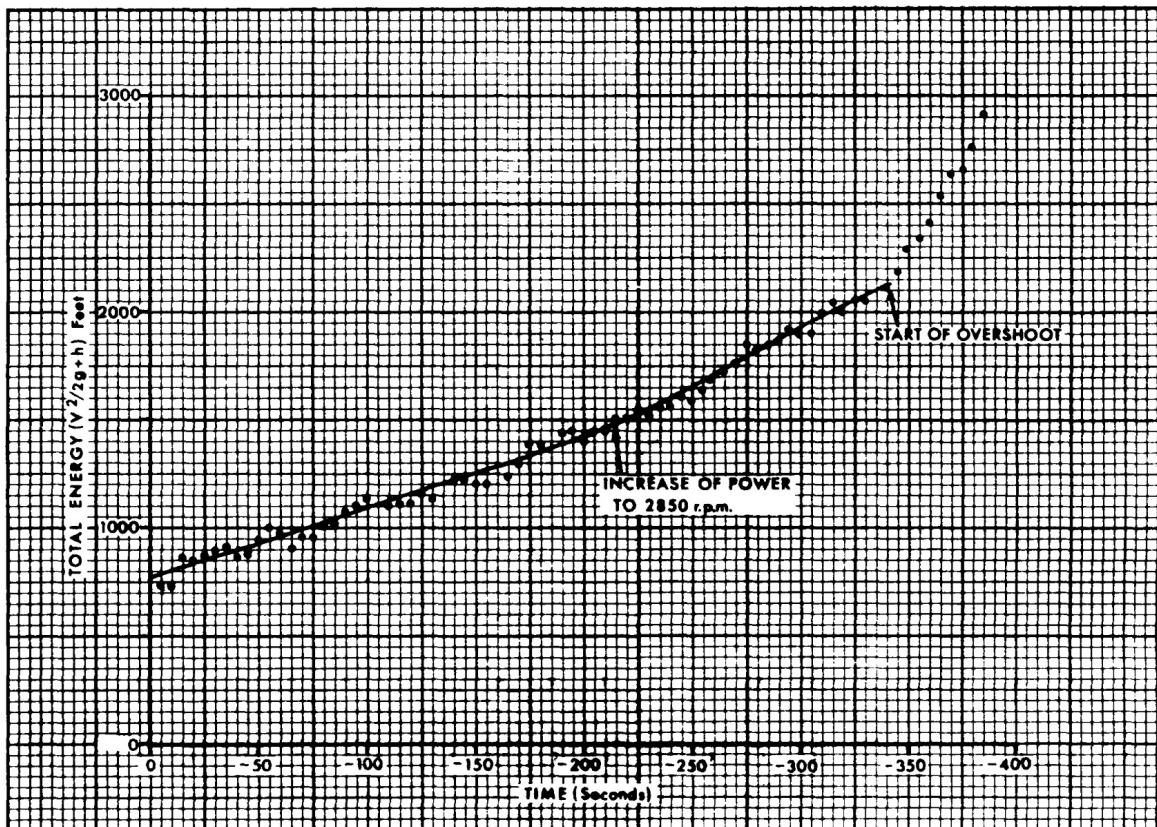
Figure 1-4. Total Energy Plot

The increase in slope at around -495 sec (see Fig. 1-5) was consistent with the extension of some 10° of flaps, followed by a decrease consistent with a small increase in power. Beyond this point the increase in slope at -430 sec suggested the failure of an engine, followed at -410 sec by the failure of a second engine at about the same time as the feathering of the propeller on the first. At -340 sec the decreased slope was consistent with increase of power on the live engines at 2 650 rpm and 48.2 in. manifold pressure, no doubt when the pilot decided to overshoot and go round again, with a further increase at -215 sec, shown on Figure 1-4, to 2 850 rpm and 58.4 in.

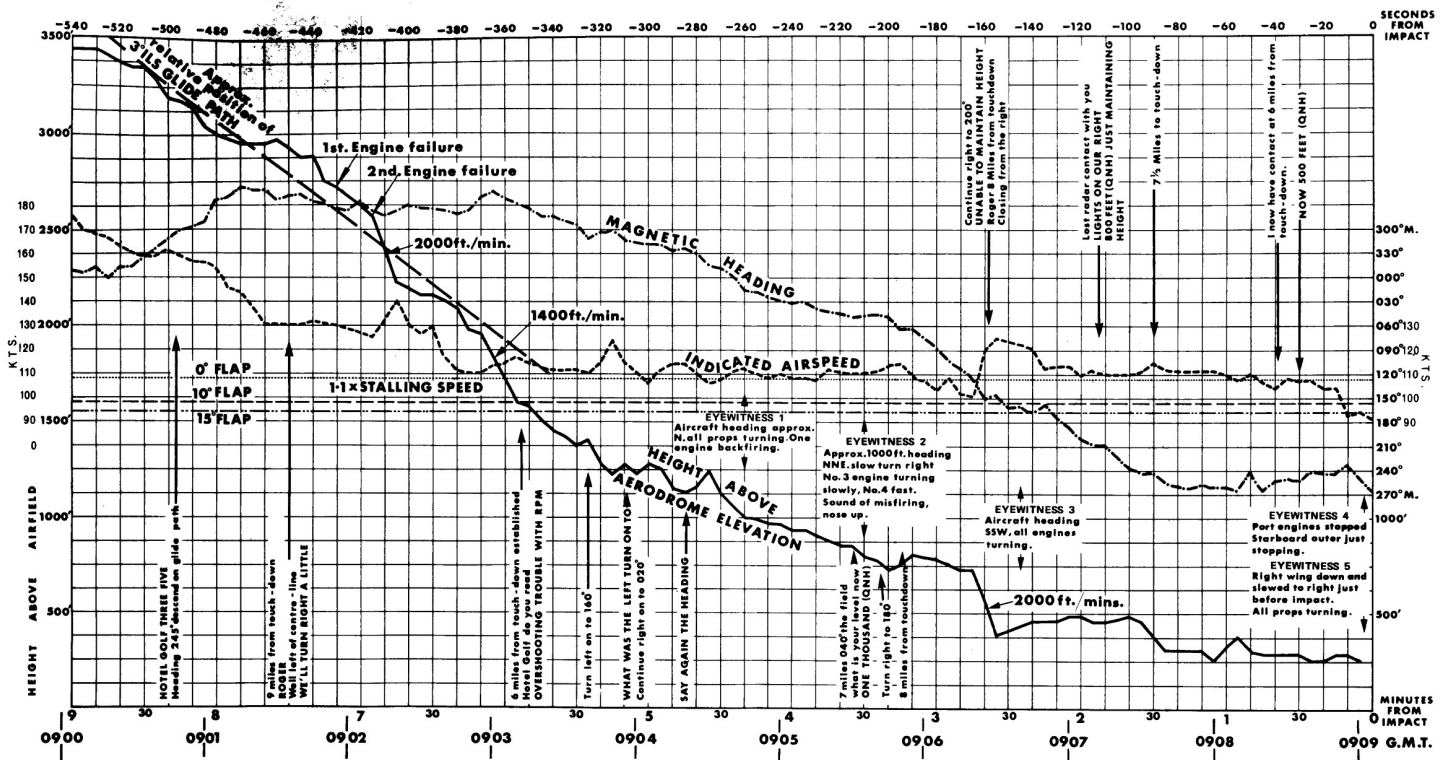
Figure 1-6. Combined Information Plot

Figure 1-6 shows the parameters of indicated airspeed, height and magnetic heading plotted to show their relation to the 3° slope of the ILS glide path, $1.1 \times$ stalling speed at 0° , 10° and 15° flap, the key R/T messages and the eyewitness statements. The sudden loss of height at the rate of 2 000 ft/min with a corresponding increase in airspeed from 126 to 140 kt between -415 and -405 sec bears out the inference from the total energy plot that two engines failed within a very short time of each other very shortly before. By -375 sec the airspeed had decayed to 110 kt and the aircraft had started to turn right, continuing to do so although vectored to the left on to 160° 50 sec later. All its behaviour as indicated on the plot was consistent only with the pilot being faced at about that time with a major emergency involving severe control difficulties, which were never overcome.

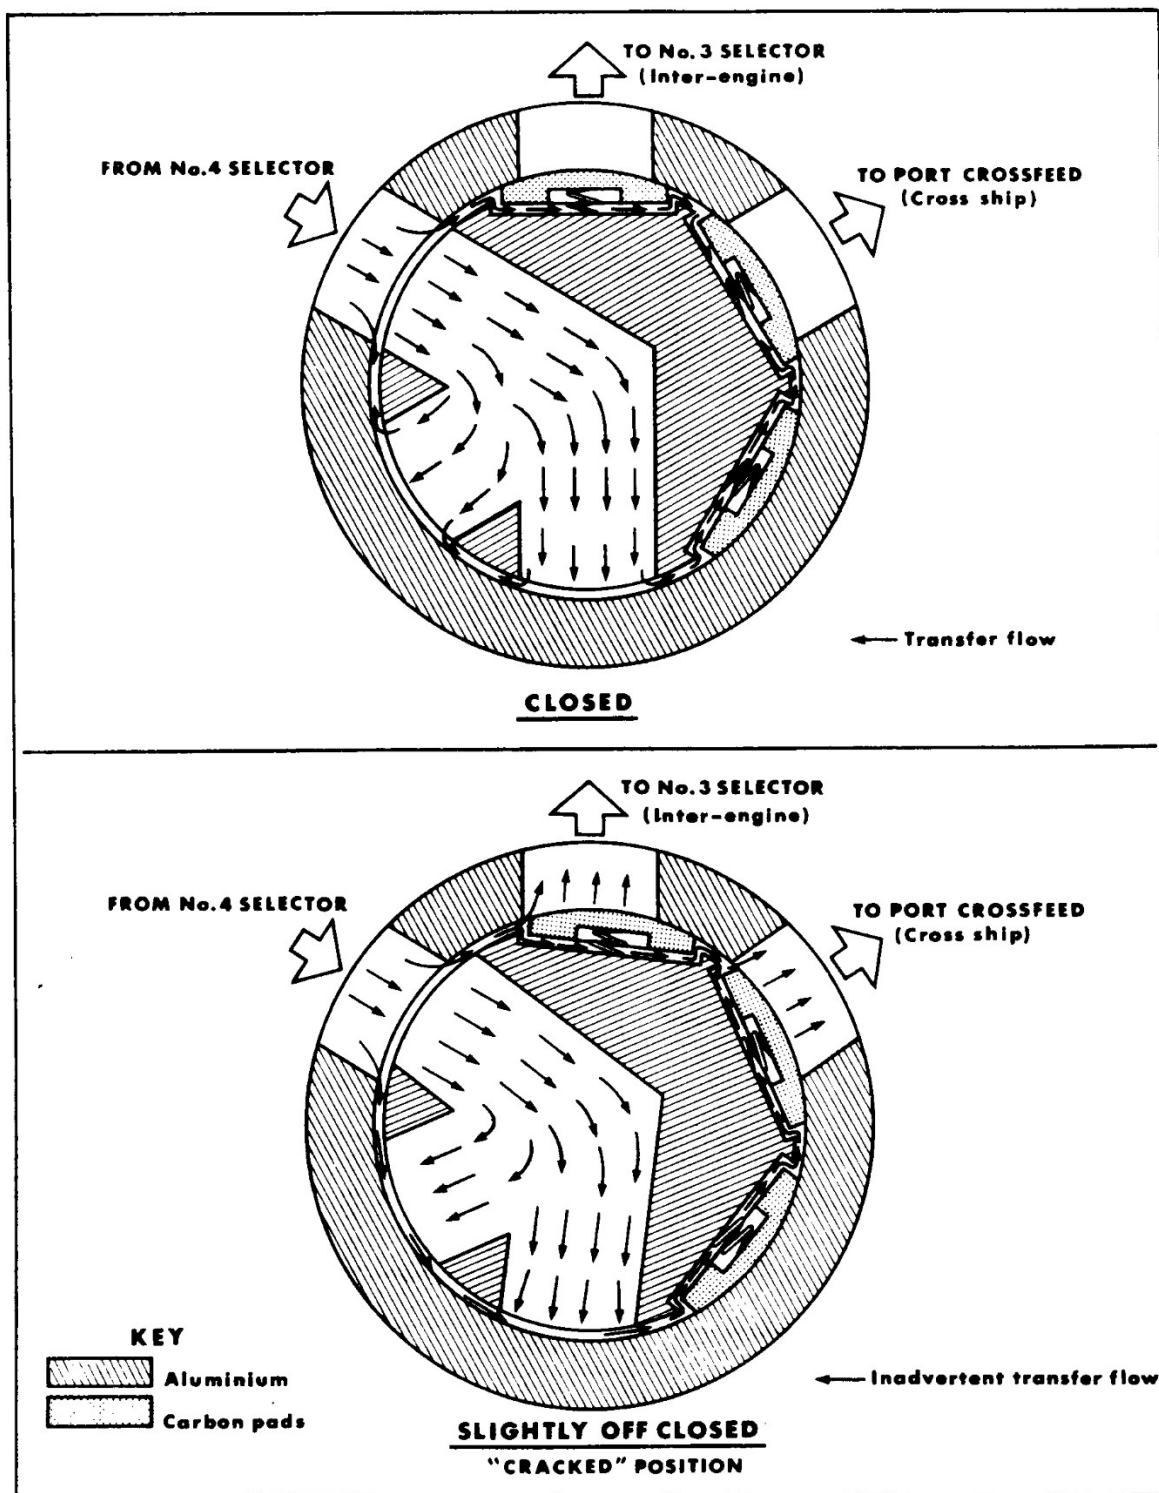
Figure 1-8. Sketch Showing Principle of Starboard Crossfeed Valve

During the ground tests it was discovered that a very slight movement of the cross feed controls back from the closed position produced first "inter-engine cross feed" and later "cross-ship cross feed" (see Fig. 1-8). Further ground engine runs were carried out with ARB representatives present. The first runs were made with the tank selector controls of Nos. 1, 2 and 3 main and all auxiliary tanks "OFF", No. 4 main tank and booster pump "ON", and the cross feed controls cracked. In this condition all four engines ran at 30 in manifold pressure, and continued to do so when No. 4 booster pump was switched off.
