No. 24

British European Airways Corporation, de Havilland Comet 4B, G-ARCO, accident about 100 miles east of Rhodes, on 12 October 1967. Civil Accident Report No. EW/A/0102, dated April 1968, released by the Board of Trade, United Kingdom, C.A.P. 305

ACCIDENT TO DE HAVILLAND COMET 4B, G-ARCO, OF BRITISH EUROPEAN AIRWAYS
CORPORATION ABOUT 100 MILES EAST OF RHODES, ON 12 OCTOBER 1967

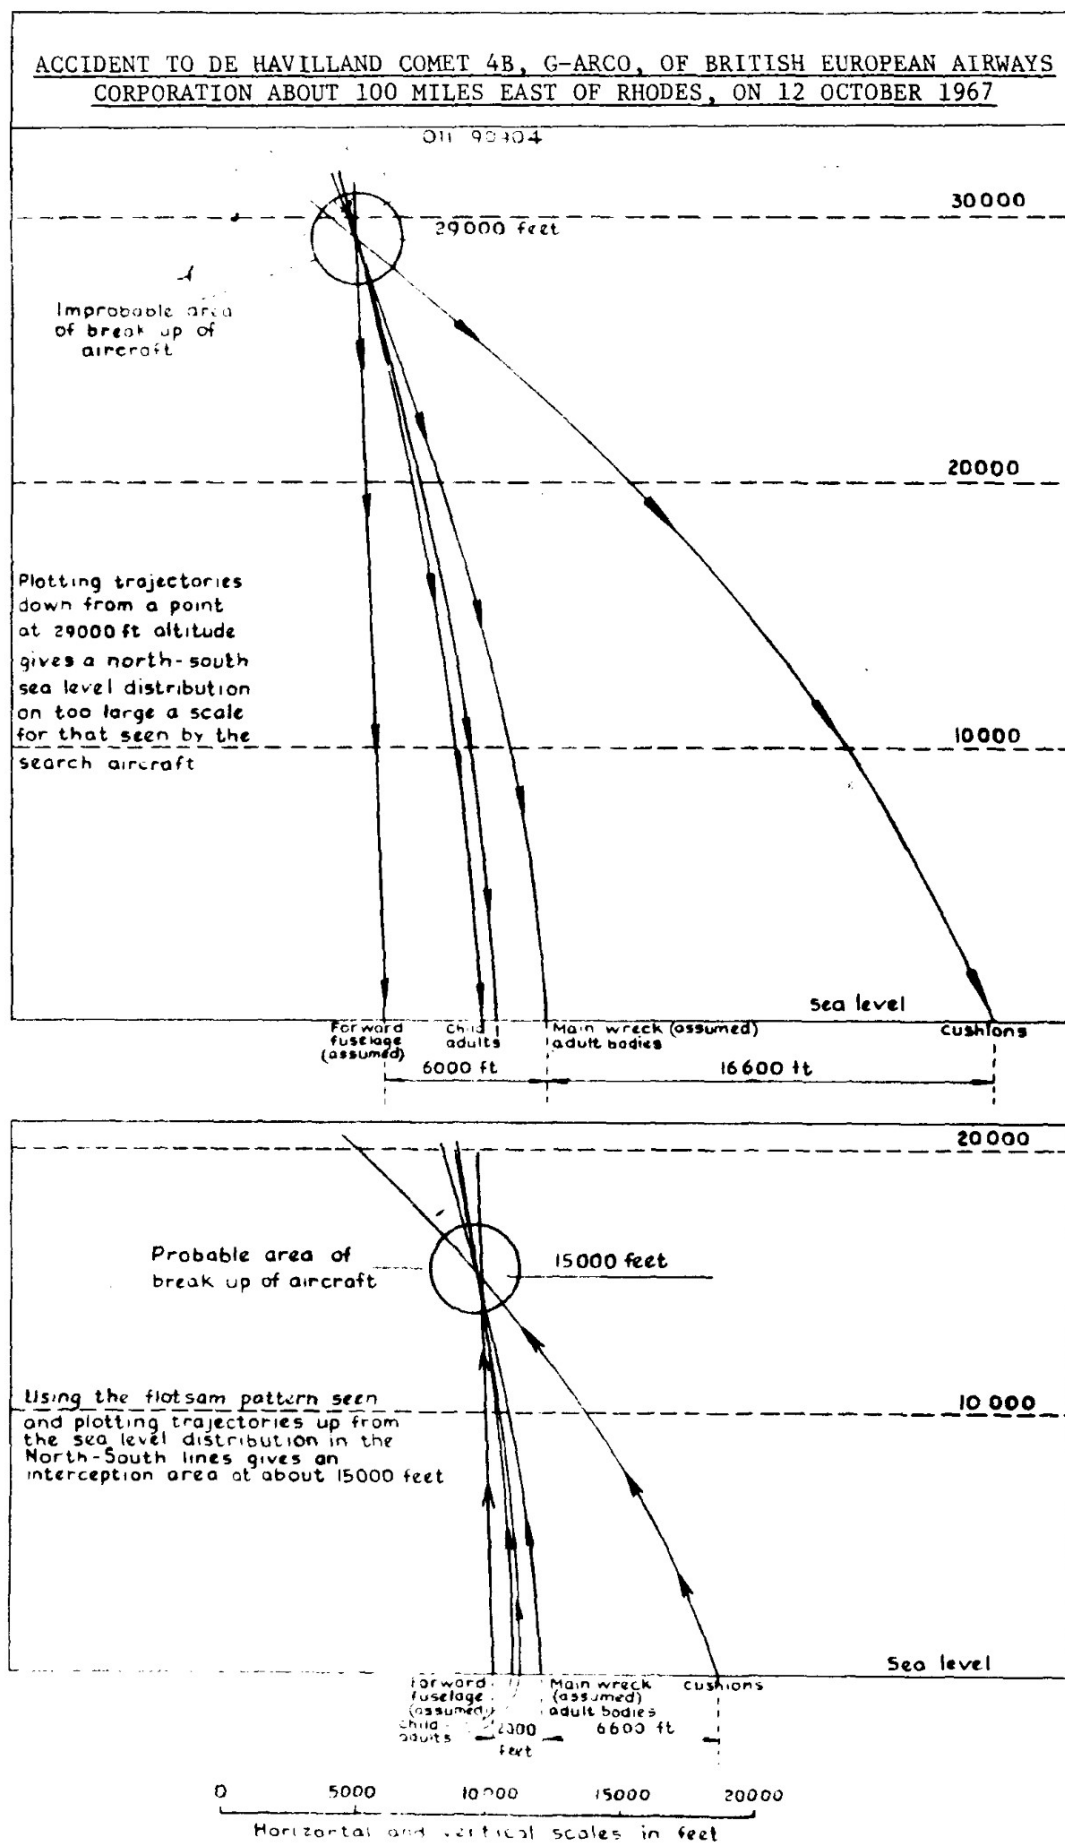
Fig. 24-2 - Trajectory plots.

Fig. 24-2 shows the results of the calculations. Plots were first made from a specific point at 29 000 ft altitude, and the resulting scatter of flotsam and bodies, at sea level, noted. This distribution was too large to be reconciled with that seen by the search aircraft. Trajectories were then plotted from sea level upwards, from the general positions for items, as suggested by charts and maps from the search aircraft. A very close interception area of plots was found at about 15 000 ft altitude, but this figure must be regarded only as an approximation and treated with caution owing to the imprecise information of the relative position of the flotsam and bodies at sea level. It was concluded that the aircraft had not broken up at its cruise altitude, but at the lower altitude, to produce the general pattern in the sea of flotsam and bodies, and the damage and injury pattern to bodies. A similar conclusion was reached by the pathologists, basing their argument purely on the medical evidence.

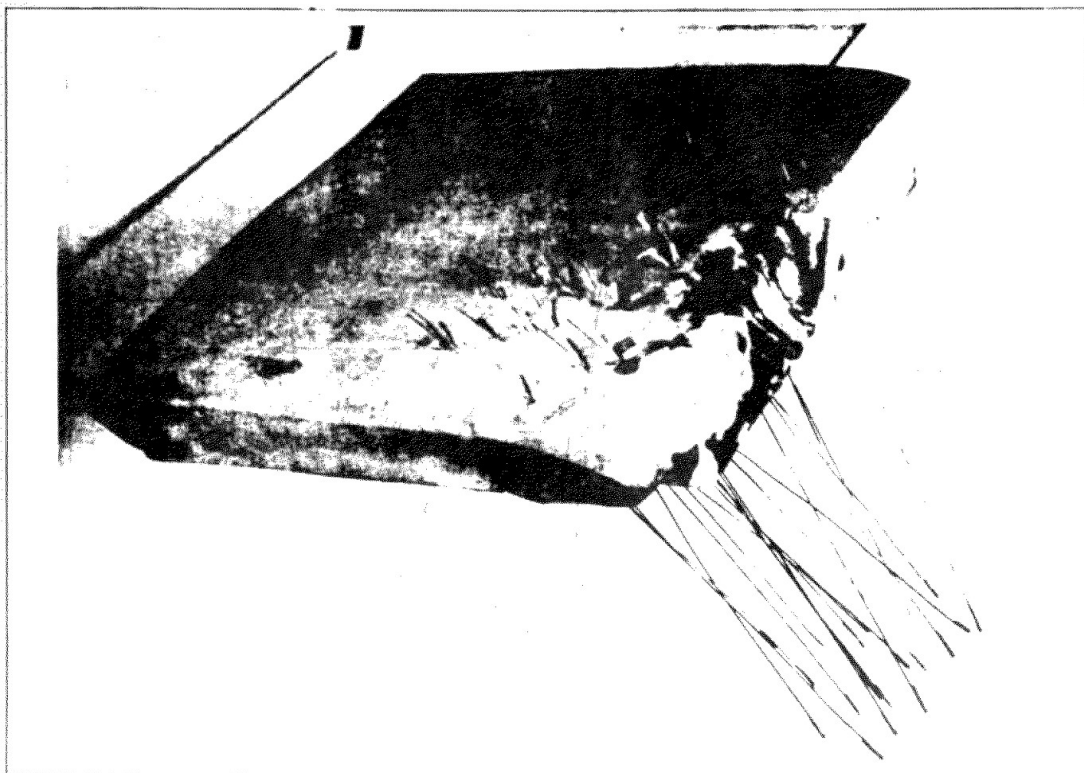
(a) The trajectories of the larger particles which perforated the cushion and those which produced the major area of damage were explored by the use of wire probes (Fig. 24-4). This suggests an origin of limited volume some 12 in below the seat roughly in the vertical plane to the rear edge of the cushion and about 3 in from the line of the port edge of the cushion. The trajectories delineated by the entry paths of the small particles embedded in the cushion confirm this position.

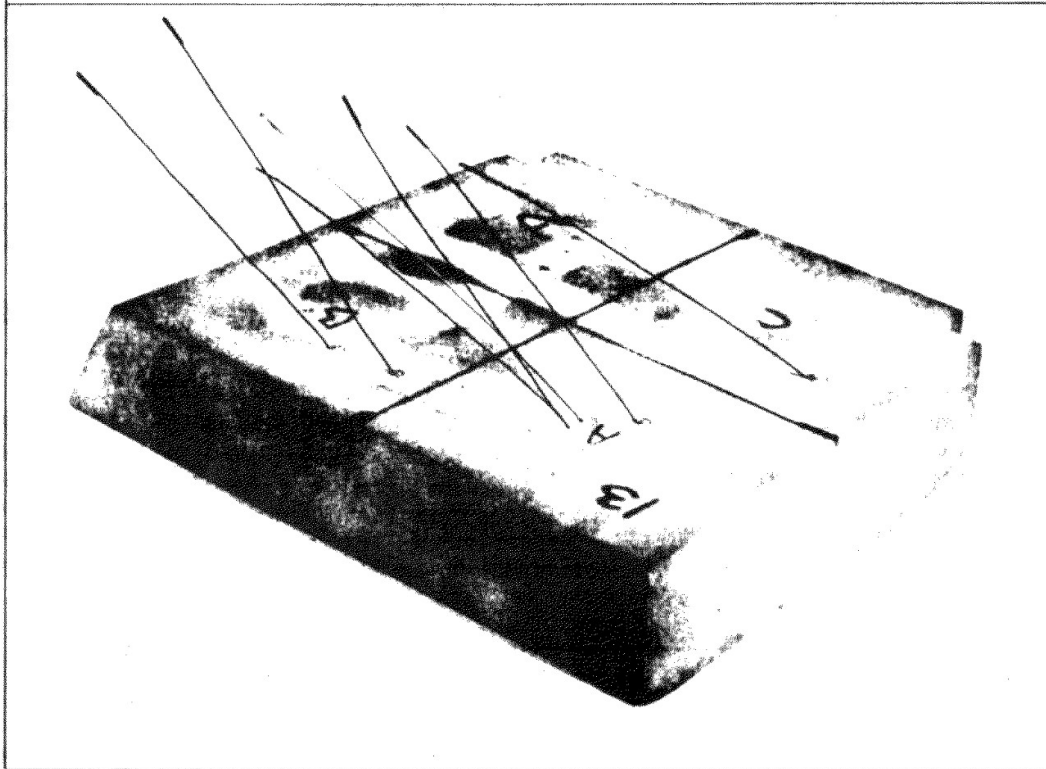
In order to verify these conclusions, RARDE carried out practical trials. An assembly was built of light alloy sheeting to simulate part of the cabin of the Comet. A new complete seat assembly was placed in position. An explosive charge of the military explosive PE4, encased in a thin-walled mild steel tube and fitted with a detonator, was placed in position, adjacent to the rear toe of the delta support, between the support and the side of the cabin. Targets were arranged to assess damage to adjacent seats, and to persons sitting in them. The results showed conclusively that a charge of about 16 oz of the explosive detonated in the position indicated would produce effects and damage similar in all details to that observed in the cushion from the Comet.

Fig. 24-5 - Second seat cushion with wires showing trajectories.
