Trans World Airlines, Inc., Douglas DC-9, N 1063T and a Tann Company Beechcraft Baron B-55, N 6127V, collided approximately 25 NM northeast of the Dayton Municipal Airport, Dayton, Ohio, U.S.A., on 9 March 1967.
Report, not dated, File No.1-0002, released by the
National Transportation Safety Board,
Department of Transportation, U.S.A.

TWA DC-9, N1063T/TANN COMPANY
BEECHCRAFT B-55 N6127V
INFLIGHT COLLISION NEAR URBANA, OHIO
MARCH 9, 1967

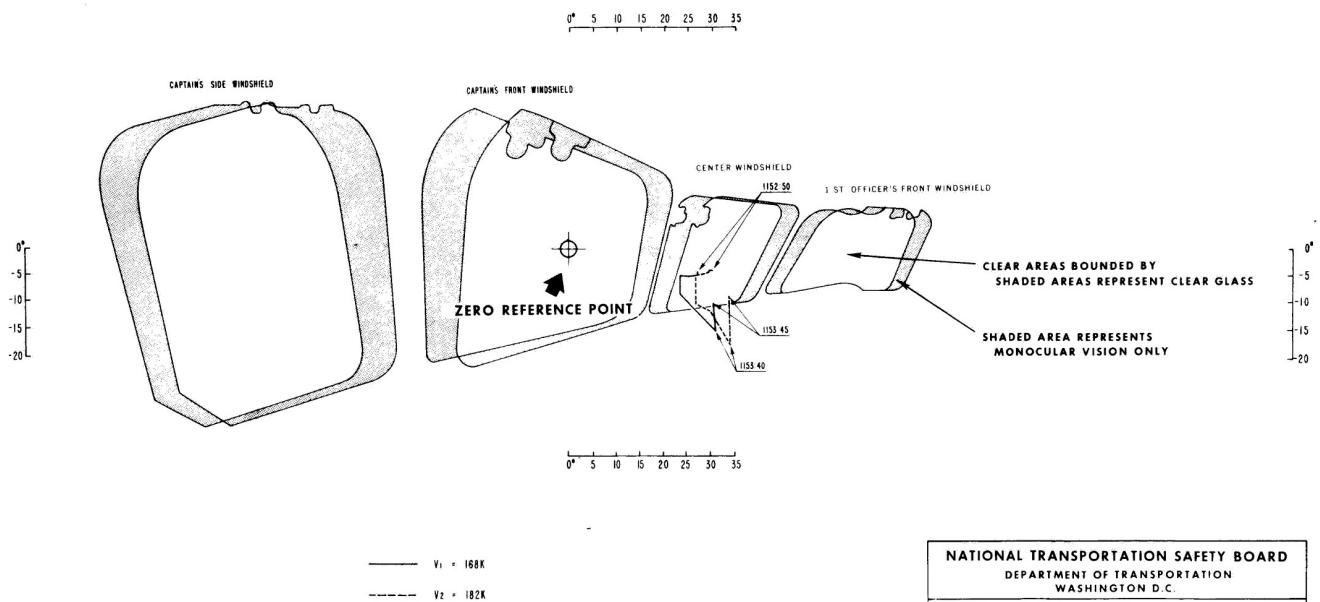
From the presentation in Figure 3-2 and 3-3 it is apparent that, between times 1152:50 hours and 1153:35 hours and again from 1153:45 to 1153:50, the Beechcraft was in such a position as to be visible to the DC-9 pilot-in-command in the centre windshield, but partially obscured to the co-pilot's view by the windshield post to the right hand side of his front windshield, assuming that both pilots were in the normal position in their seats. Had either or both of them moved their heads forward to the alert position, they would have enhanced their ability to detect the target presented by the Beechcraft.

CALCULATED DC-9 PILOT'S VIEW

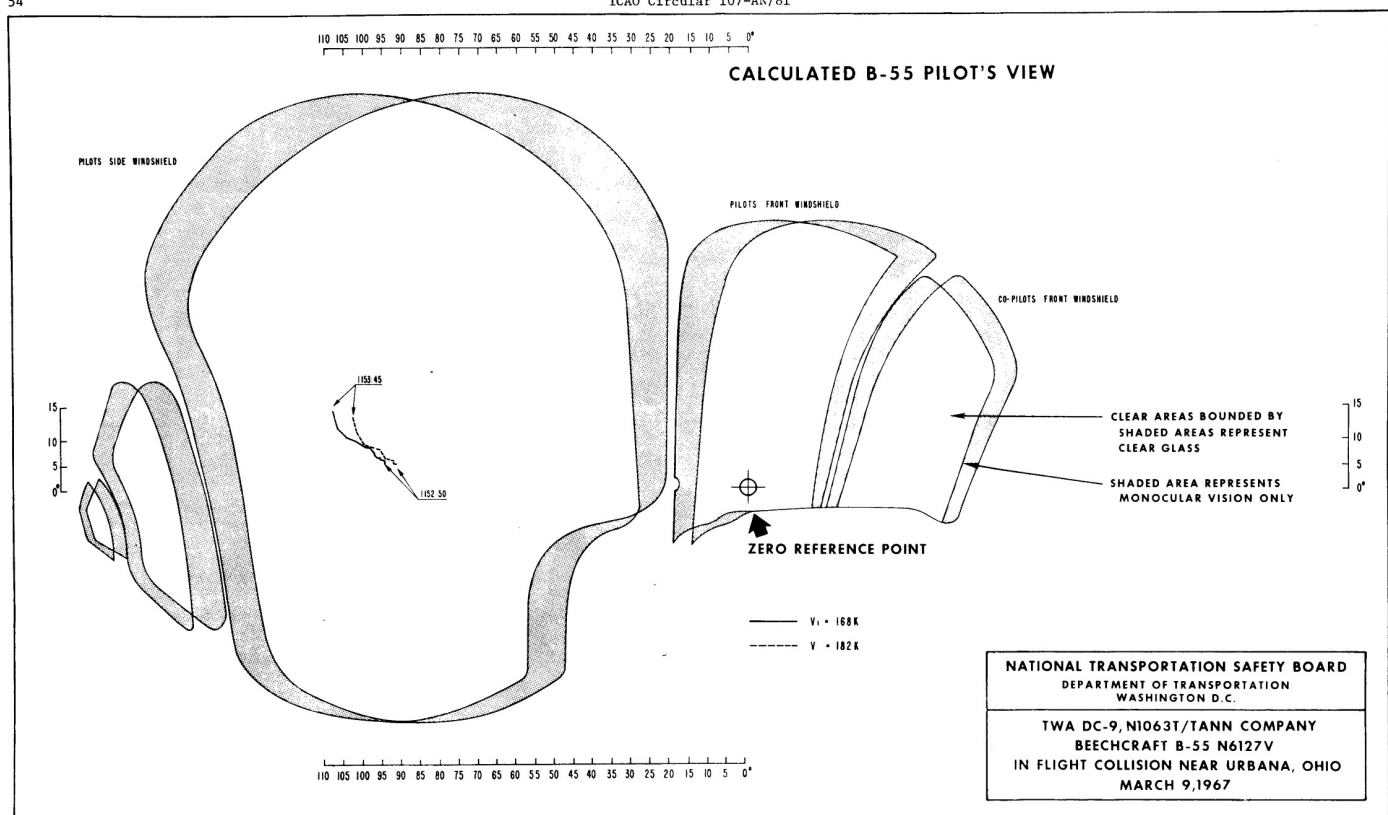
Figure 3-4 depicts the position of the DC-9 in relation to the left side cockpit cabin window of the Beechcraft. It was in a position to be seen by the Beechcraft pilot, should he have looked to his left between 92° and 108° and between 6° to 14° up. However, his attention was predominantly focused in the direction of his flight path as the primary responsibility of all pilots operating under VFR conditions is to assure that they have a clear flight path and to avoid other traffic in that airspace. The present-day "see and be seen" concept is based on all flight crews maintaining a lookout for other aircraft when they are operating under VFR flight conditions. This applied to the crew of the DC-9 who, although they were operating on an IFR flight plan, were in VFR conditions
