No. 6

Philippine Air Lines, Inc., Fokker F-27, PI-C501, accident at Basak,
Lapu-Lapu City, the Philippines, on 28 February 1967.
Report, dated April 1967, released by the
Aircraft Accident Investigation Board,
the Philippines

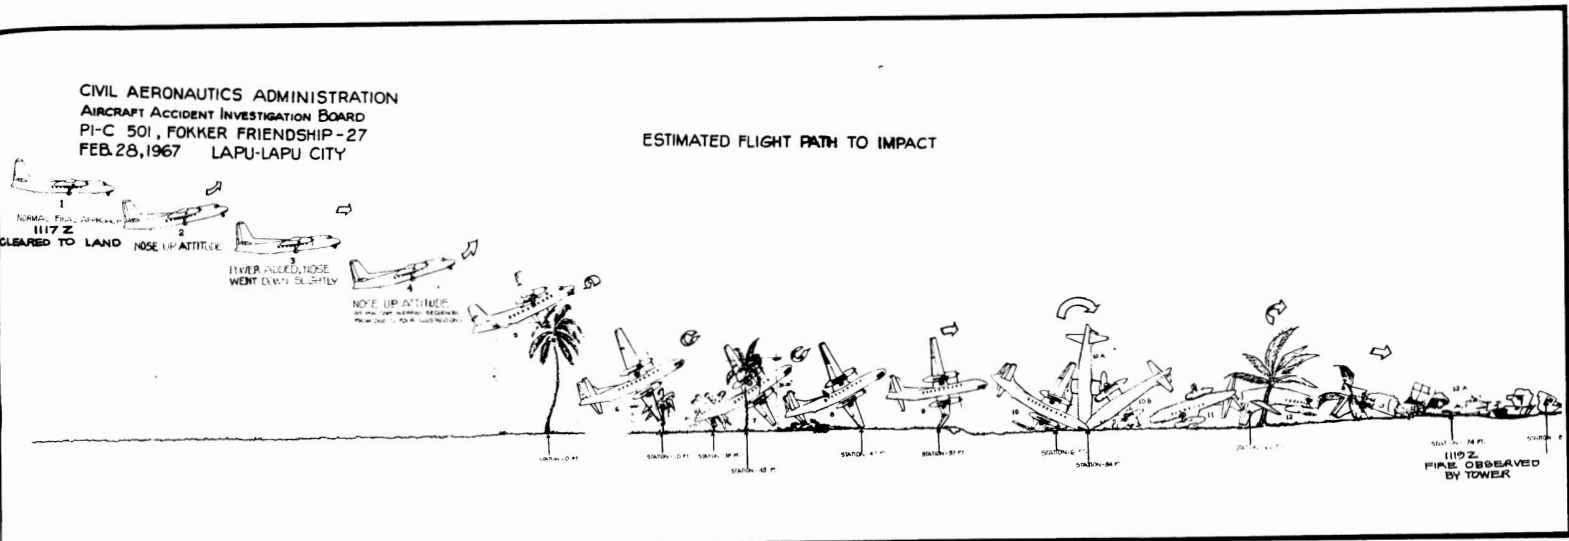
Figure 6-1

The wreckage was scattered over an area 80 ft in diameter. Examination of the accident site revealed that the aircraft was descending in a left wing low attitude and that its left wing struck a coconut tree and some banana trees before plowing the ground with its tip for about 10 ft. The left propeller then struck the ground and separated from its engine. The aircraft nosed over and slid on its back, the fuselage broke up and burned and both engines were torn off (Fig. 6-1).
