No. 9

Civil Air Transport, Boeing 727-92C, B-1018, accident at Linkuo, near Taipei, Taiwan, on 16 February 1968. Report not dated released by the Civil Aeronautics Administration, Republic of China

ACCIDENT TO BOEING 727-92C, B-1018, OF CIVIL TRANSPORT, AT LINKUO,  
NEAR TAIPEI, TAIWAN, ON 16 FEBRUARY 1968

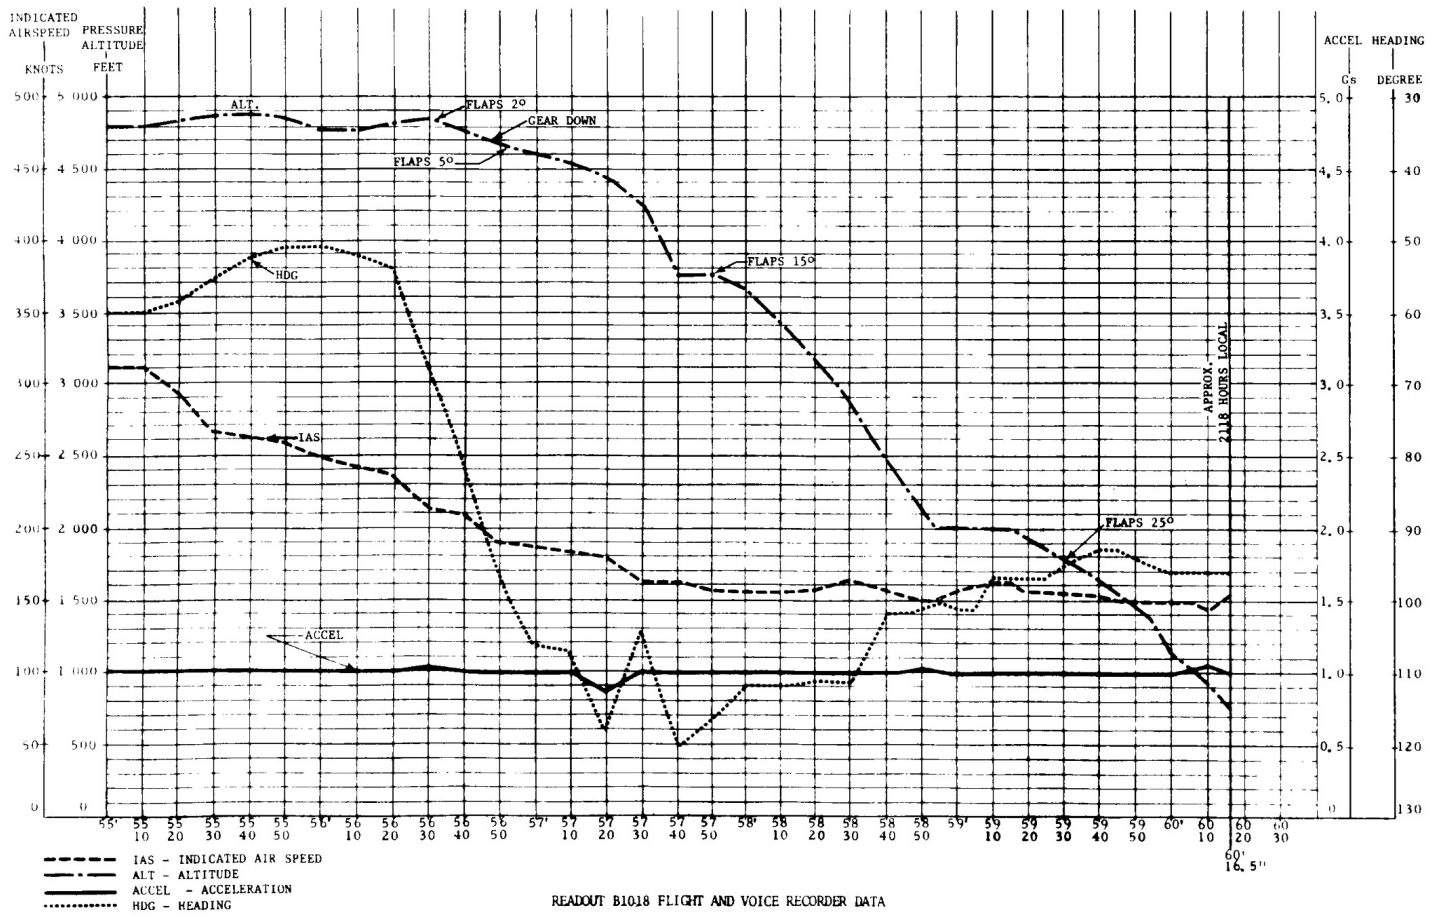
Fig. 9-1

The aircraft carried a Fairchild Flight Data Recorder and a Fairchild A-100 Voice Recorder. Both recorders were found after the accident and the tapes were in good condition for re-assembling and reading-out. (See Fig. 9-1.)

READOUT B1018 FLIGHT AND VOICE RECORDER DATA

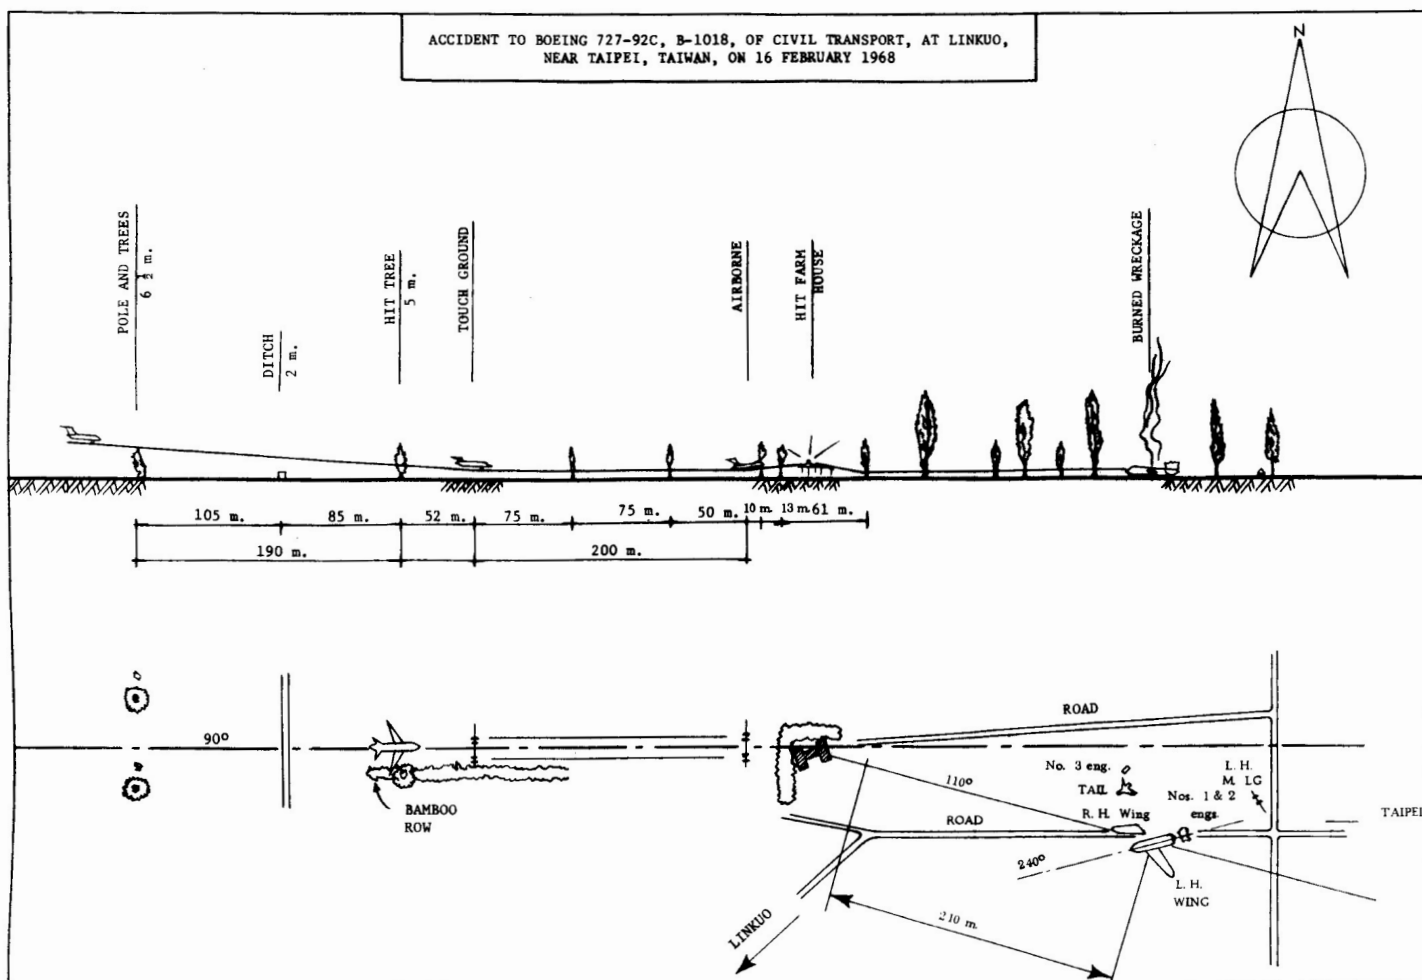
Fig. 9-2

The site of the accident and the distribution pattern of the wreckage are shown in Fig. 9-2.

The fuselage was broken off near the tail section and was nearly completely destroyed by the subsequent fire, only a few frame structures remained. The tail unit was separated from the fuselage, resting upside down about 100 metres away from it and free from fire damage. The left wing was broken off at the root, but remained close to the fuselage. Flaps and leading edge slats were extended; they were damaged and slightly burned. The right wing was broken off at the root, resting at about 15 metres from the fuselage; its flaps and leading edge slats were broken away and scattered over other locations of the site. All three engines were separated from their mounts and were damaged. Landing gears and nose gear were broken off from their original position and were damaged.
