No. 13

SABENA, Boeing 707-329C, OO-SJK, accident 8 miles north of Lagos/Ikeja Airport, Nigeria on 13 July 1968. Report dated 20 August 1969, released by the Federal Ministry of Transport, Nigeria

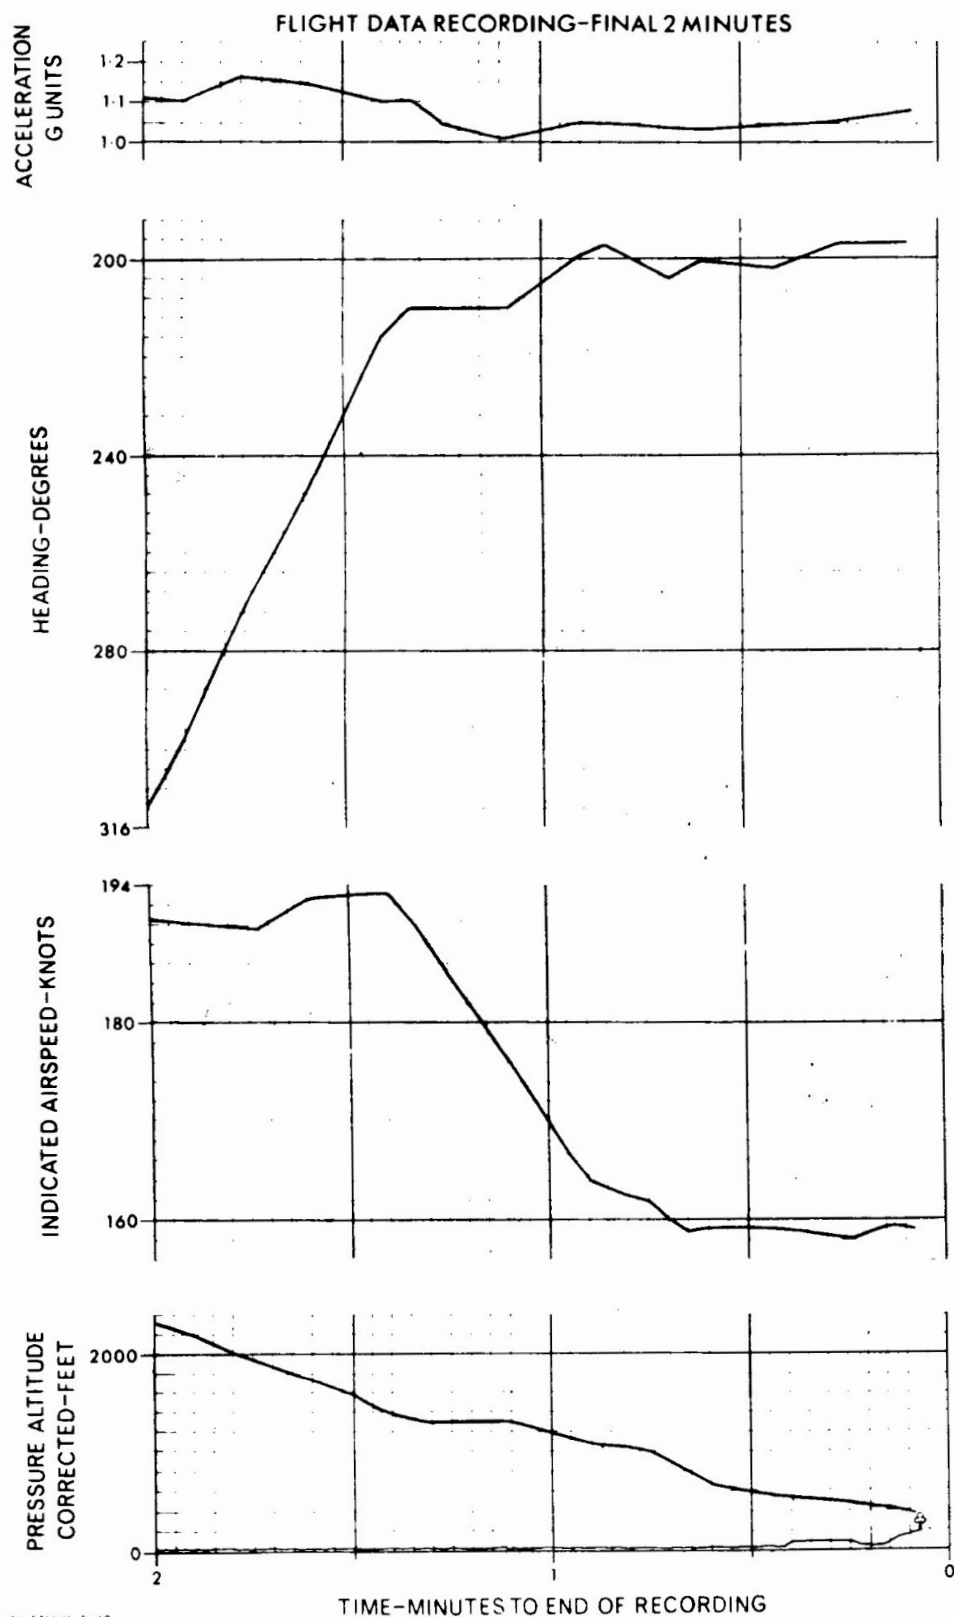
Fig. 13-1

At 0327 hours the aircraft reported an ETA overhead Ibadan NDB of 0344 hours in response to a request for this information from Lagos. One minute later it reported that the Ibadan NDB did not appear to be operating. At 0336 the aircraft requested descent clearance. It was cleared to Lagos at FL 60 and commenced the descent from FL 330 at that time. Three minutes later the aircraft reported passing Ibadan and descending through FL 275 but since it had reported earlier that the Ibadan NDB seemed not to be radiating it is not known how the position was determined. In reply Lagos approach stated that there was no delay in the approach and that the runway in use was 19. At 0341 hours, when the aircraft was about 50 miles north of Lagos, it was recleared to 2 200 ft on a QNH of 1012 mb and told to report field in sight. (See Figure 13-1.)

ACCIDENT TO BOEING 707-329C, 00-SJK, OF SABENA, 8 MILES NORTH OF LAGOS/IKEJA
AIRPORT, NIGERIA, ON 13 JULY 1968
