# National Transportation Safety Board Aviation Accident Final Report

<b>Location:</b>	Fort Lauderdale, FL	<b>Accident Number:</b>	DCA17MA022
<b>Date &amp; Time:</b>	10/28/2016, 1751 EDT	<b>Registration:</b>	N370FE
<b>Aircraft:</b>	MCDONNELL DOUGLAS MD 10-10F	<b>Aircraft Damage:</b>	Substantial
<b>Defining Event:</b>	Landing gear collapse	<b>Injuries:</b>	2 None
<b>Flight Conducted Under:</b>	Part 121: Air Carrier - Non-scheduled

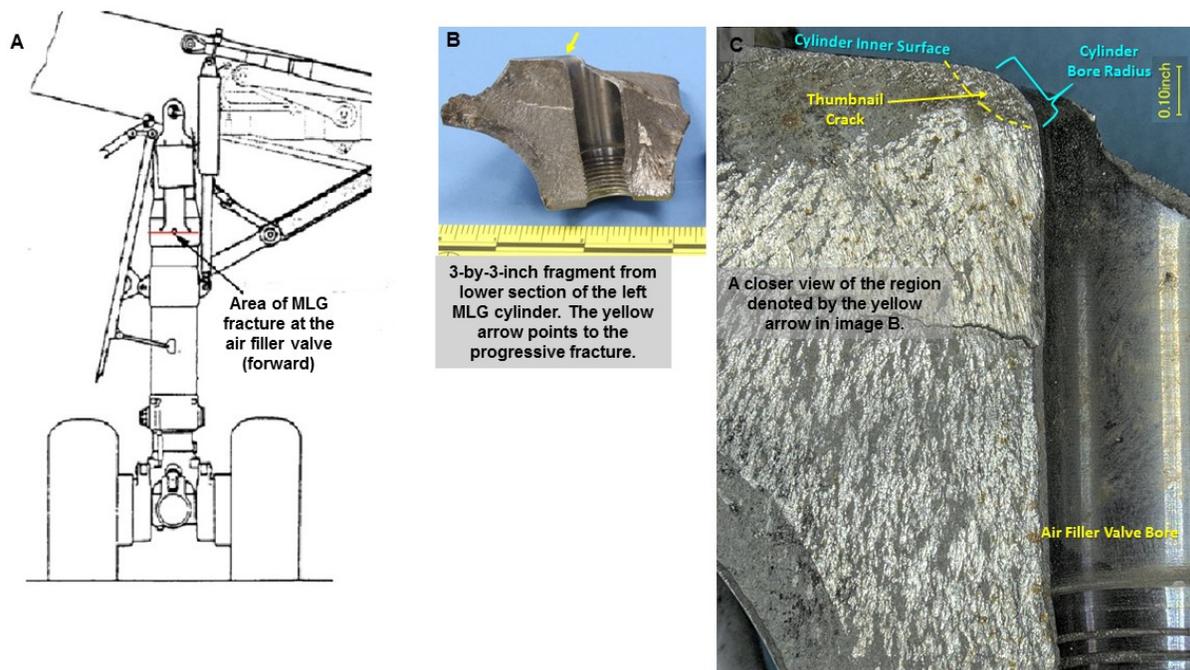
Metallurgical examination of a 3-by-3-inch fragment of the left MLG cylinder (see images B and C in figure 1) and the mating fracture region on the largest piece of the fractured left MLG (see figure 2) found indications consistent with overstress fracture having emanated from the air filler valve bore. The overstress features emanated from a small thumbnail crack, located at the radius between the cylinder inner diameter surface and the air filler valve bore surface. This thumbnail crack was observed on both mating fracture surfaces of the MLG and the 3-by-3-inch fragment, and it exhibited features (such as crack arrest marks) consistent with a pre-existing crack that progressed to fracture of the MLG. The observed features in the initiation region of the thumbnail crack were found to be consistent with fatigue cracking, as exhibited by the fatigue striations observed during microscopic examination. Later propagation regions of the thumbnail crack revealed features consistent with mixed mode fatigue, overstress, and

intergranular fracture. These findings confirmed that once the crack progressed to a critical length, the left MLG cylinder fractured in overstress due to the loads imposed during landing.

Figure 1. A diagram of an MD-10-10F left MLG (A), photograph of the 3-by-3-inch fragment from the lower section of the accident left MLG cylinder (B), and closer view of the region pointed out in image B (C).

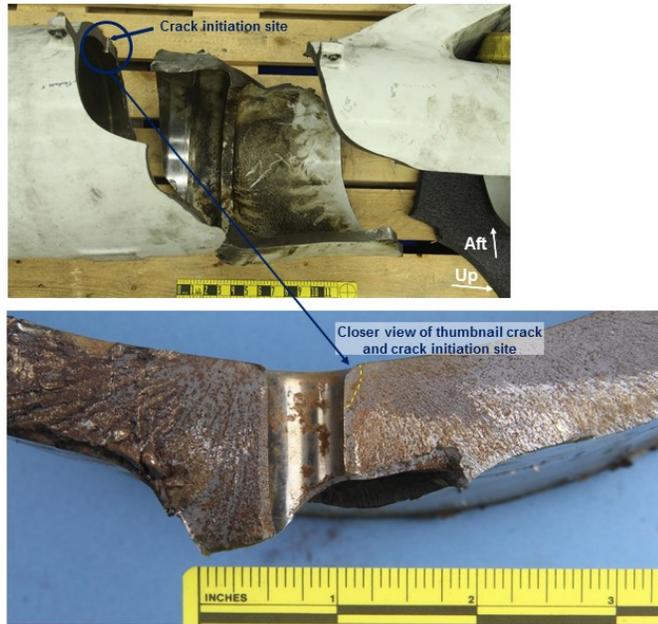
Figure 2. Photographs of largest piece of fractured left MLG pointing to the crack initiation site (top) and a closer view of the crack initiation site, with a yellow dashed line highlighting the mating thumbnail crack (bottom).

The most prominent quality of the crack initiation site was a feature consistent with a corrosion pit. No indications of nickel, chrome, or cadmium plating were found at the radius or along the smooth sections of the air filler valve bore, as stipulated by maintenance instructions. The absence of a protective coating, over time, could lead to corrosion pitting. Any corrosion pitting or mechanical damage to the protective coating incurred during maintenance can lead to fatigue cracking.

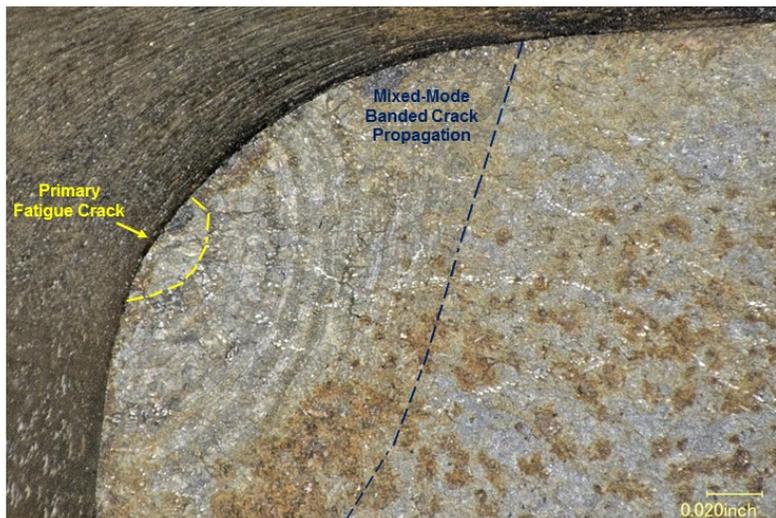
Figure 3. Closer view of the primary fatigue crack region (highlighted by the dashed yellow line) and the region of mixed-mode crack propagation (highlighted by the dashed blue line).

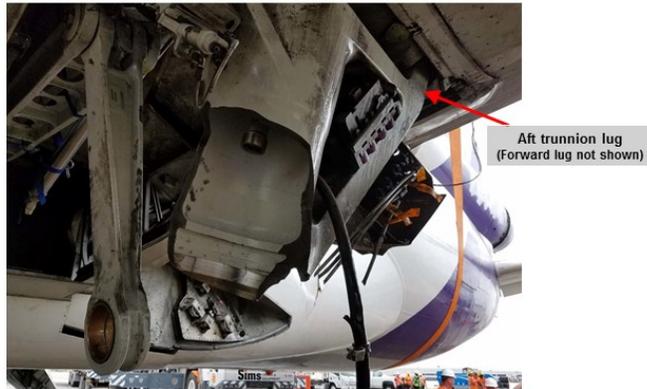
The airplane came to rest off the left side of runway 10L near the A4 taxiway. The outer cylinder of the left MLG was fractured midway through the air filler valve bore on the aft side. The outer cylinder of the left MLG shock strut fractured around its entire circumference; the upper portion of the cylinder remained intact and attached to the airplane at the forward and aft trunnion lugs (figure 1 shows a diagram of an MD-10-10F MLG and figure 2 shows the upper portion of the accident MLG). No anomalies were noted with the trunnion lugs or trunnion bolt attachment points.

Figure 2. Upper portion of the left MLG attached to the airplane.

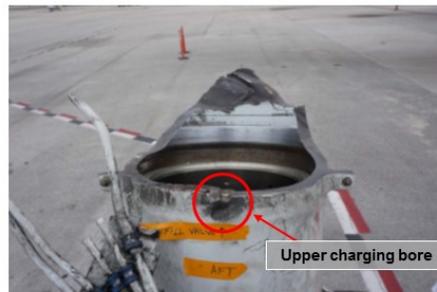
The inboard side lugs and bolt and nut for the retract actuator attach points and the fixed door attach points remained intact. On the aft side of the lower section of the fractured gear, about half of the upper charging bore was visible (see figure 3). On-scene examination identified features consistent with fatigue on the fracture surface of the outer cylinder in the area of the air filler valve bore (see Tests and Research for more information).

Figure 3. Aft side of the lower section of the left MLG cylinder and fill valve.

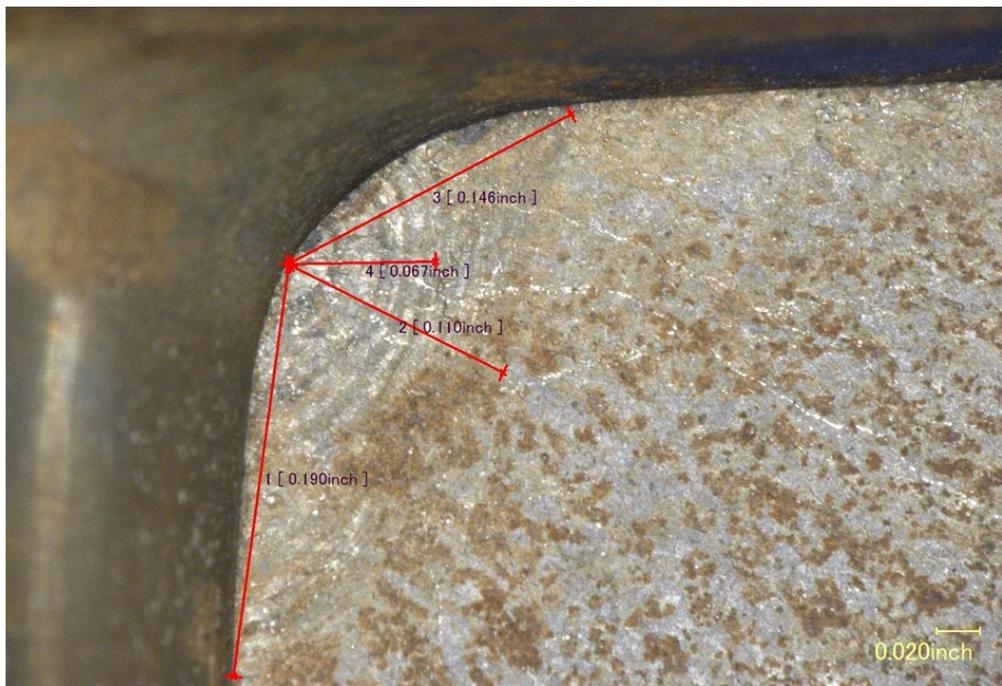
The estimated total number of cycles for each band are summarized below (figure 4 shows a closeup view of the fatigue striation region); the number in parentheses represents the total striation quantity summation to that point:

- Striation count in 1st fatigue thumbnail (origin to intergranular band): 526
- Striation count in 1st fatigue thumbnail (intergranular band to overstress band 1): 165 (691 total to this point)
- Striation count before overstress band 1: 691
- Striation count in 2nd band: 253 (944)
- Striation count in 3rd band: 242 (1186)
- Striation count in 4th band: 218 (1404)

Figure 4. A closeup view of the fatigue striation region.
