1. Report No. NTSB-AAR-76-19		2. Government Accession No.		3. Recipient's Catalog No.	
4. Title and Subtitle Aircraft Accident Report -- Overseas National Airways, Inc., Douglas DC-10-30, N1032F, John F. Kennedy International Airport, Jamaica, New York, November 12, 1975				5. Report Date December 16, 1976

AIRCRAFT ACCIDENT REPORT

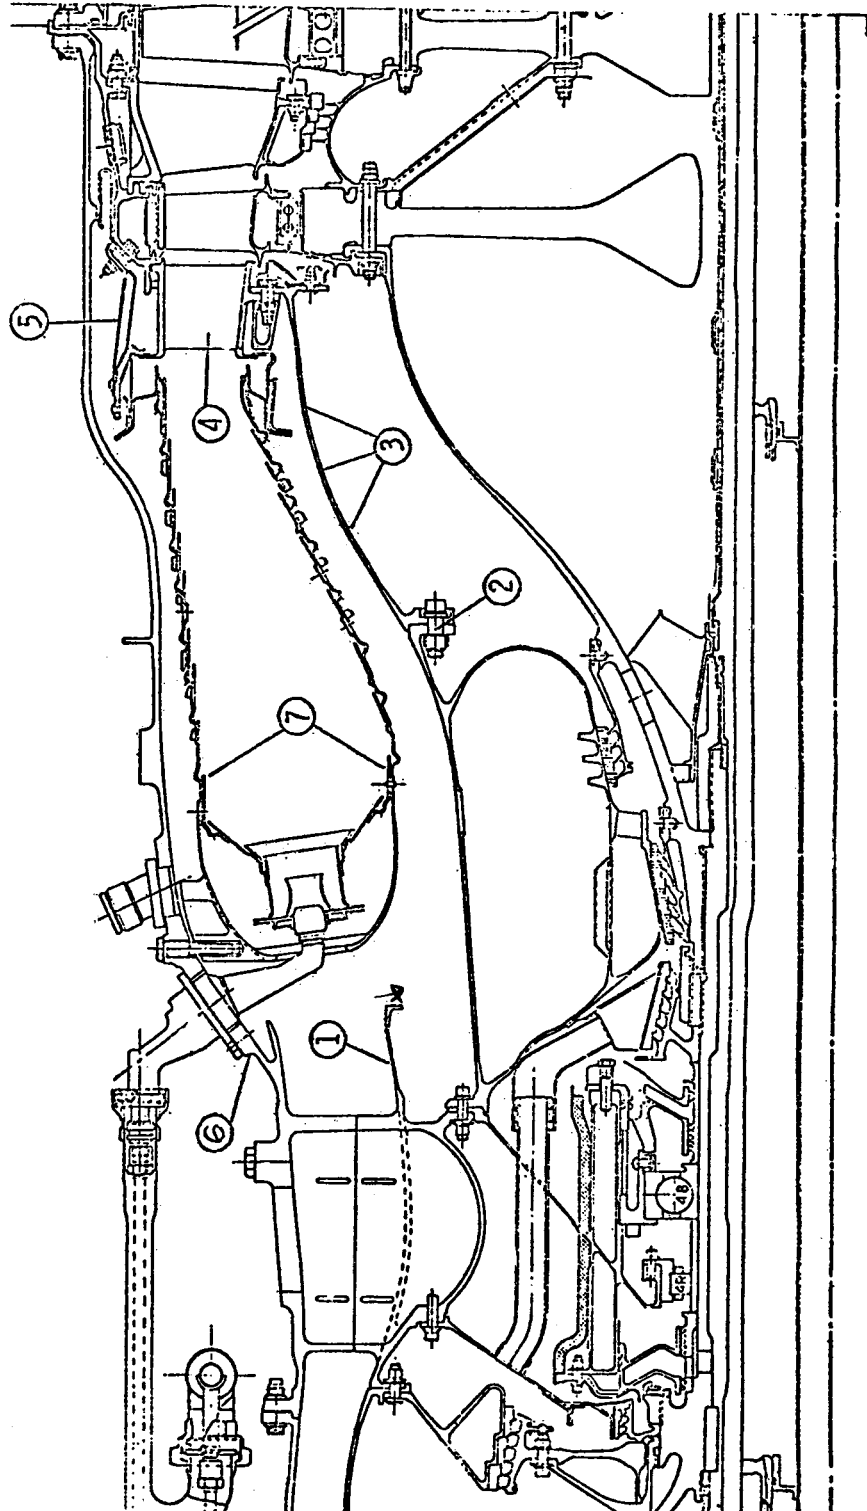
DEFORMATION LOCATION

7. Combustor Liner  
Inward and aft buckling of shell  
Normal differential pressure is 15 PSI  
Pressure required for buckling is 192 PSI differential pressure
