1. Report No. NTSB-AAR-75-15		2. Government Accession No.		3. Recipient's Catalog No.	
4. Title and Subtitle Aircraft Accident Report - Western Air Lines, Inc., Boeing 737-200, N4527W, Casper, Wyoming, March 31, 1975.				5. Report Date October 30, 1975

AIRCRAFT ACCIDENT REPORT

WESTERN AIR LINES, INC.
BOEING 737-200, N4527W
CASPER, WYOMING
MARCH 31, 1975

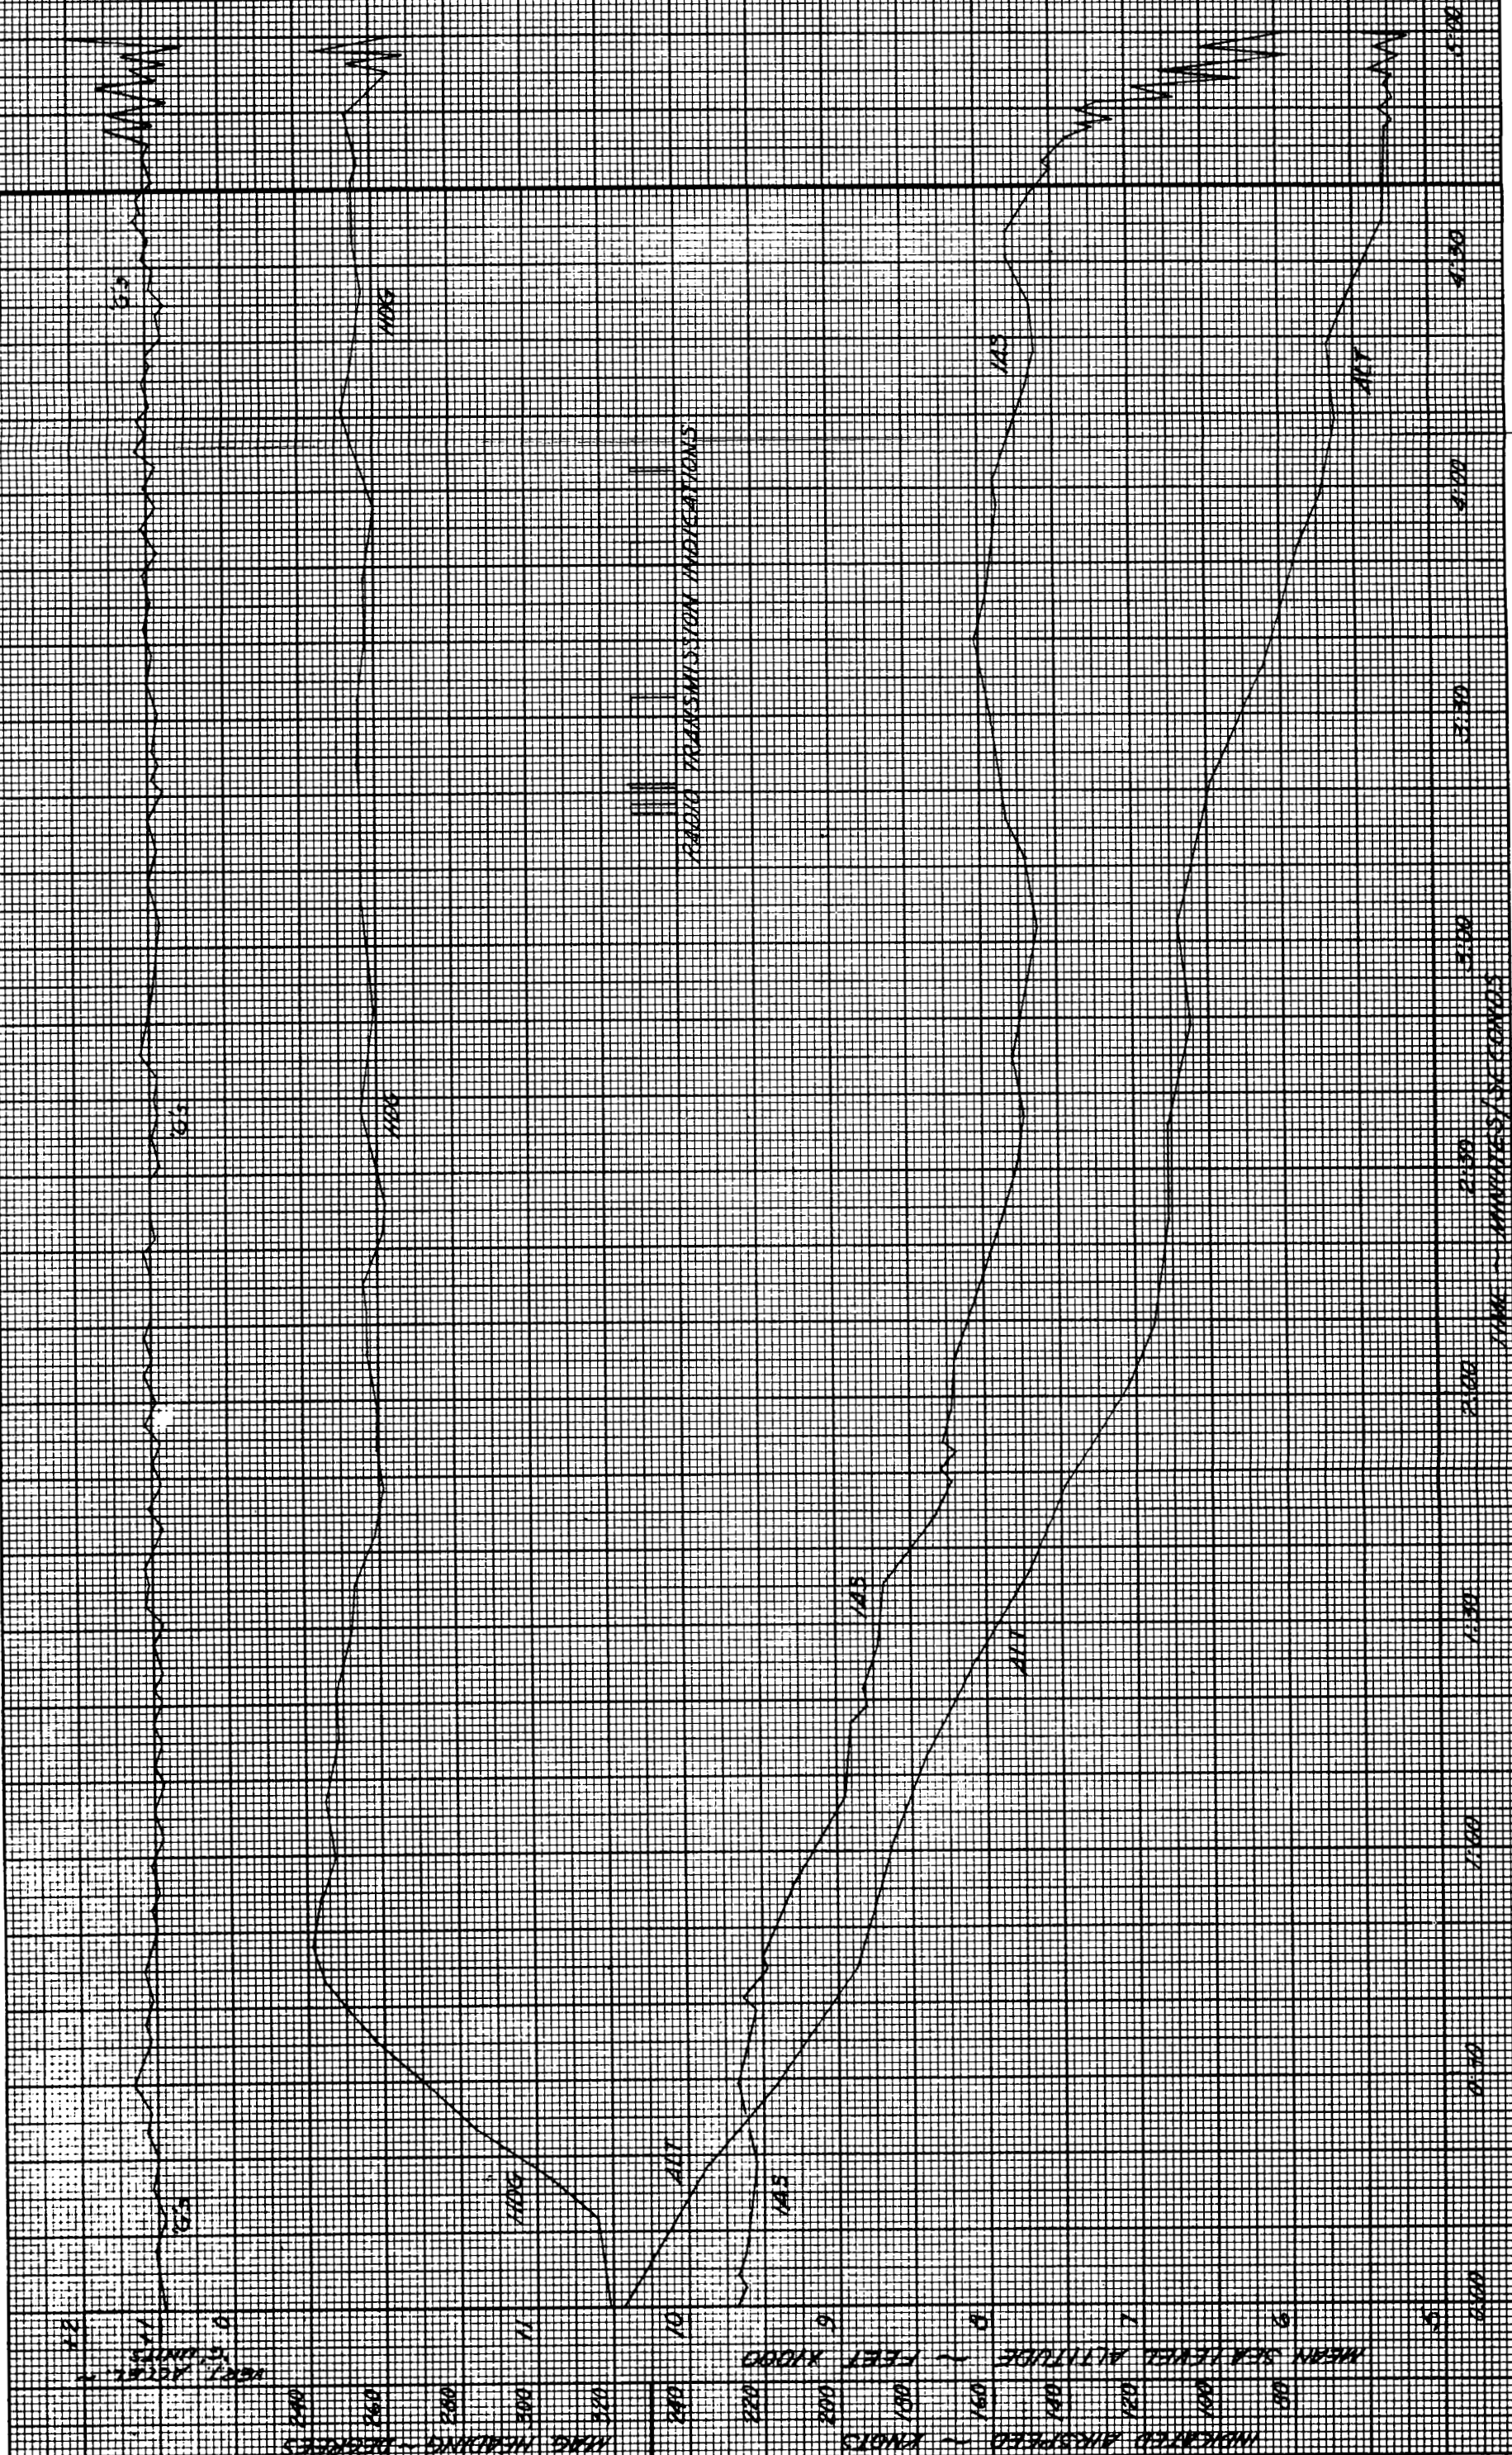
APPENDIX G

The FDR also shows that the aircraft's descent rate after departing the final approach fix was about 750 ft./min. This rate would have been acceptable had a headwind existed; however, with a tailwind the rate should have been increased to place the aircraft at the MDA at a sufficient distance from the runway threshold to continue the approach safely and to cross the threshold at or near the recommended height of 50 ft. The captain stated that the aircraft was at 300 ft. at 3/4 to 1 mile from the runway. If the captain's assessment of his altitude was correct, only a small increase in the descent rate would have been required to put the aircraft in the correct position for landing.
