# AIRCRAFT ACCIDENT REPORT

DOUGLAS DC-X, N6

DuBOIS , PENNSYLVANIA

REPORT NUMBER: NTSB-AAR-75-11

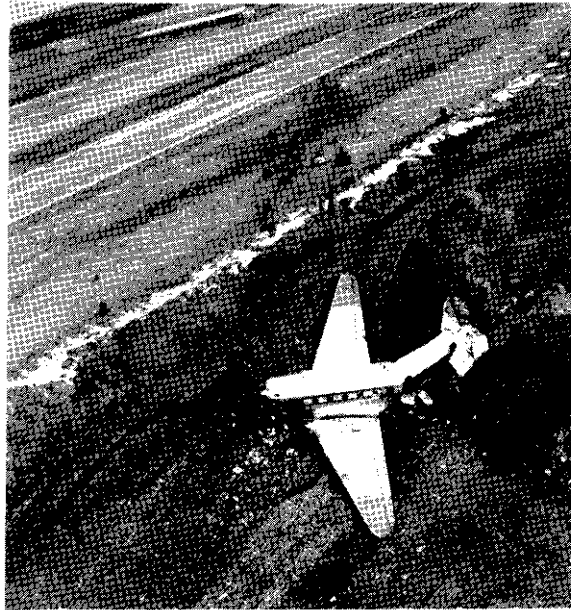
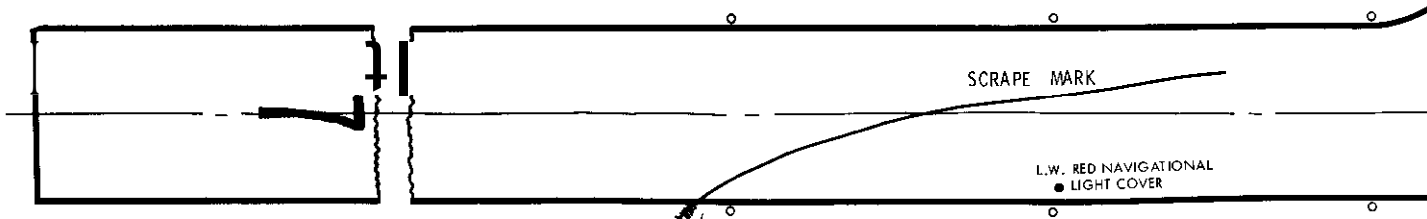
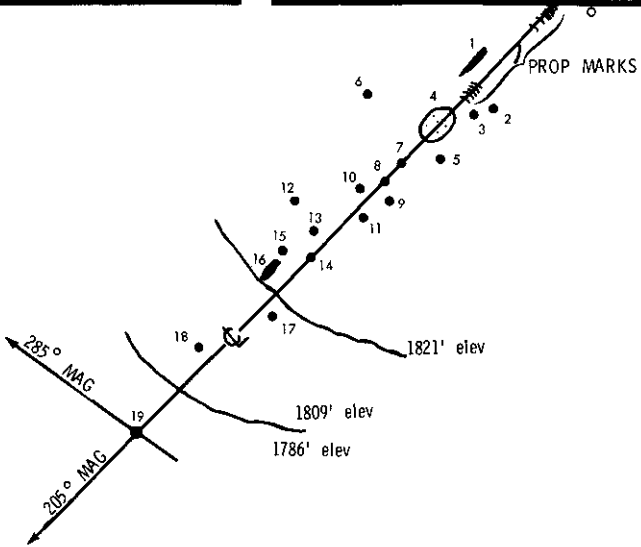
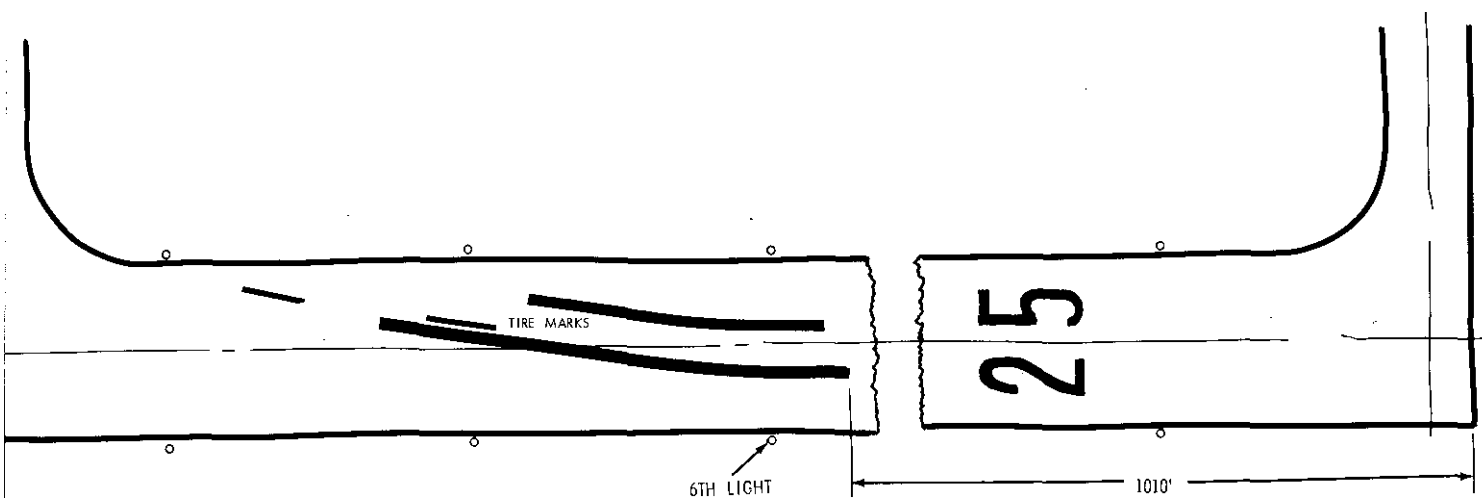
APPENDIX E

The aircraft came to rest in a ravine, 35 ft. below the airport elevation, on a magnetic heading of 285°. (See Appendix E.) The wreckage was confined to an area measuring 345 ft. by 60 ft. The fuselage nose radome, the radar dish, the left crew door, the left engine, the left and right propellers, the right main landing gear, and the tailwheel separated from the aircraft and were located between the edge of the runway and the main wreckage.
