NATIONAL TRANSPORTATION SAFETY BOARD

AIRCRAFT ACCIDENT REPORT

EASTERN AIR LINES, INC.
BOEING 727-225, N8845E

JUNE 24, 1975

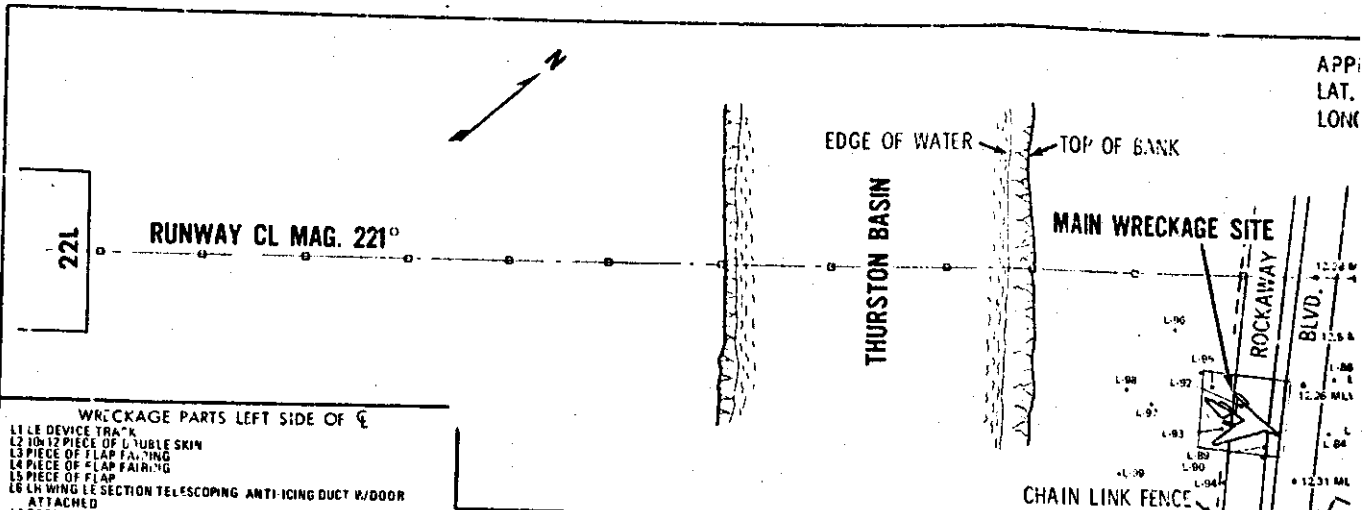
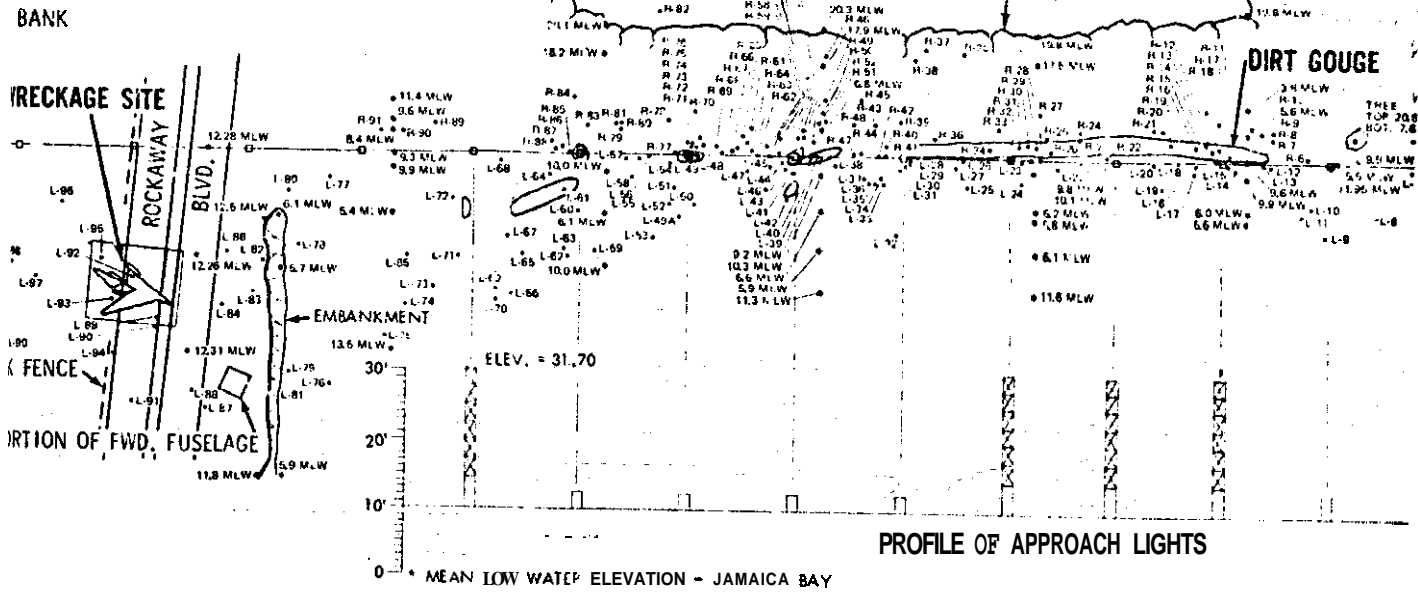
WRECKAGE PARTS LEFT SIDE OF C

Eastern 66 first contacted the top of the No. 7 approach light tower at an elevation of 27 feet above the mean low-water level and 2,400 feet from the threshold of runway 22L. The aft end of the jack-screw fairing for the left, outboard trailing edge flap lodged in the tower. The aircraft continued and struck towers 8 and 9. The aircraft's left wing was damaged severely by impact with these towers-- the outboard section was severed. The aircraft then rolled into a steep left bank (well in excess of 90°) between towers 9 and 10, where it first contacted the ground. Its descent angle between the No. 7 tower and the beginning of the ground mark was 4.5°. It missed towers 10, 11, and 12; a gouge in the earth, about 340 feet long, paralleled the approach light towers on the northwest side from near tower No. 10 to tower No. 13. Three large outboard sections of the left wing were located near the beginning of the gouge.

Near the No. 13 tower, the aircraft's direction of travel changed from a magnetic heading of 220° to 205° ; the fuselage struck towers 13, 14, 15, 16, and 17. The aircraft then continued to Rockaway Boulevard, where it came to rest. The approach light towers and large boulders along the latter portion of the path caused the fuselage to collapse and disintegrate. (See Appendix G.)
