**Aircraft Accident Report - Southern Company
Services, Inc., Beech-Hawker-125-600A, N40PC,
McLean, Virginia, April 28, 1977**

1. Report No. NTSB-AAR-78-11		2. Government Accession No.		3. Recipient's Catalog No.	
4. Title and Subtitle Aircraft Accident Report - Southern Company Services, Inc., Beech-Hawker-125-600A, N40PC, McLean, Virginia, April 28, 1977				5. Report Date September 14, 1978

AIRCRAFT ACCIDENT REPORT

SOUTHERN COMPANY SERVICES, INC.
BEECH-HAWKER-125-600A, N40PC
McLEAN, VIRGINIA
APRIL 28, 1977

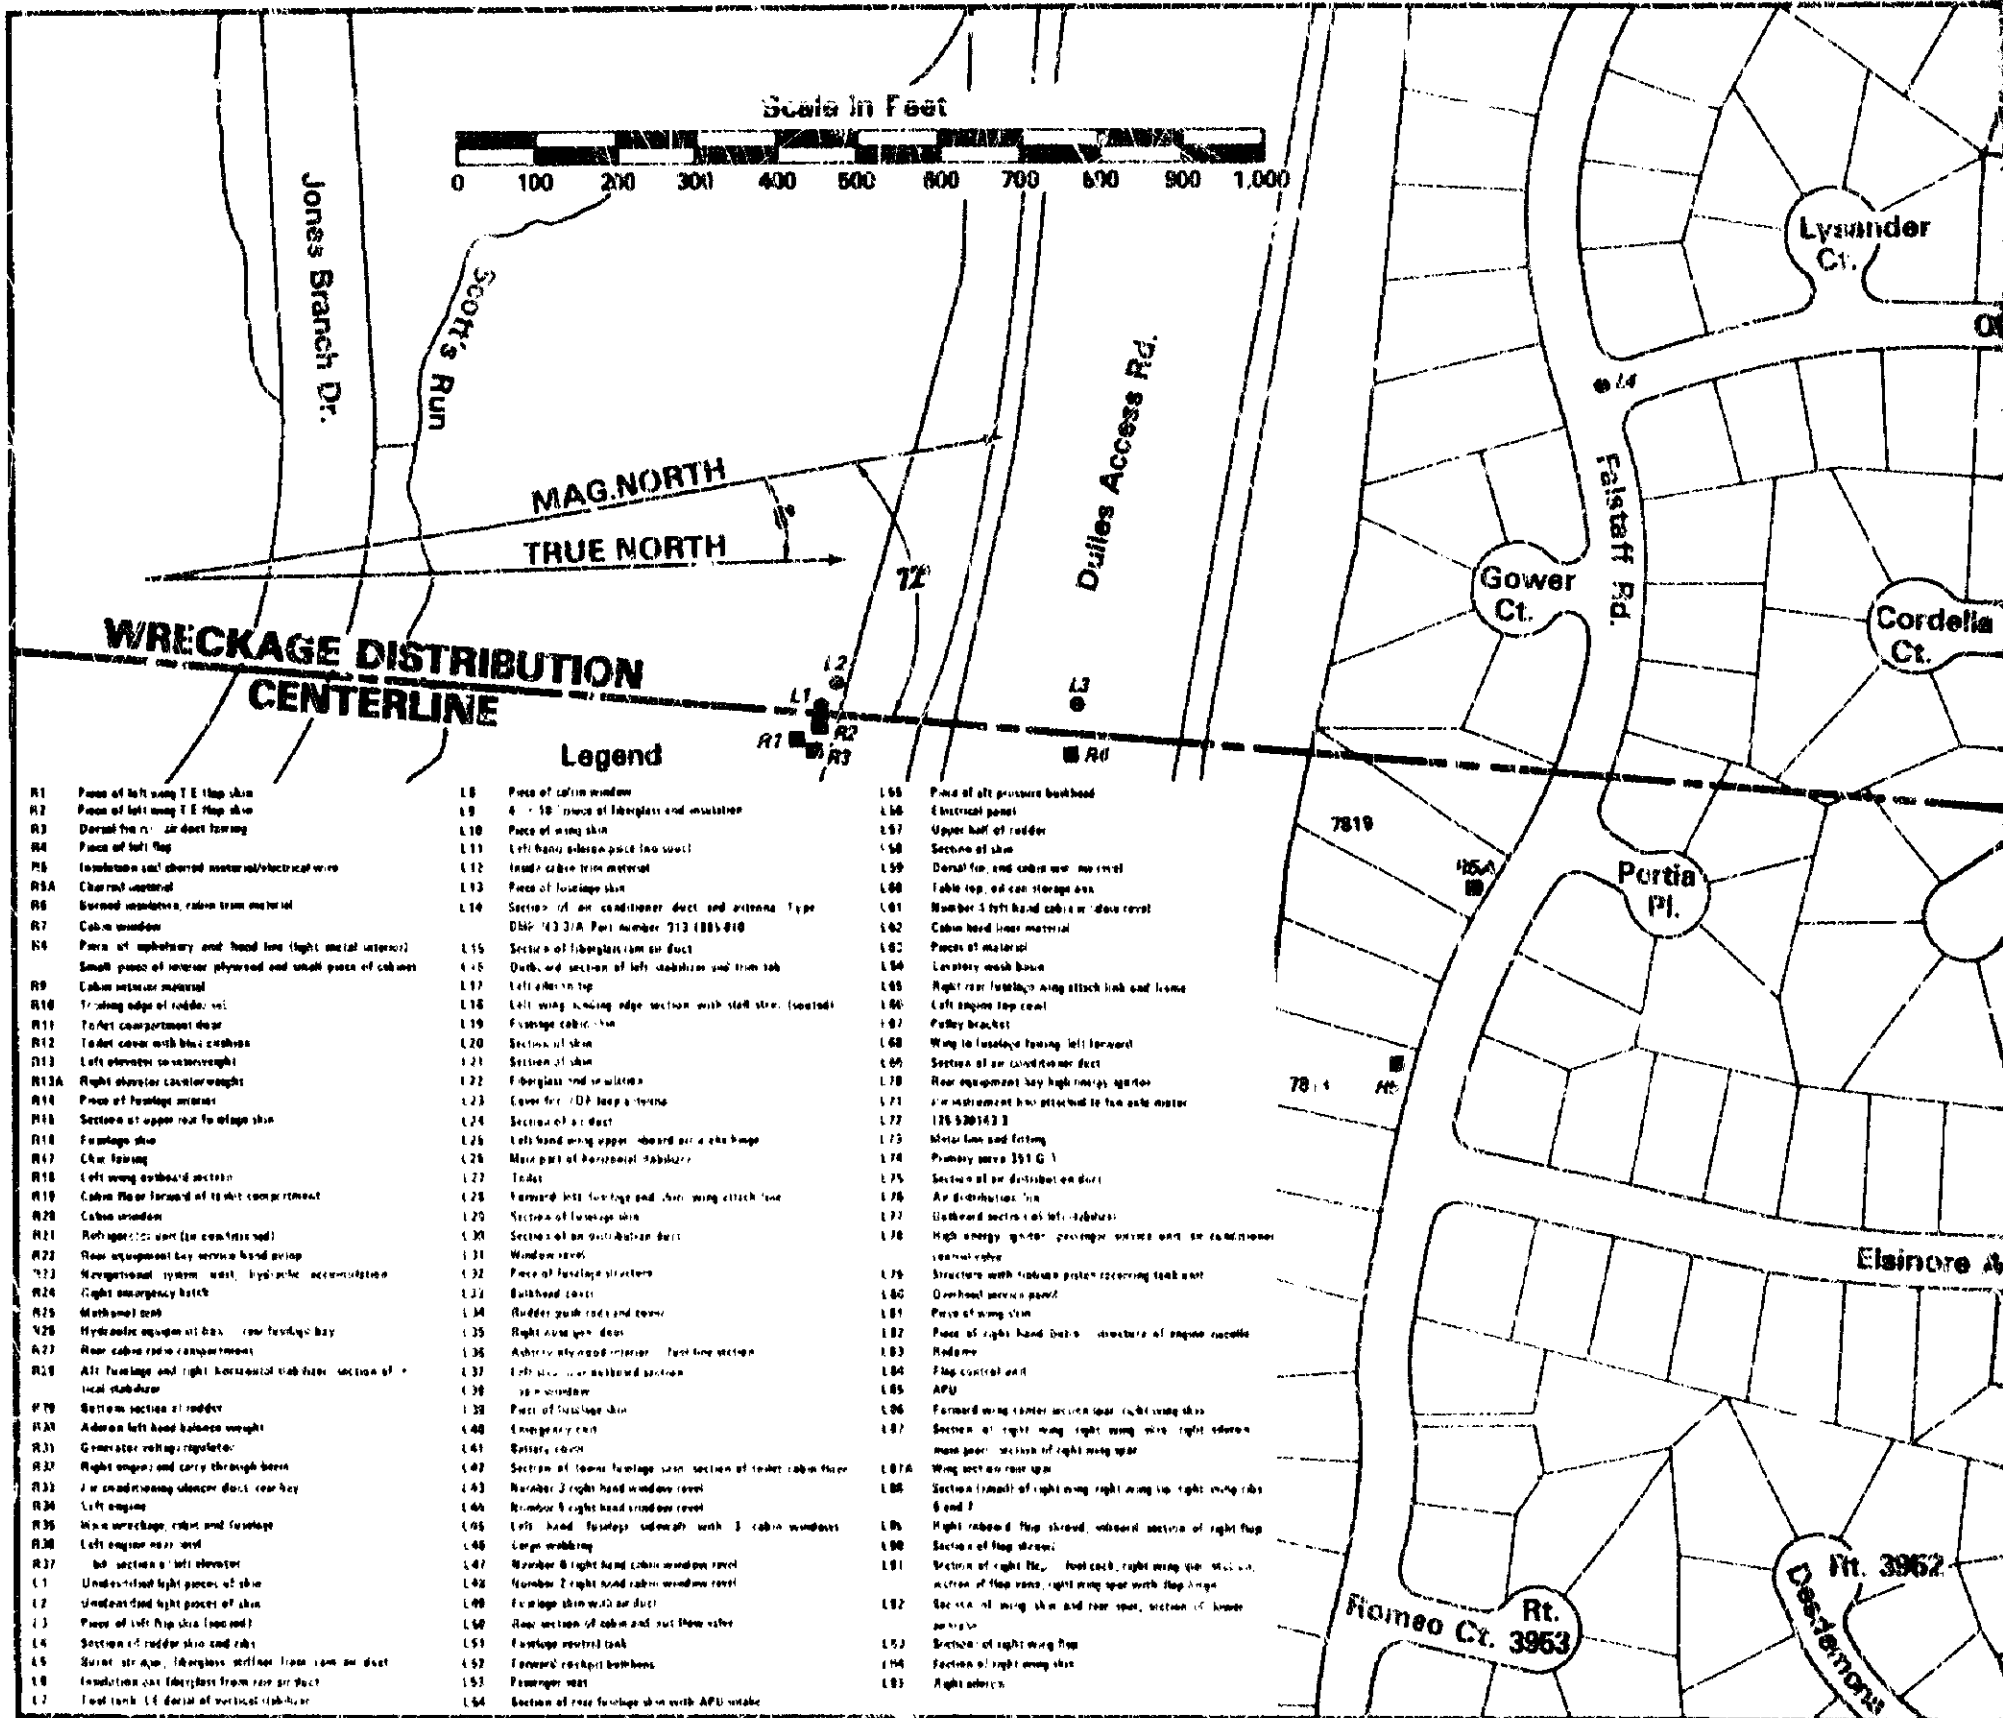
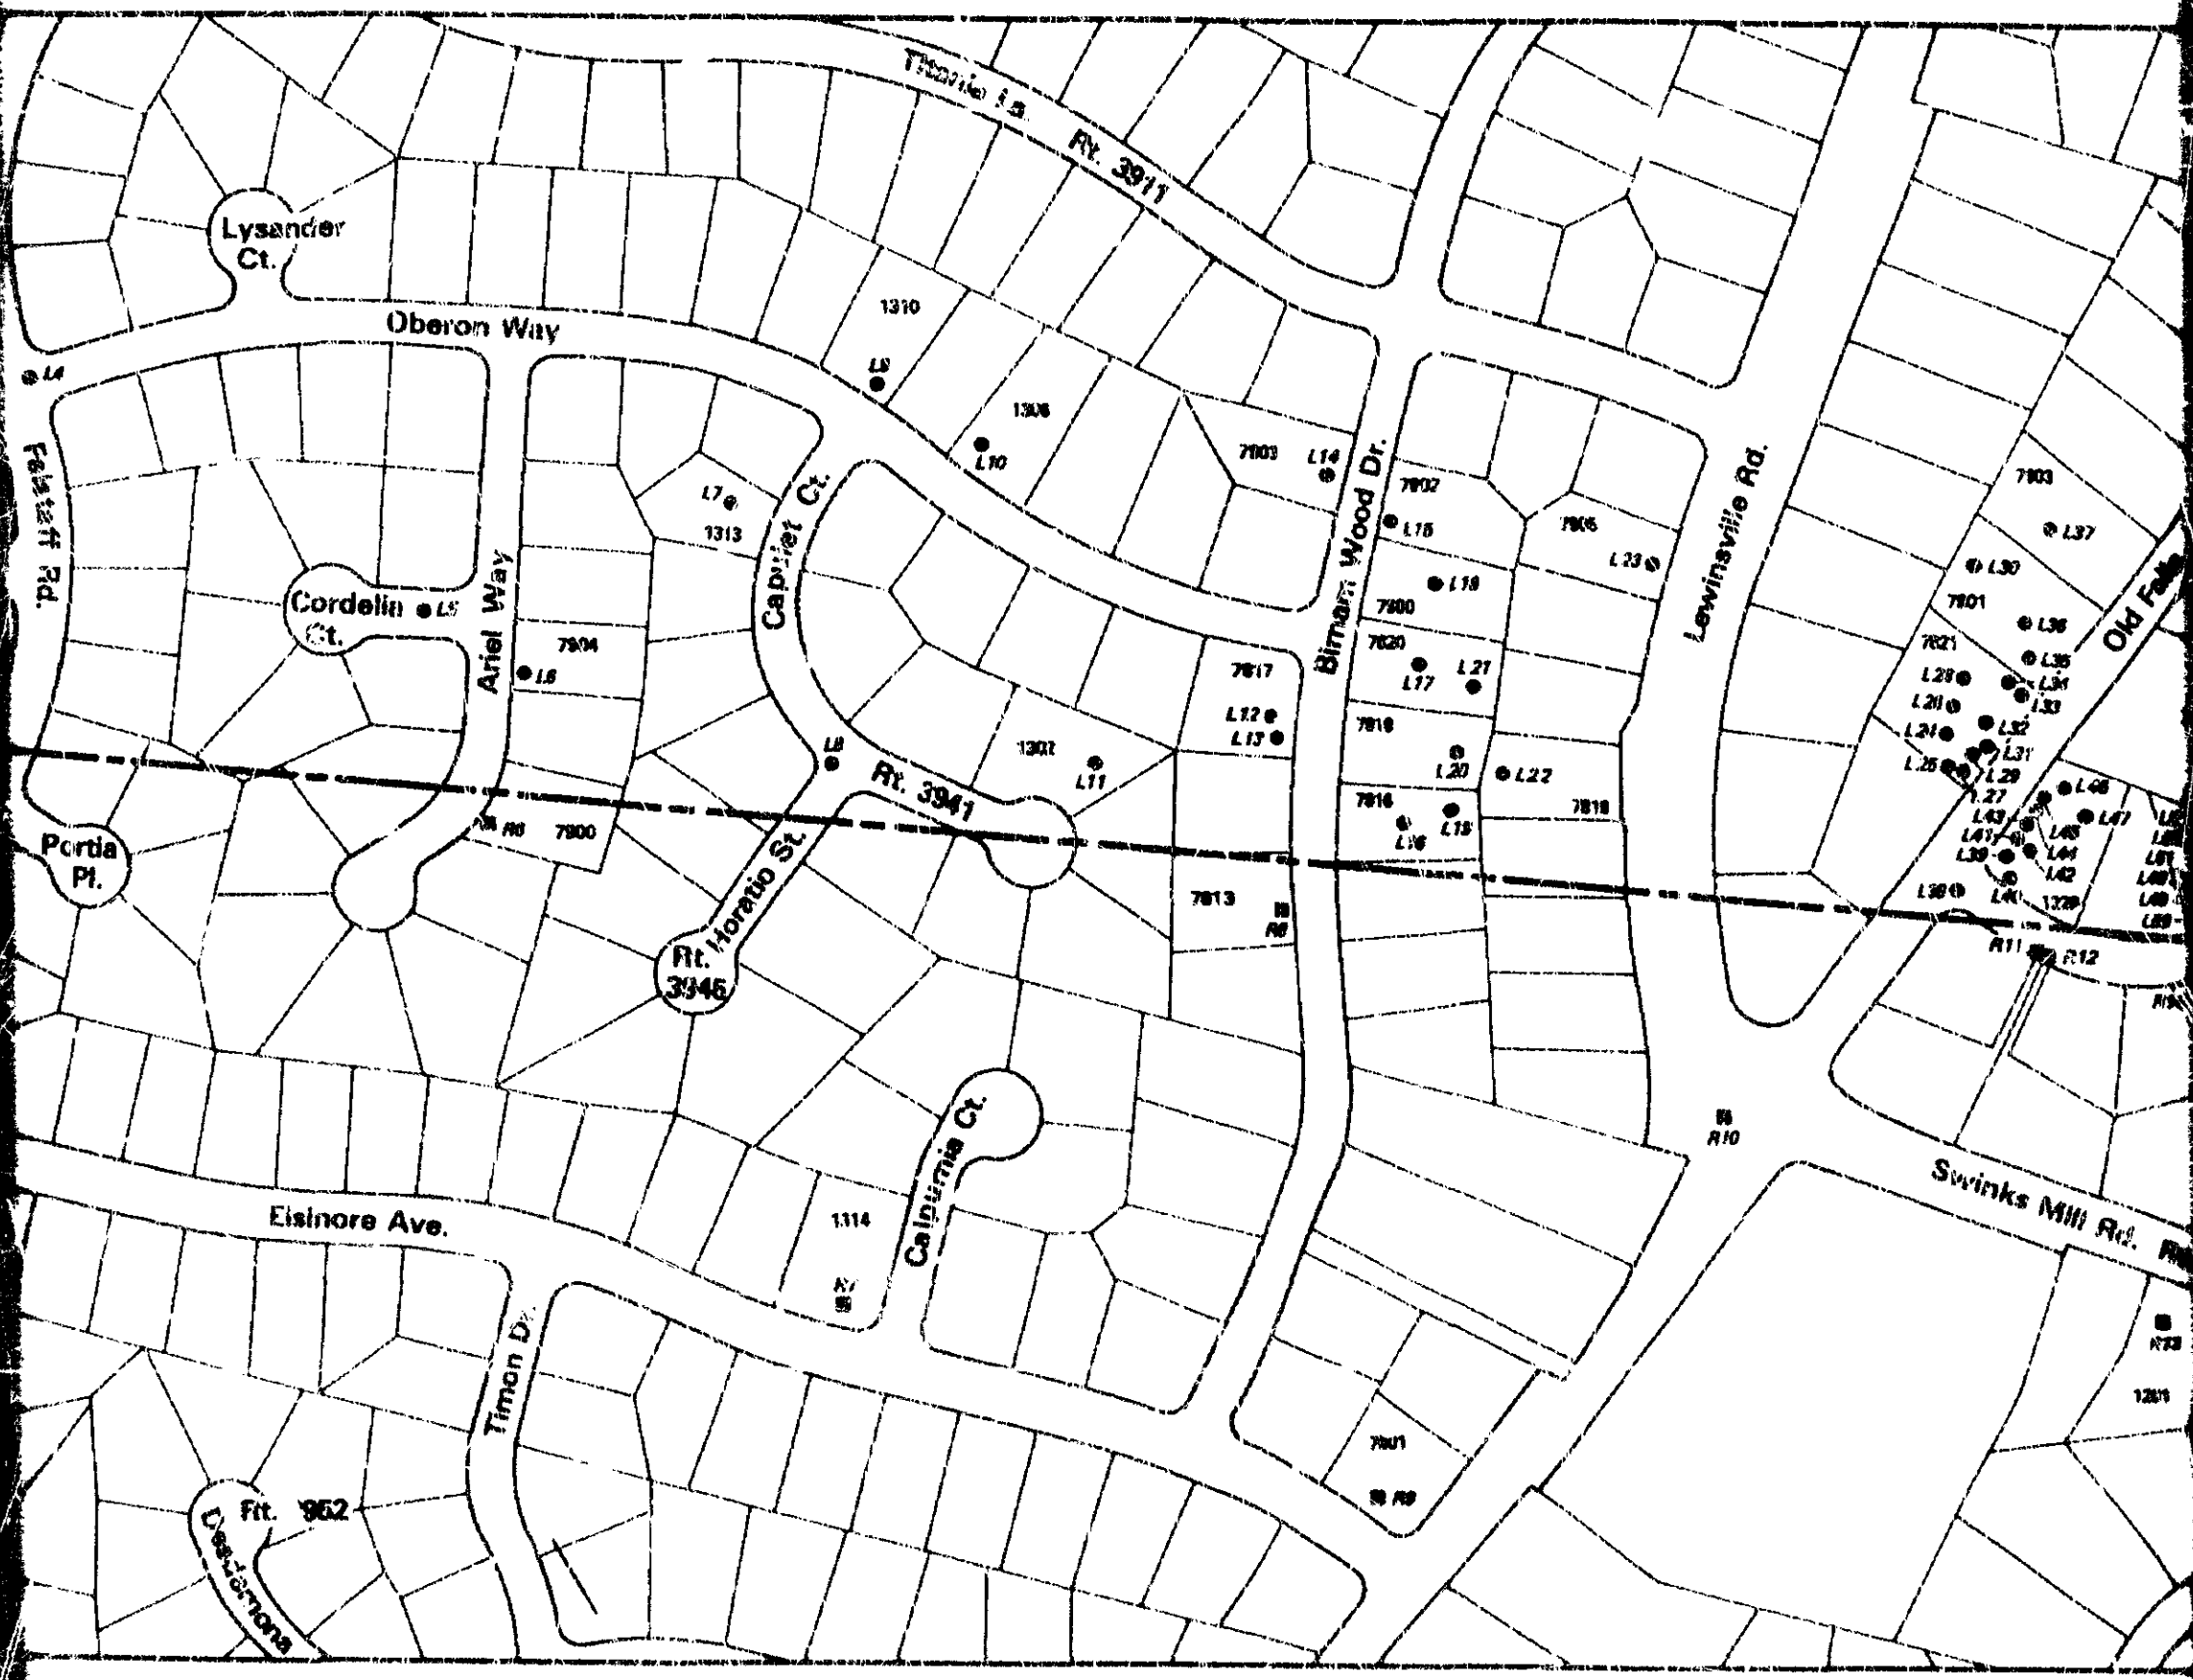
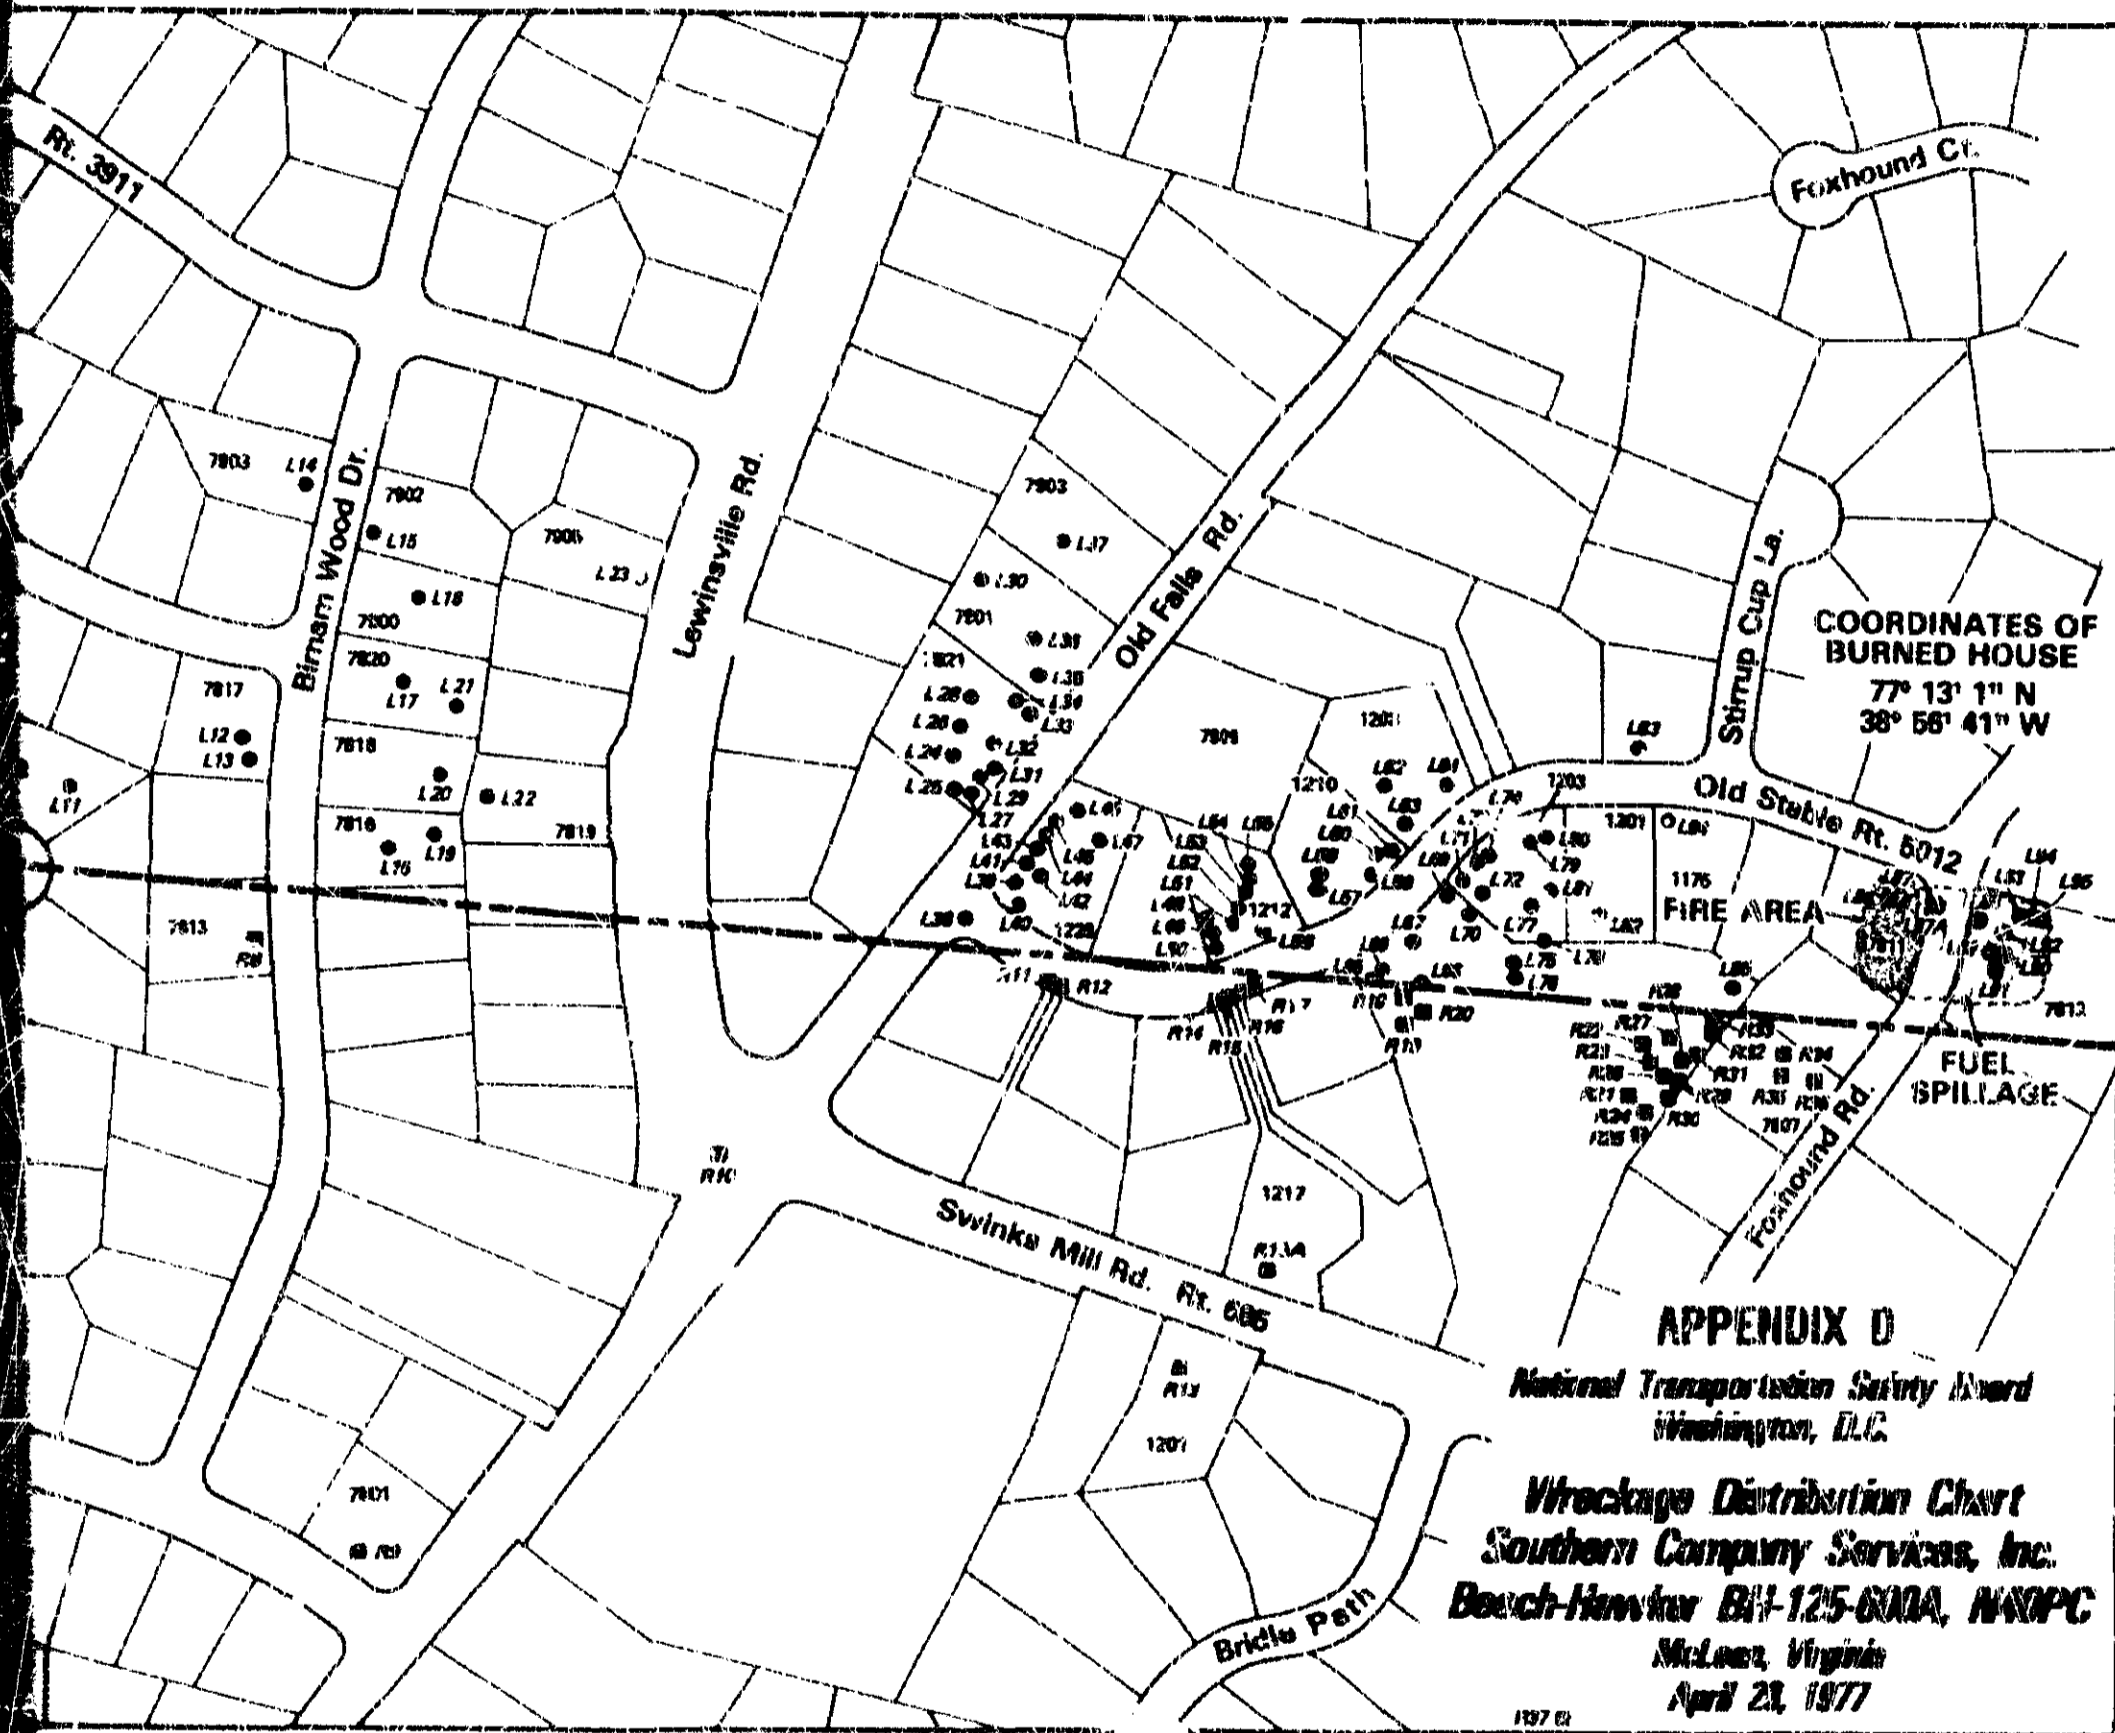
*Wreckage Distribution Chart
Southern Company Services, Inc.
Boech-Hawker BH-125-600A, N40PC
McLeas, Virginia
April 28, 1977*

The aircraft broke up in flight and was scattered over an area 4,200 ft long and 1,600 ft wide. The wreckage was strewn through the heavily populated residential area on a heading of 022°. Starting at the perimeter of the 4,200-ft-long wreckage path, the first major piece of structure was the middle section of the rudder. The dorsal fuel tank was found about 900 ft farther along the wreckage path with portions of the left aileron, left wing leading edge, and left elevator within the next 1,100 ft. The outboard section of the left wing was about 600 ft farther along the wreckage path. A large section of the rear fuselage with two-thirds of the vertical stabilizer attached was found 300 ft farther along the wreckage path. A large section of the rear fuselage with two-thirds of the vertical stabilizer attached was found 300 ft farther along the wreckage path. Finally, the right wing and wing center section struck a house, which was subsequently burned, and the main section of the fuselage landed inverted in the backyard of another house, bounced, penetrated the back wall of the house and became lodged. Both engines, which had separated in flight, and the aircraft batteries, which had also separated, were located near the main section of the fuselage. (See Appendix D.)
