No. 10

Hawker-Siddeley HS-125, CF-CFL, accident at Churchill Falls, Canada, on 9 December 1977. Report No. H70003, not dated, released by the Ministry of Transport, Canada, in both English and French.

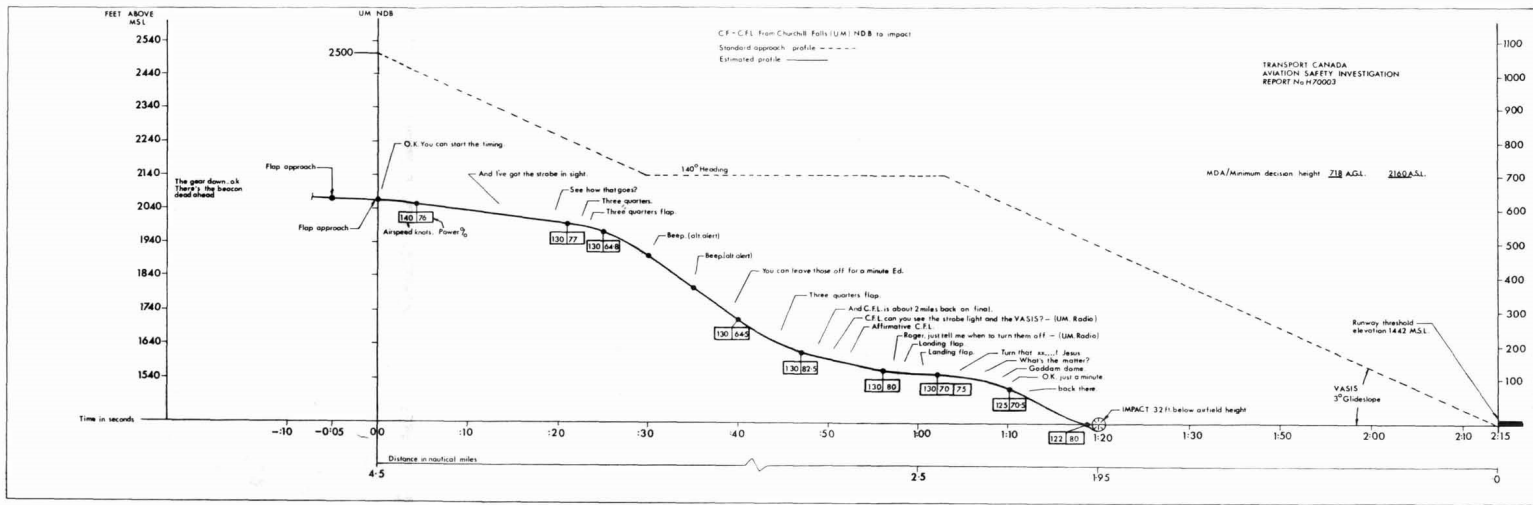
FIGURE 3

- a) The aircraft must have crossed the Churchill Falls NDB on final approach about 400 ft below the published altitude;¹
- b) The frequent power adjustments during the final approach indicate that the pilot was unsure of his distance, proper altitude and approach angle in relation to the runway threshold environment lights;
- c) The aircraft was never on a stabilized approach path;
- d) It is unlikely that the VASIS and strobe lights were visible throughout the final approach;

analysis of the "beeps", may have been set incorrectly. As can be seen on the simulated flight profile, Figure 3, and in the cockpit voice recorder report, Appendix A, the altitude alert system was being used during the approach. It is possible that the pilots were placing undue reliance on this system, normally intended to be used before the final approach phase is entered. The analysis provided by flight test duplication indicates that the altitude alert system may have been used as low as the MDA (minimum descent altitude).

By analysing the sound frequency spectrum it was possible to derive the % N2 RPM during the last 4 minutes of the flight. Once the physical characteristics of the Rolls-Royce Viper powerplants were determined, it was possible to develop the relationship between frequency and RPM and a graph of % N2 RPM versus CVR elapsed time. This is incorporated in Figure 3.
