**TECHNICAL REPORT DOCUMENTATION PAGE**

| 4. Title and Subtitle Aircraft Accident Report -<br>National Jet Services, Inc., Douglas DC-3, N51071<br>Evansville Dress Regional Airport, Indiana,<br>December 13, 1977 | | | | 5. Report Date<br>August 17, 1978 | |
| 9. Performing Organization Name and Address<br><br>National Transportation Safety Board<br>Bureau of Accident Investigation<br>Washington, D. C. 20594 | | | | 10. Work Unit No.<br>2255-B | |

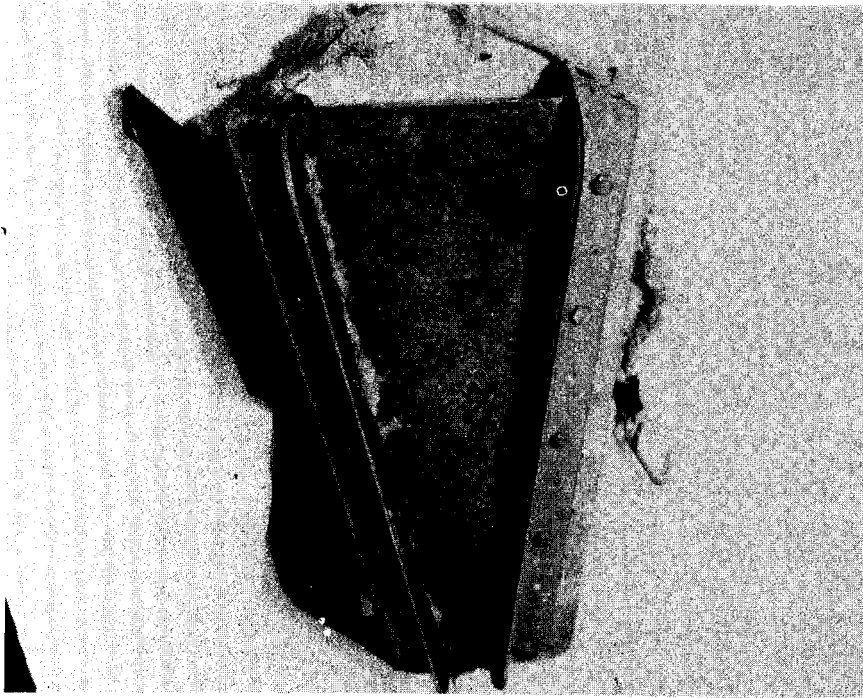
The rudder external control lock assembly was constructed from 1/8-gage aluminum sheet metal and 90° angle stock material. The lock is wedge-shaped, is approximately 15 ins. long, and has a horizontal sheet member positioned between two upper and two lower vertical sections at right angles to the horizontal sheet member. The four vertical angle sections extend 1 1/2 in. above and below the center horizontal member.

Figure 1. Upper side of the rudder control lock showing horizontal and vertical members. The forward end of the control lock is at the top of the picture.

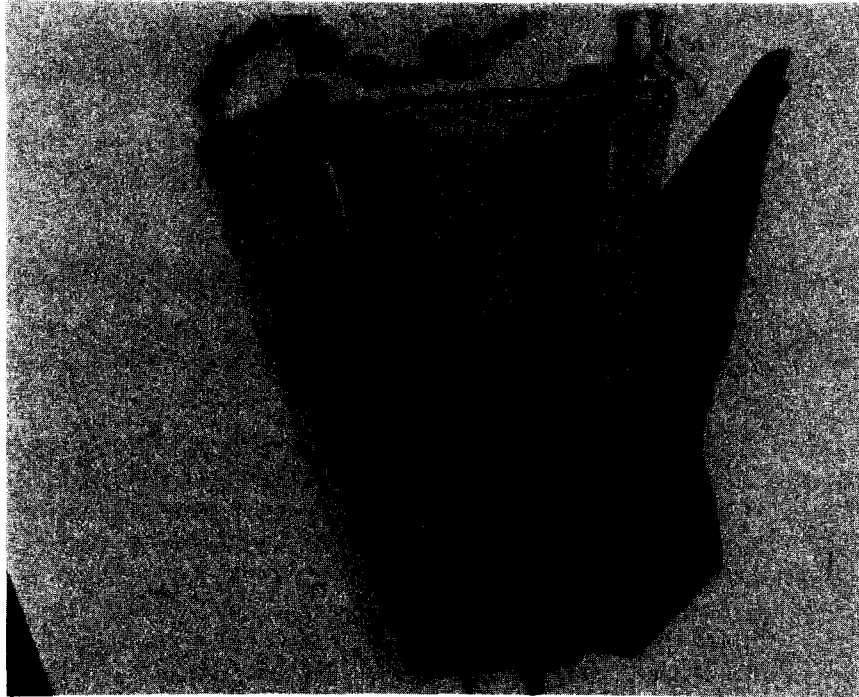
When the rudder control lock is in position, it rests entirely on the upper surface of the fuselage tail cone closure rib and, because of its design, displaces the rudder trailing edge about 1/2 in. to the left of the vertical stabilizer centerline. (See figure 1.) The aft end of the lock is 2 ins. forward of the rudder trailing edge and fuselage tail cone trailing edge. The forward end of the lock is positioned adjacent to the vertical structural member within the cone assembly. (See figure 2.)

Figure 2. Lower side of the rudder control lock showing the horizontal and vertical members. The forward end of the lock is at the top of the picture.

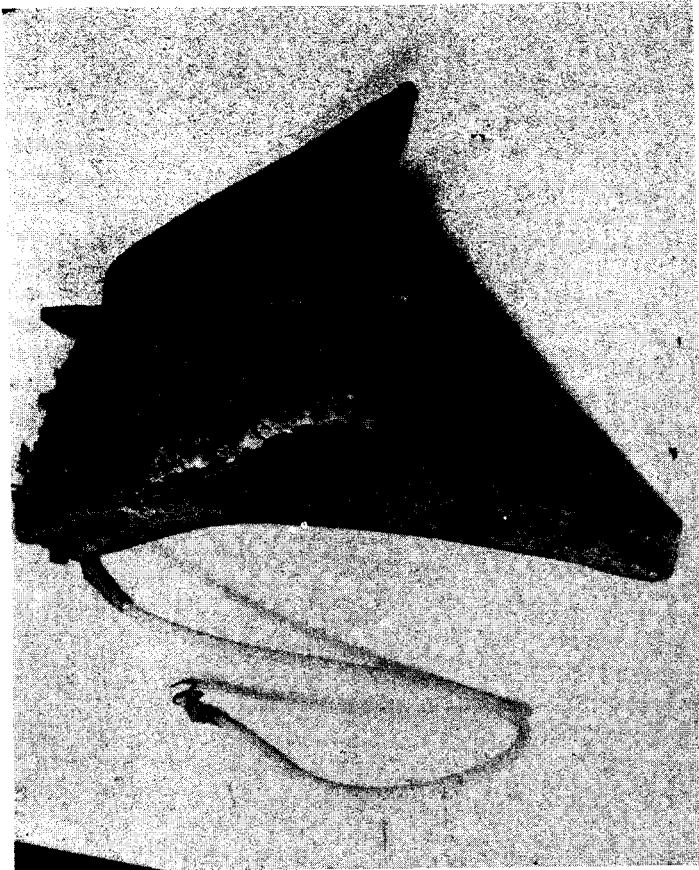
The aileron external control lock was constructed from 1/16-gage ferrous sheet stock material. The control lock is about 14 1/2 ins. long, 8 1/2 ins. wide at its aft end, and 3 ins. wide at its forward end. (See figures 3 and 4.) The design of the control lock is such that it retains the aileron by an upper and lower curved horizontal member that extends outboard from the vertical member. The aileron is held in the neutral position by (1) a left upper horizontal member which extends inboard from the vertical member and rests on the

Figure 3. Left (inboard) side of the right aileron control lock showing the inboard side of the vertical member, and the upper horizontal member which holds the wing structure. There is no lower horizontal member to permit operation of the flaps with the lock installed.

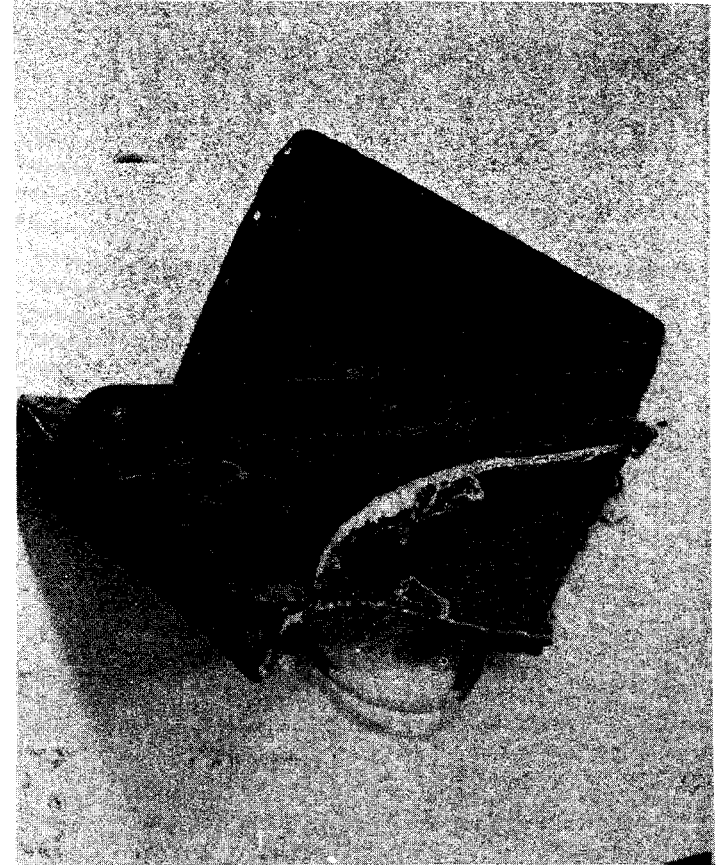
Figure 4. The right (outboard) side of the right aileron control lock showing the vertical member of the lock and the upper and lower horizontal members which hold the inboard end of the aileron.

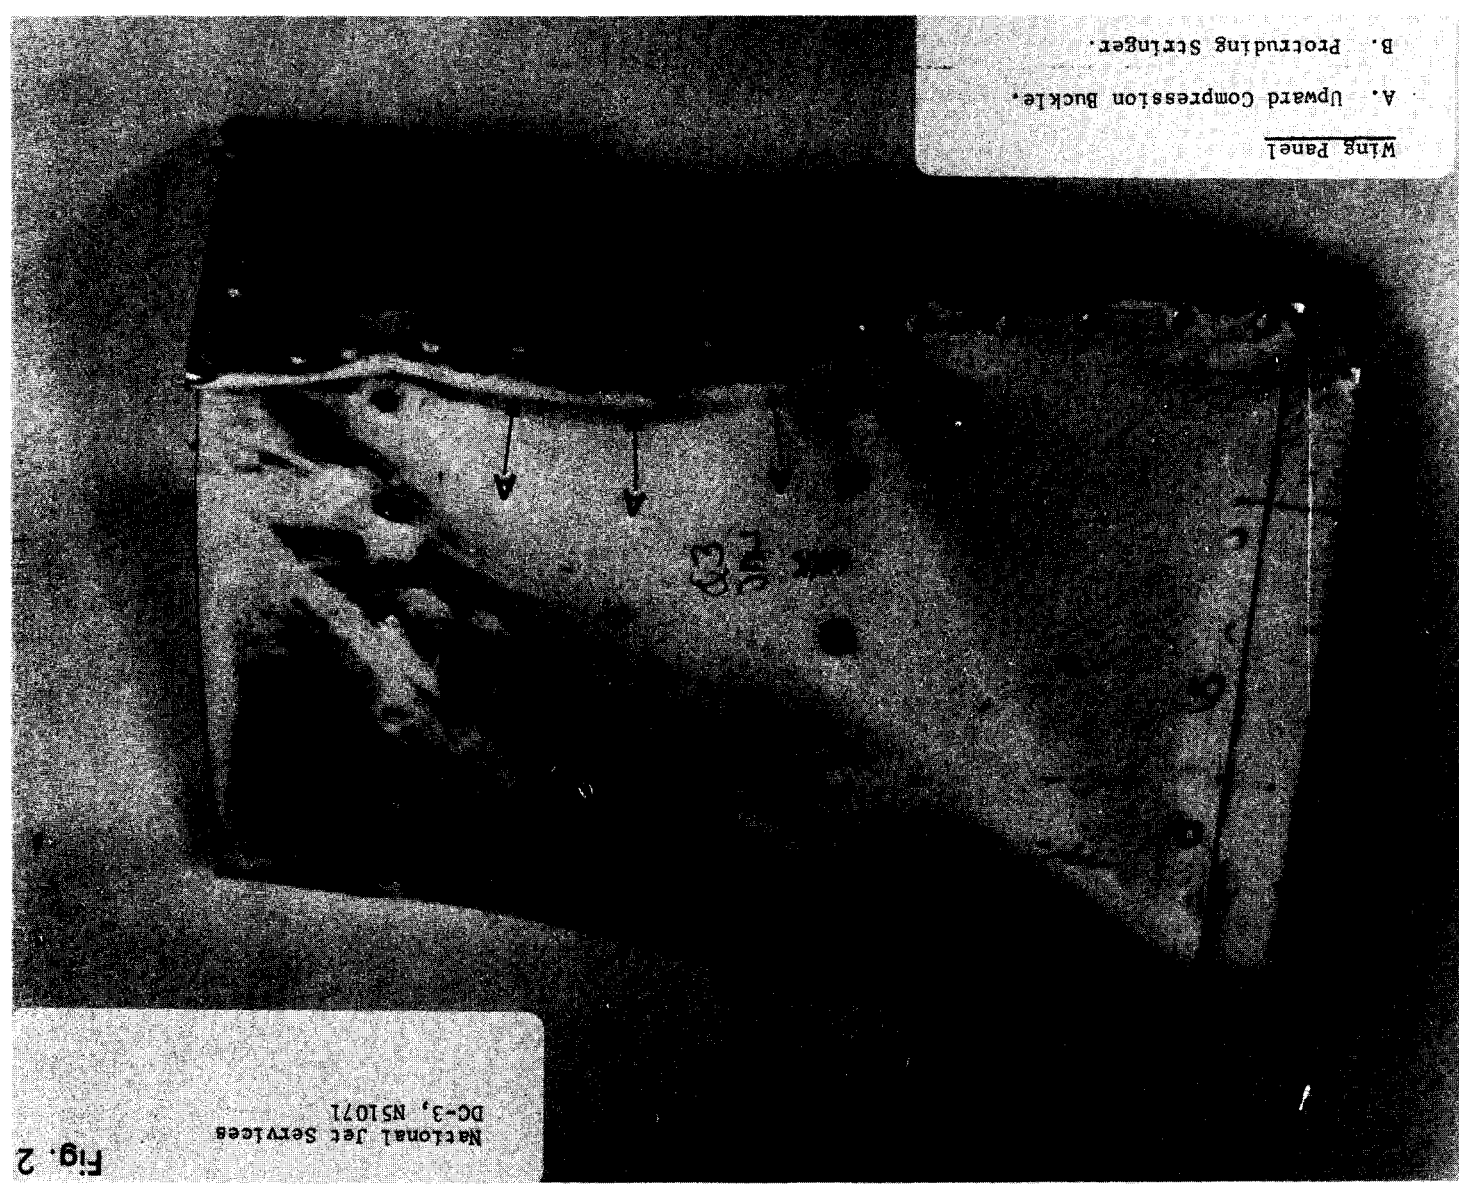
Fig. 2

Based on the damage to the aileron closure rib, to the upper wing panel closure rib, and to the upper wing panel in the area adjacent to the right aileron, the right aileron external control lock evidently was in position on the wing at impact. Although the wing panel and wing

panel closure rib were compressed and bent heavily, there was no evidence of similar damage to the adjoining aileron closure rib. Also, since the wing panel and its closure rib did not receive any impact damage, the sturdily constructed control lock protected them from direct contact with the right wing, but transmitted the impact forces to the panel and closure rib. This contention is confirmed by the penetration of the support stringer through the wing panel closure rib and the forward bending of the outboard end of the stringer. In order for the stringer to be bent in this manner, it would have to hit a solid object. The solid object was the vertical member of the aileron control lock. (See Appendix G, figures 1 through 7.)

Wing Panel

A. Upward Compression Buckle.
