No. 6

DeHavilland DHC-6-200 (floats), CF-AIV, accident at Vancouver Harbour, B.C., Canada on 3 September 1978. Report No. H80003 released by Transport Canada, Canada.

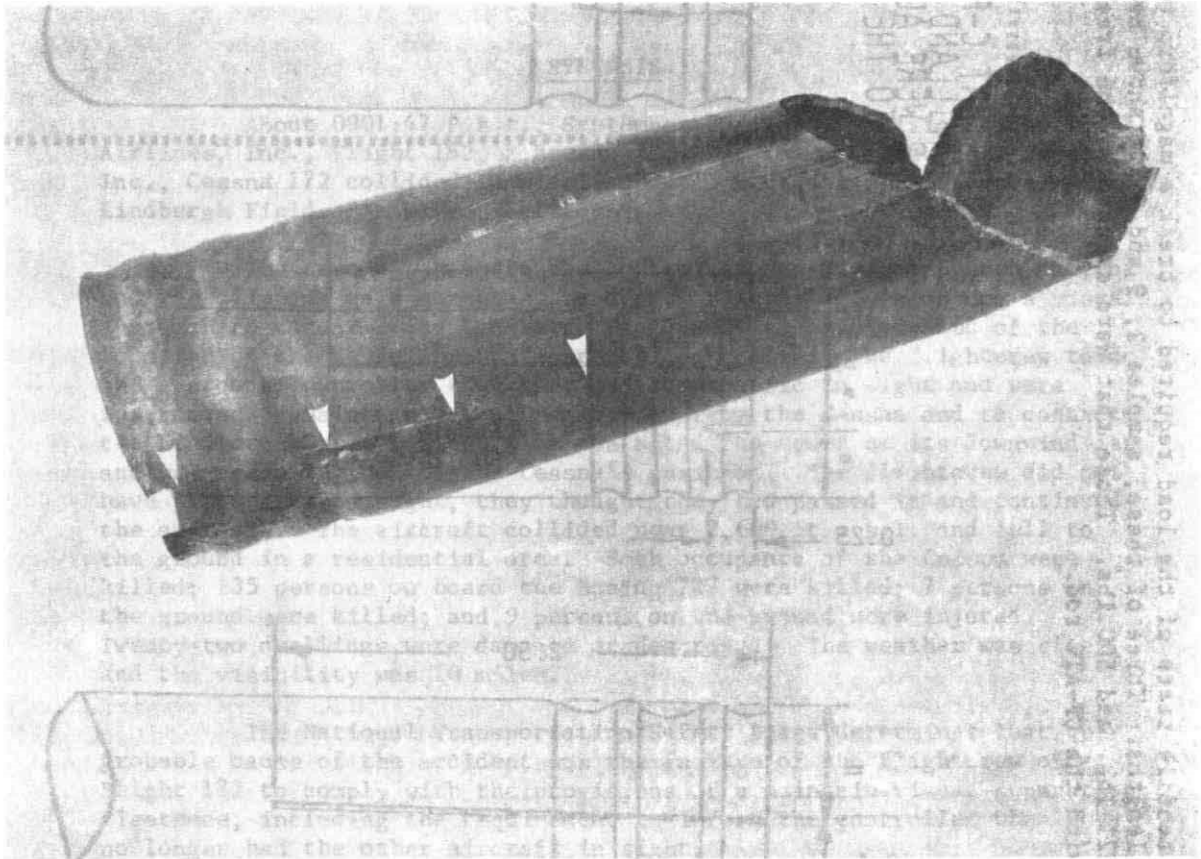
Figure 2

From these analyses, it was concluded that prior to impact, the flap control rod contained one major and other secondary stress corrosion cracks. The main fracture was 2-3/4 inches in length and extended longitudinally from the open end of the tube. This crack alone was shown to have reached a sufficiently advanced stage of growth to bring about separation of the tube from the end cap fitting at less than applied loads from the full flap setting in the approach configuration. In the case of the accident aircraft, the flaps were set at the full down position during the approach.

CLOSE-UP PHOTOGRAPH OF THE INBOARD TUBE END OF THE
BELL CRANK TO INBOARD ROD, FLAP ROD ASSEMBLY.
SHOWN BY ARROWS IS THE 2-3/4 INCH STRESS CORROSION
CRACK.

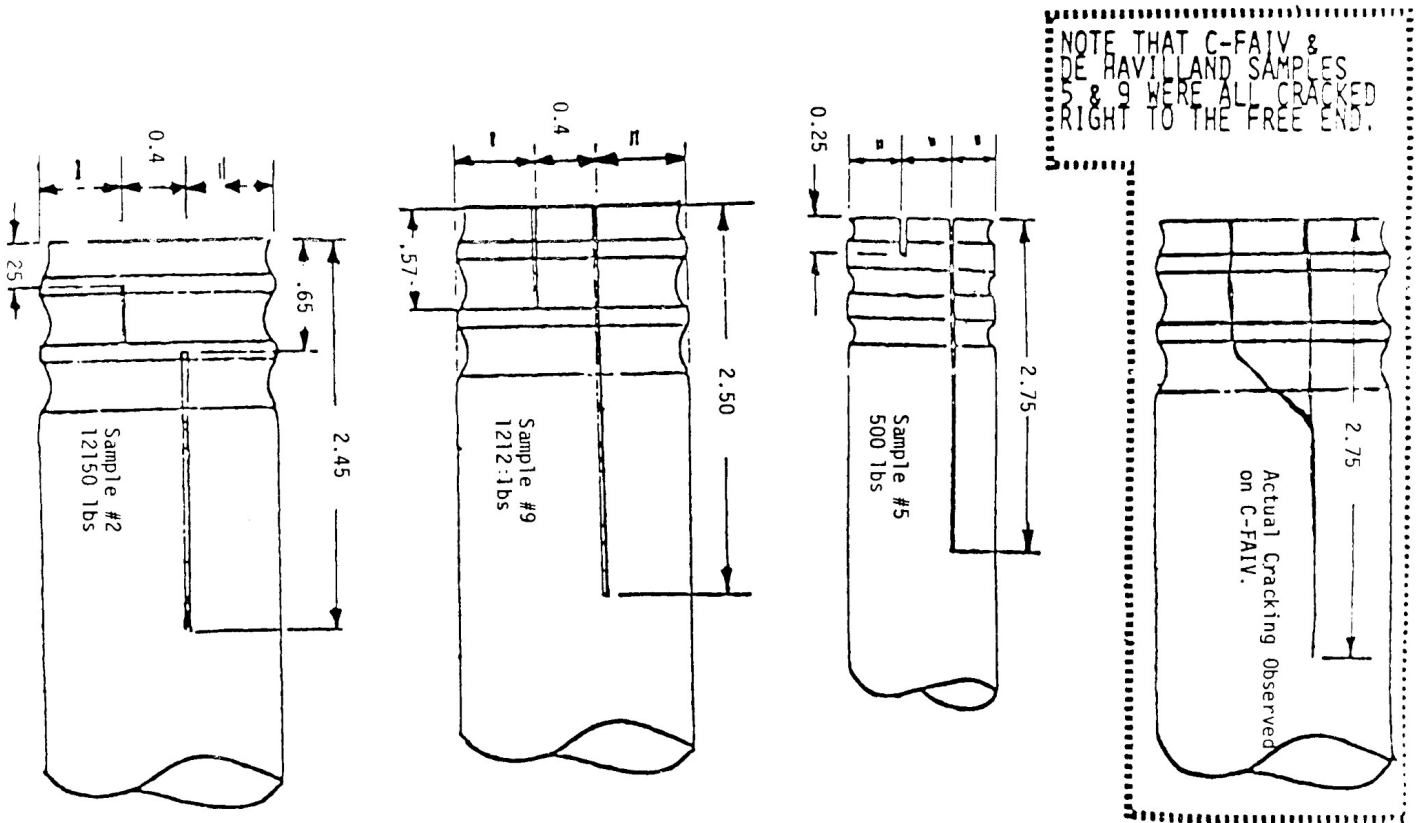
Figure 3

(See attached pictorial of Swaged-connection, Figure 3.)

DHC 6 Flap Rod - Magniform Connection - Tensile Tests

The manufacturer carried out a series of tensile tests of the load required to break a magniform connection with cracks artificially cut to specific lengths. Three of these, samples 2, 9 and 5 are shown below with tensile-strength values of 12150 lbs., 1221 lbs. and 500 lbs. Those that were cracked to the free end, failed at low values; such was the case with the CF-AIV rod.
