## **AIR TRANSPORTATION SAFETY INVESTIGATION REPORT A18P0031**

### **LOSS OF CONTROL AND COLLISION WITH TERRAIN**

Island Express Air Inc.  
Beechcraft King Air B100, C-GIAE  
Abbotsford Airport, British Columbia  
23 February 2018

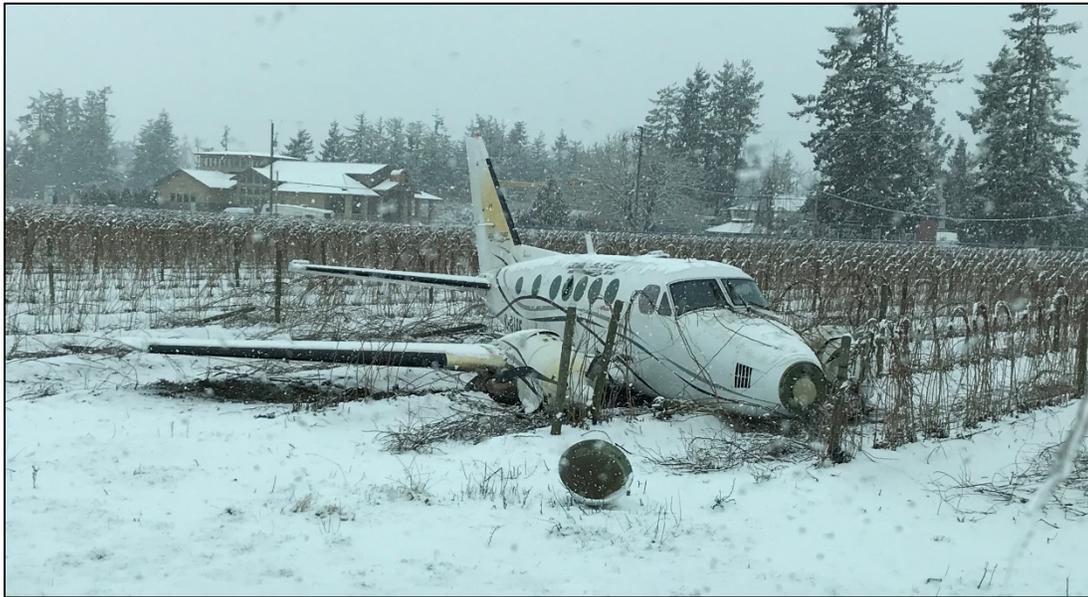
Figure 1. Occurrence aircraft where it came to rest (Source: Transport Canada)

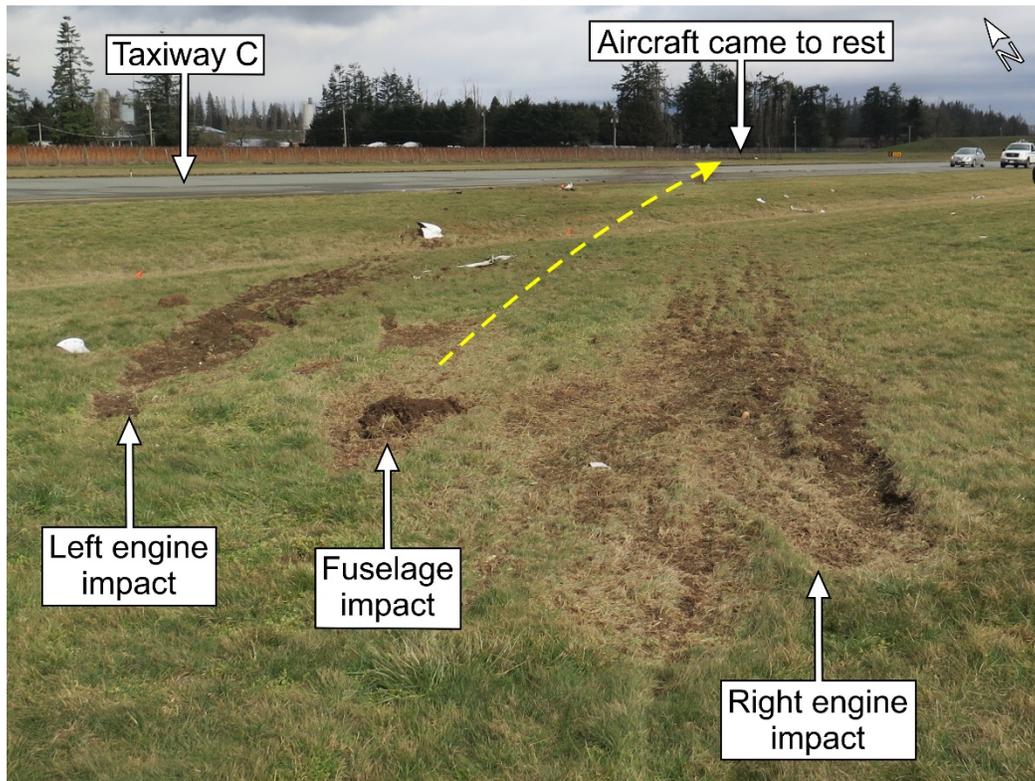
Examination of the initial point of collision on the terrain showed 3 distinguishable ground scars (Figure 2). The 2 long ground scars consistent with impact by the bottoms of the engine nacelles were on each side of a ground scar consistent with impact by the bottom of the fuselage. The maximum depth of this ground scar was estimated to be greater than 1 inch (2.5 cm). Crushing to the bottom of the fuselage and both engine nacelles, as well as the absence of signs of interaction between the right wingtip and the ground, indicated the aircraft had been nearly level in pitch and roll when it collided with the terrain. Signs of vertical shear on both sides of the fuselage were consistent with a large upward impact force transmitted from the wing spars when the bottoms of the engine nacelles struck the ground.

Performance calculations carried out at the TSB Engineering Laboratory determined that the vertical descent velocity of the aircraft at the time of the crash (at the beginning of the impact) was estimated to be at least 20 fps.

Figure 2. The aircraft's initial point of collision with terrain and the direction of travel (photograph taken 27 February 2018) (Source: TSB)

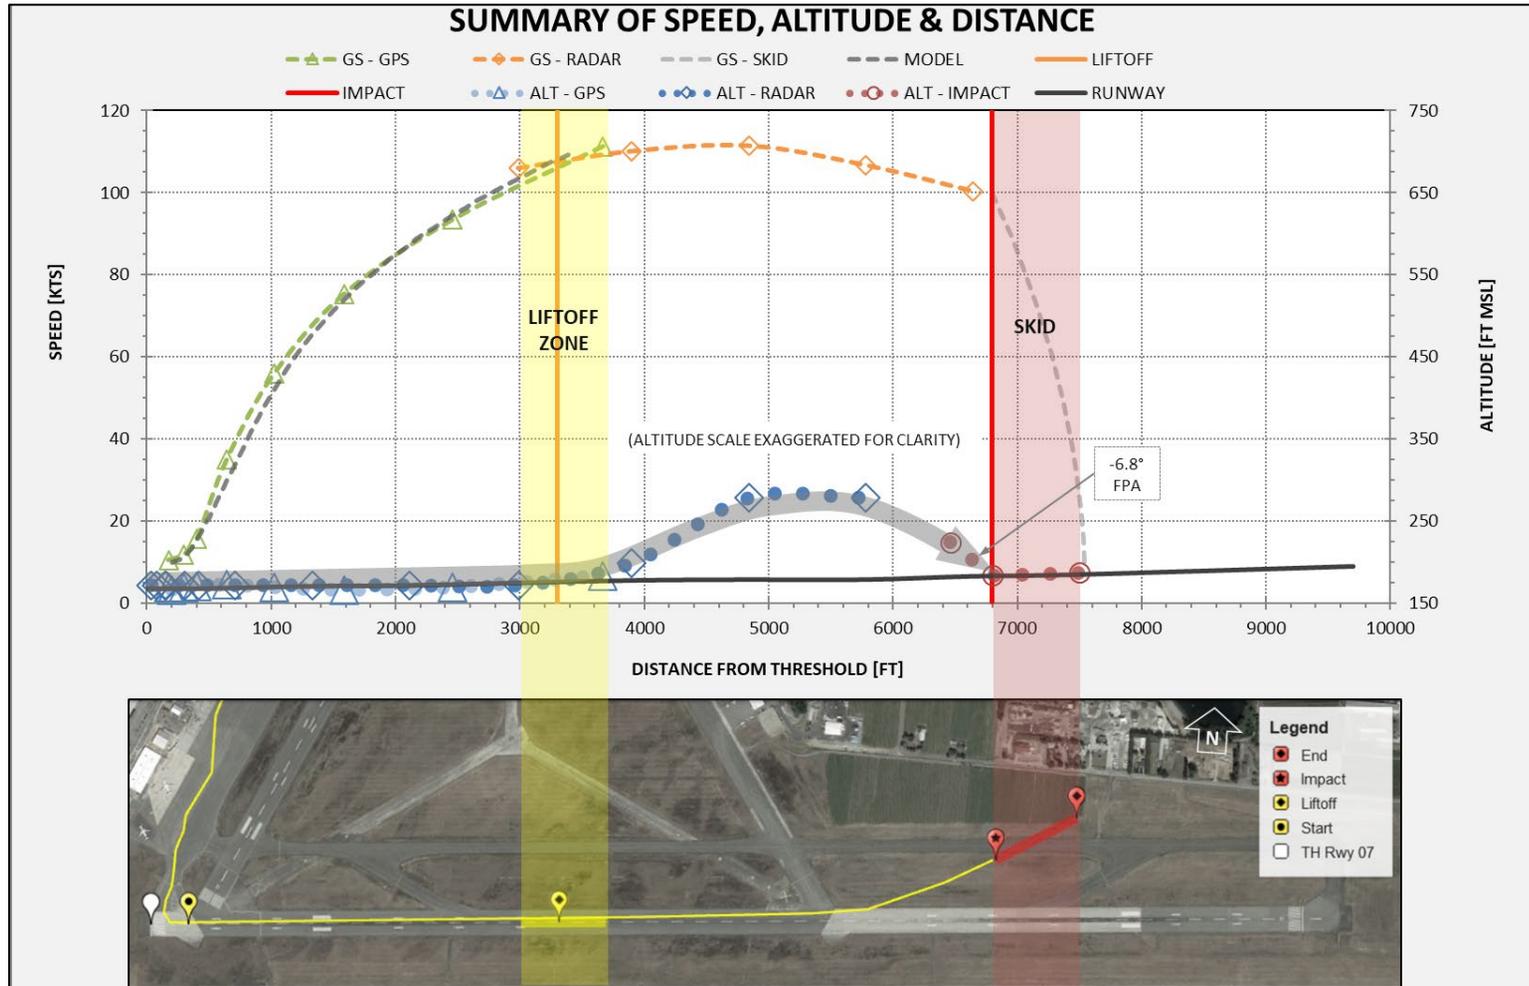
### Appendix C – Reconstruction of the path taken by the occurrence aircraft

Note: The "Model" line represents the predicted runway performance based on the aircraft flight manual, aircraft loading, and environmental considerations. (Source: TSB)

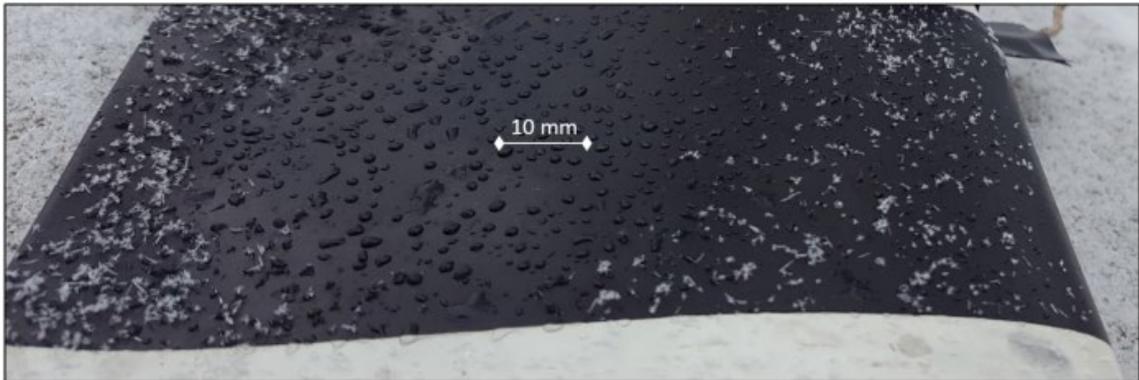
In the cooling tests, the first snowflakes that fell on the warm component melted into small water drops about 1 to 2 mm in size. As the surface quickly cooled, the melt rate decreased, and a mixture of water drops and partially melted flakes was observed (Appendix D, Figure D1). As the surface reached  $0^\circ\text{C}$ , ice crystals began to grow from the water drops (Appendix D, Figure D2). As snowfall continued, the falling flakes bonded with the partially melted and re-frozen precipitation layer, creating a very rough surface that protruded up to

Figure D1. Cooling test showing melted flakes and ice crystals

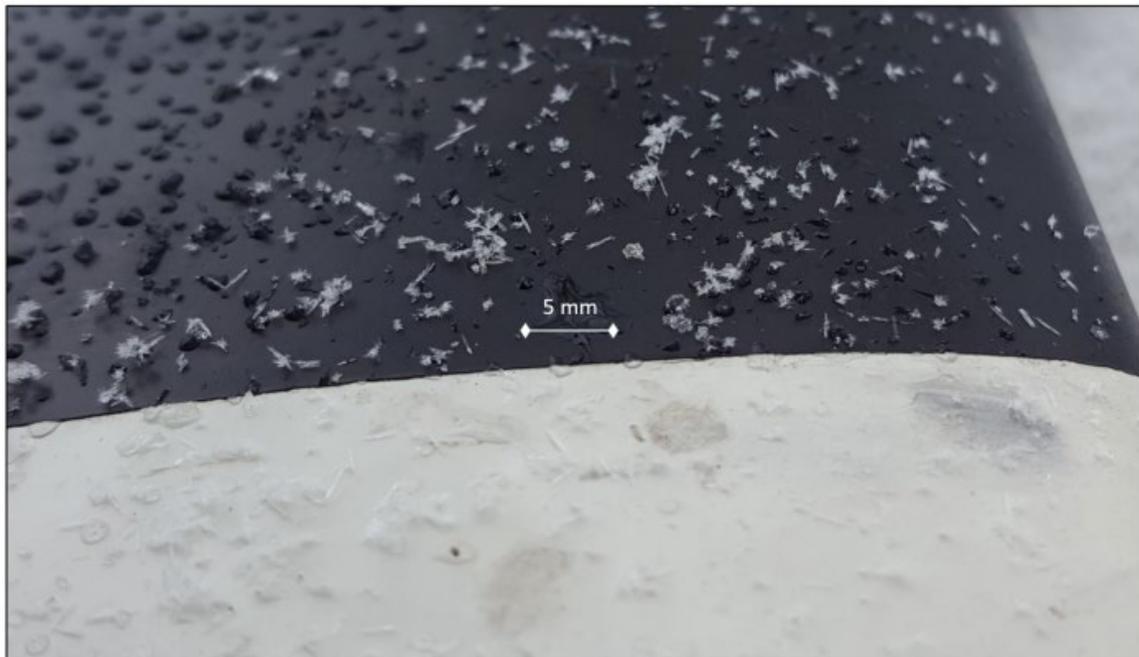
Figure D2. Cooling test (close-up)

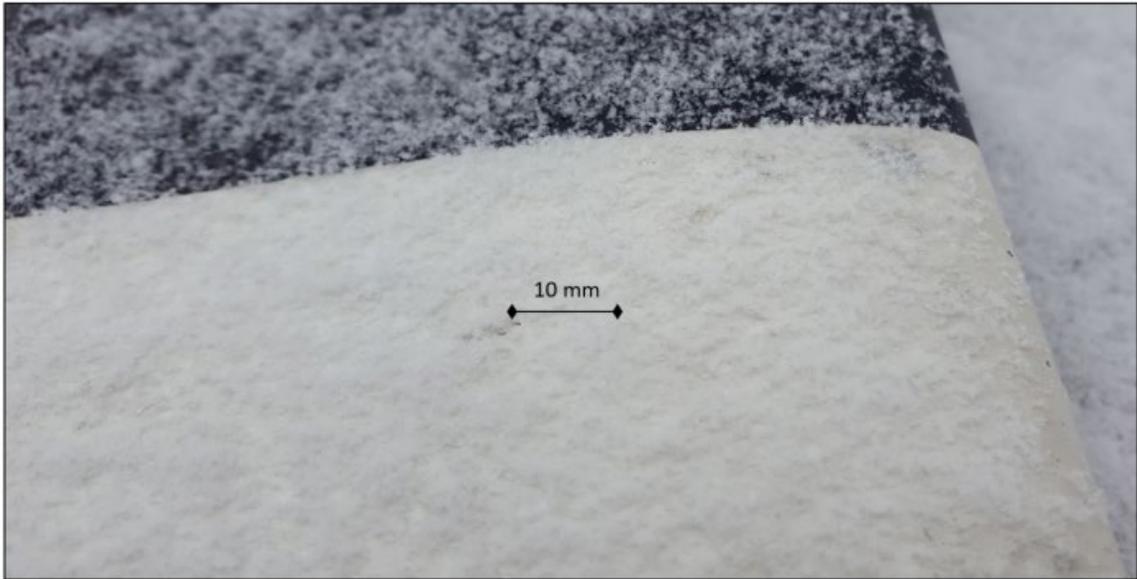
Figure D3. Cooling test after additional snowfall

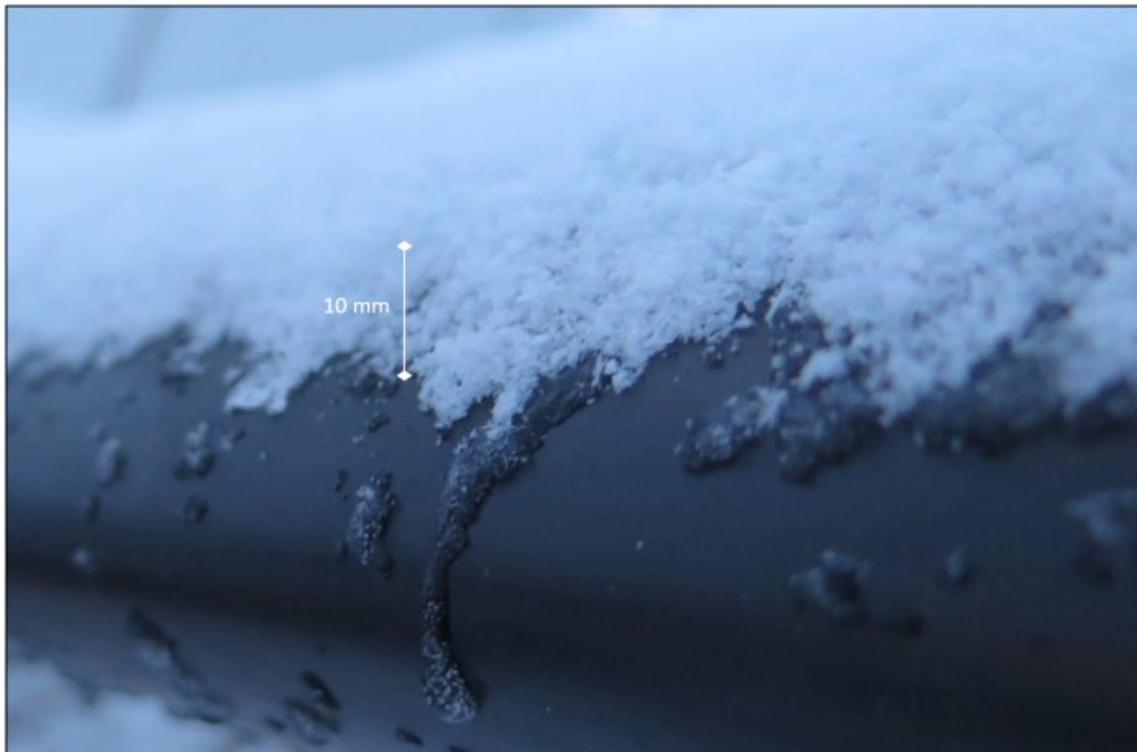
Figure D4. Occurrence wreckage demonstrating the melt/refreeze process approximately 8 hours after the occurrence
