Sint Maarten Civil Aviation Authority

Aircraft Accident Report

SkyWay Enterprises Inc., Flight 7101, Shorts SD3-60, N380MQ

Loss of Control – In flight, crash into the sea (LOC-I) near

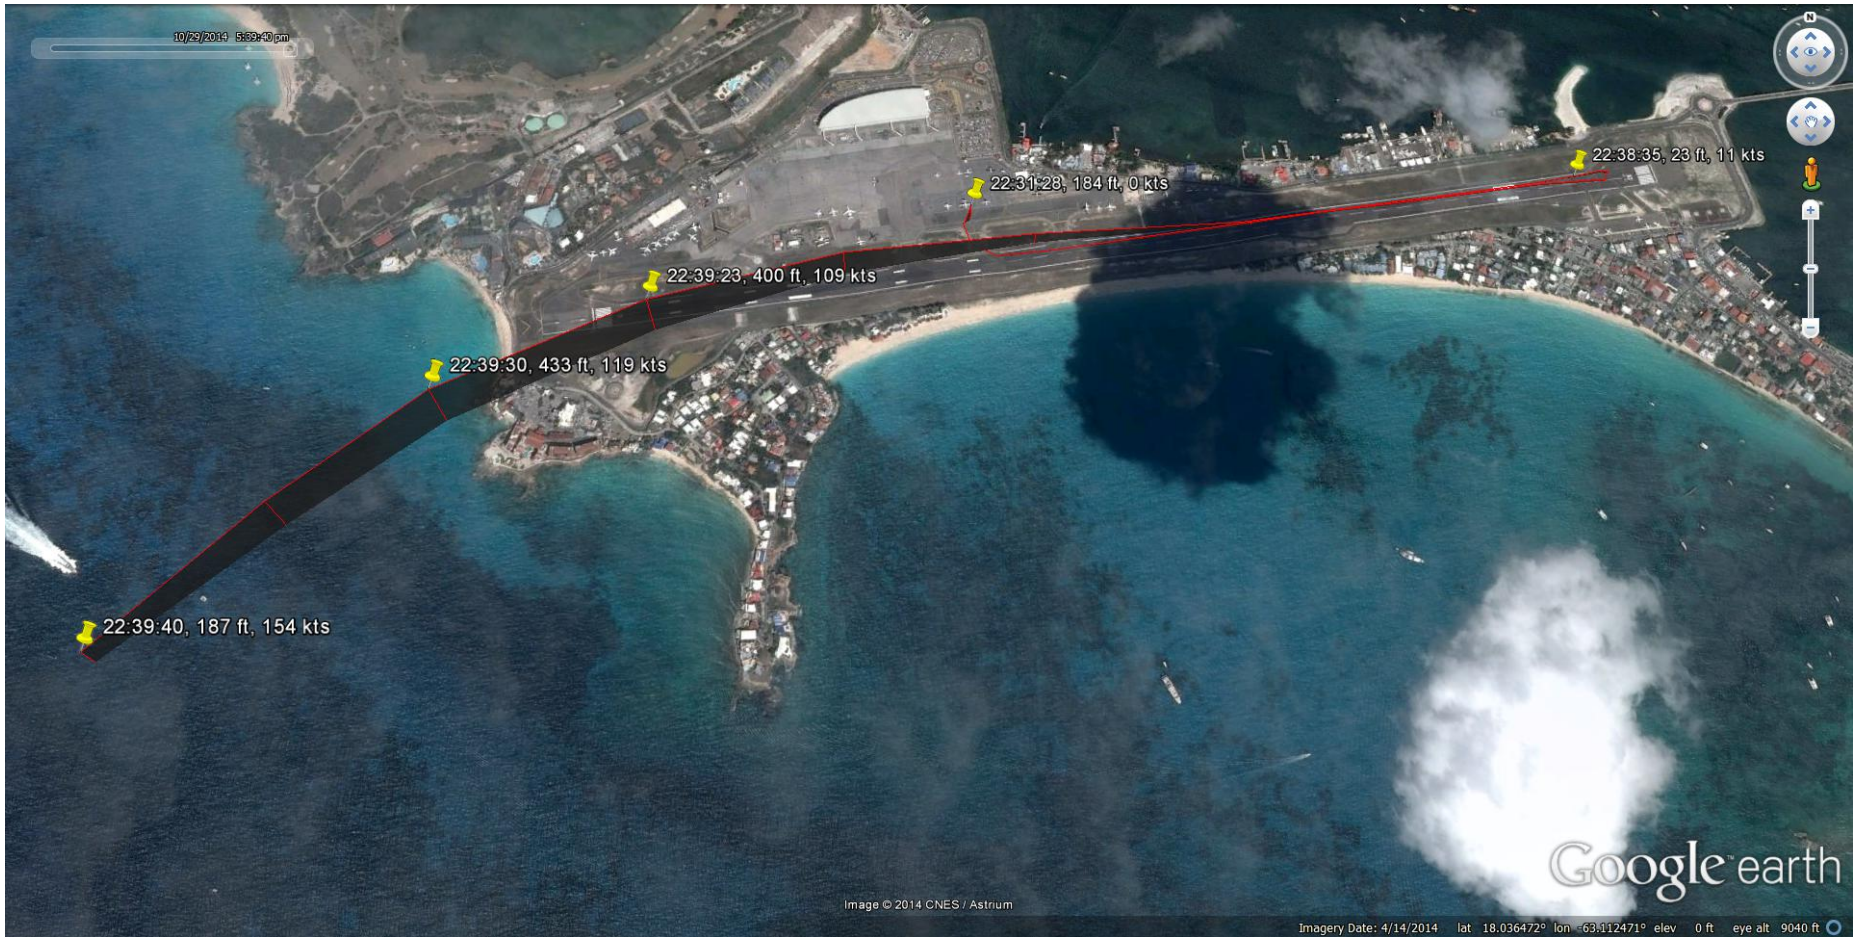
Figure 9. Google Earth overlay of entire recording.

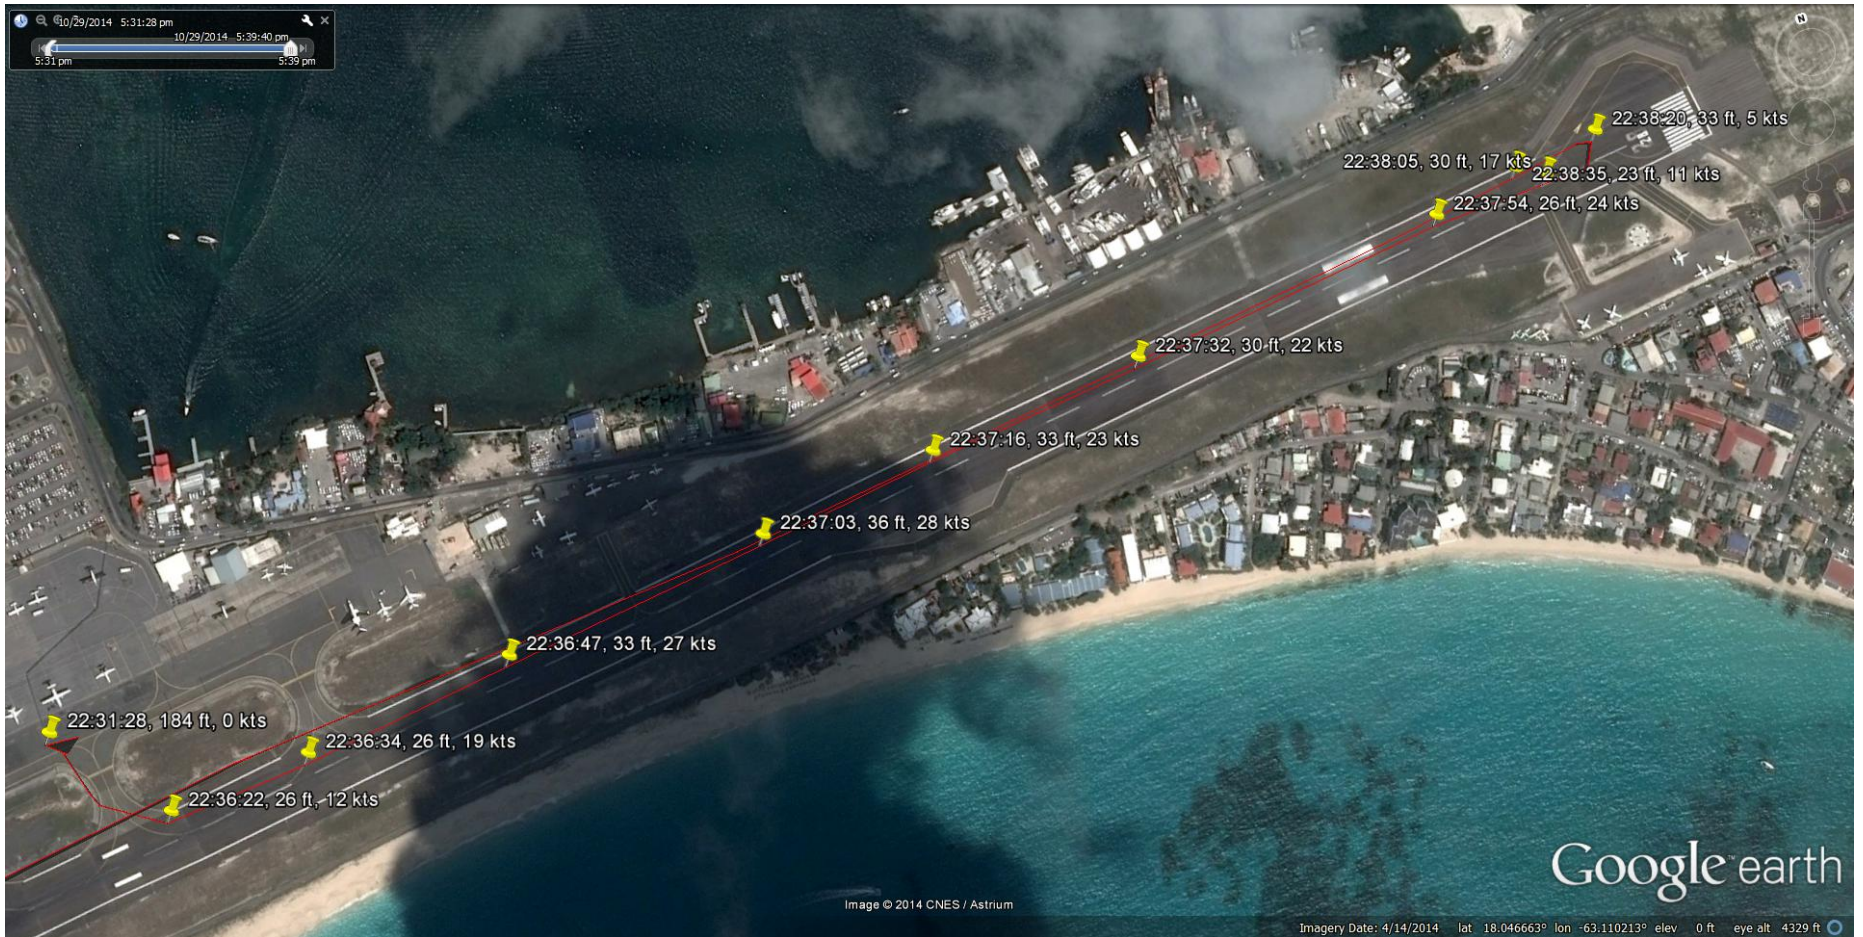
Figure 10. Google Earth overlay of ground operations.

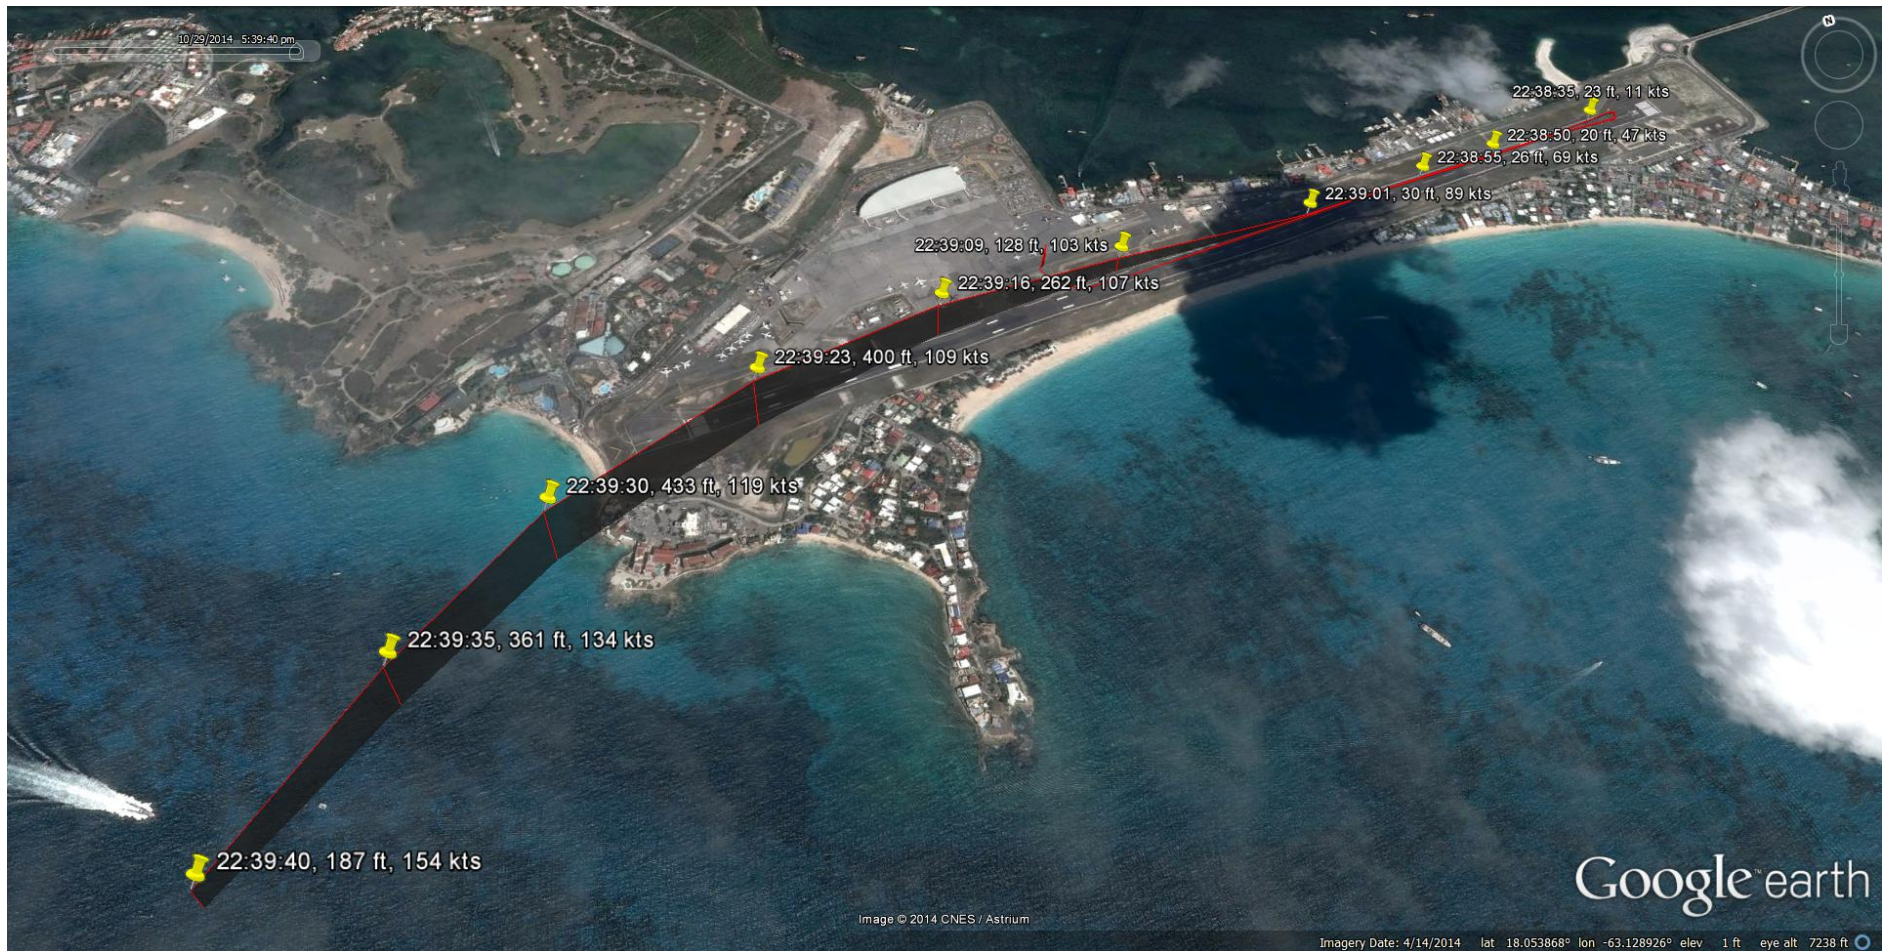
Figure 11. Google Earth overlay of takeoff run until end of recording.
