Runway Excursion During Landing
Delta Air Lines Flight 1086
Boeing MD-88, N909DL
New York, New York
March 5, 2015

NTSB/AAR-16/02
PB2016-104166

Aircraft Accident Report

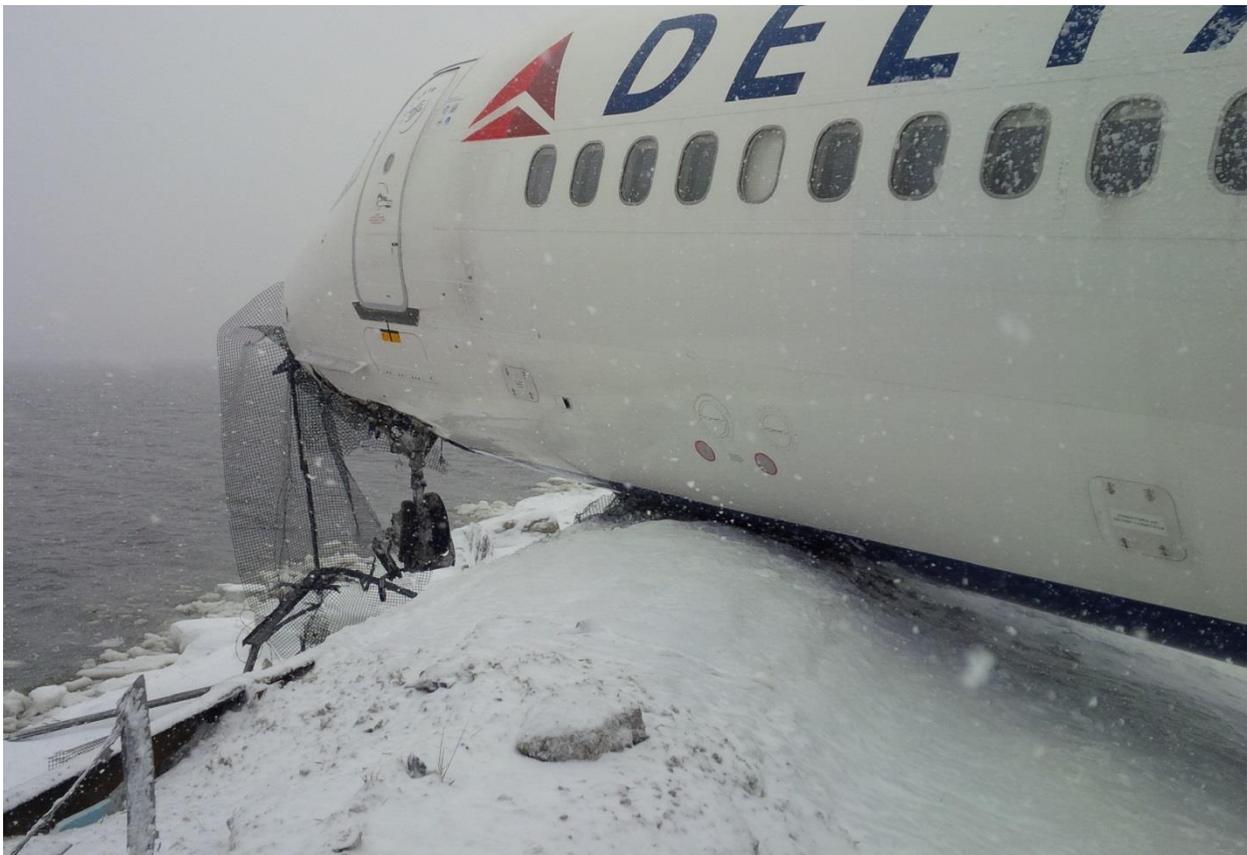
Note: Several pieces of the perimeter fence and support posts are shown.
