# Investigation Report

Type of Occurrence:	Accident
Date:	12 January 2014
Location:	Near Trier-Fohren
Aircraft:	Airplane
Manufacturer / Model:	Cessna / Cessna 501 Citation I/SP
Injuries to Persons:	Two pilots and two passengers fatally injured
Damage:	Aircraft destroyed
Other Damage:	Open wire, forest and crop damages
State File Number:	BFU CX001-14

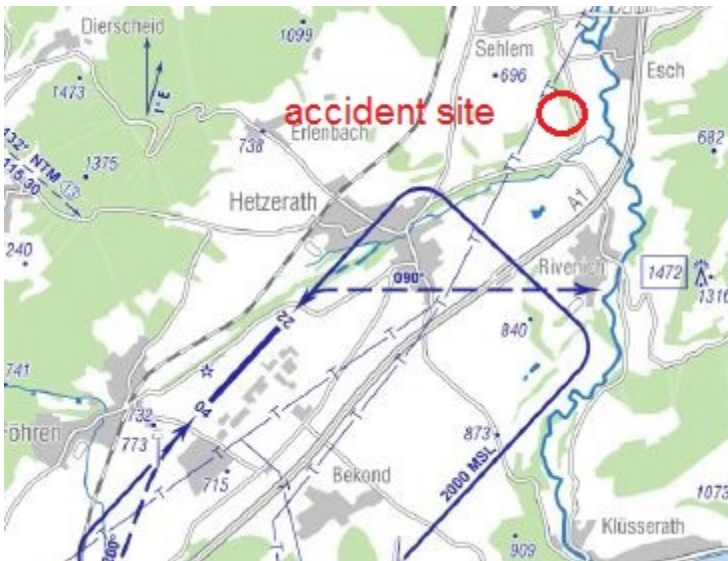
Accident site

The accident site was located approximately 2.3 NM prior to the threshold of runway 22 of Trier-Fohren Airfield; about 0.3 NM south-east of the extended runway centre line in 666 ft AMSL.

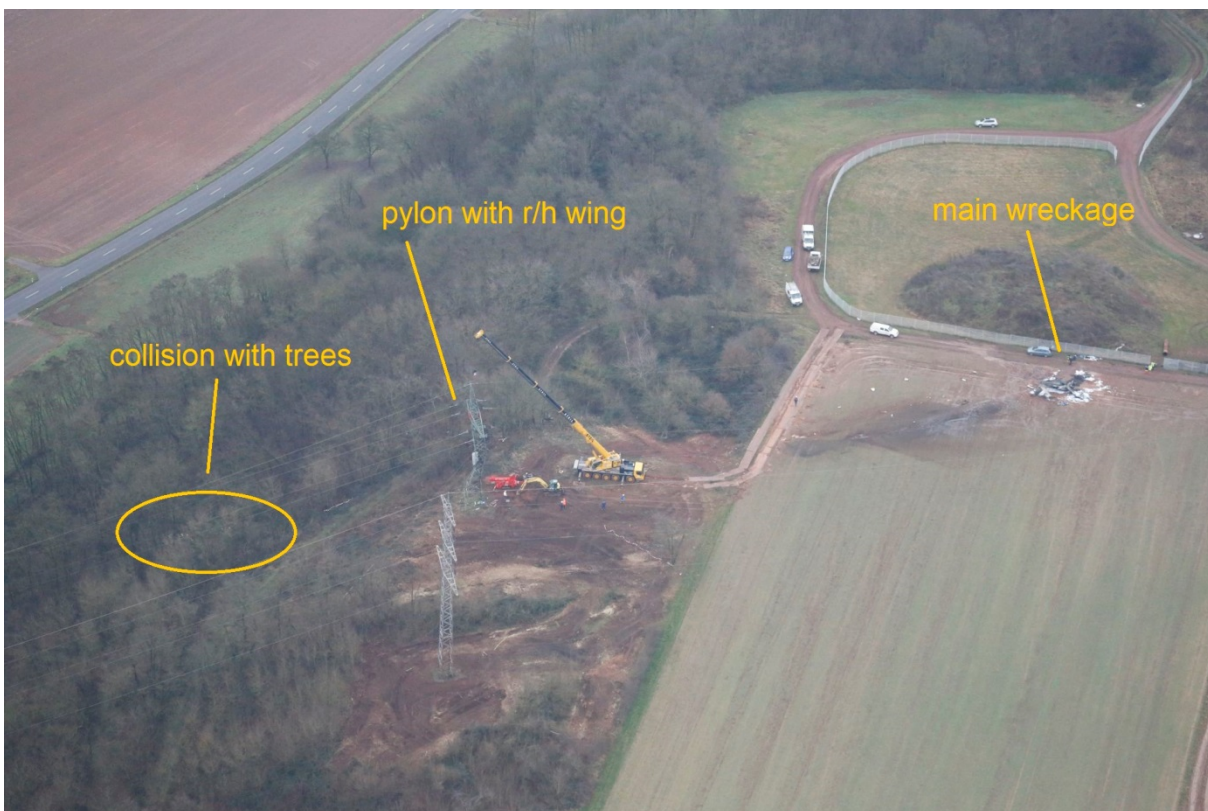
Accident site viewing direction south-east

Approximately 10 m below the plateau of a forested steep slope the aircraft had contact with trees. The traces in the trees show, that the airplane had had a left bank angle of about 25°.

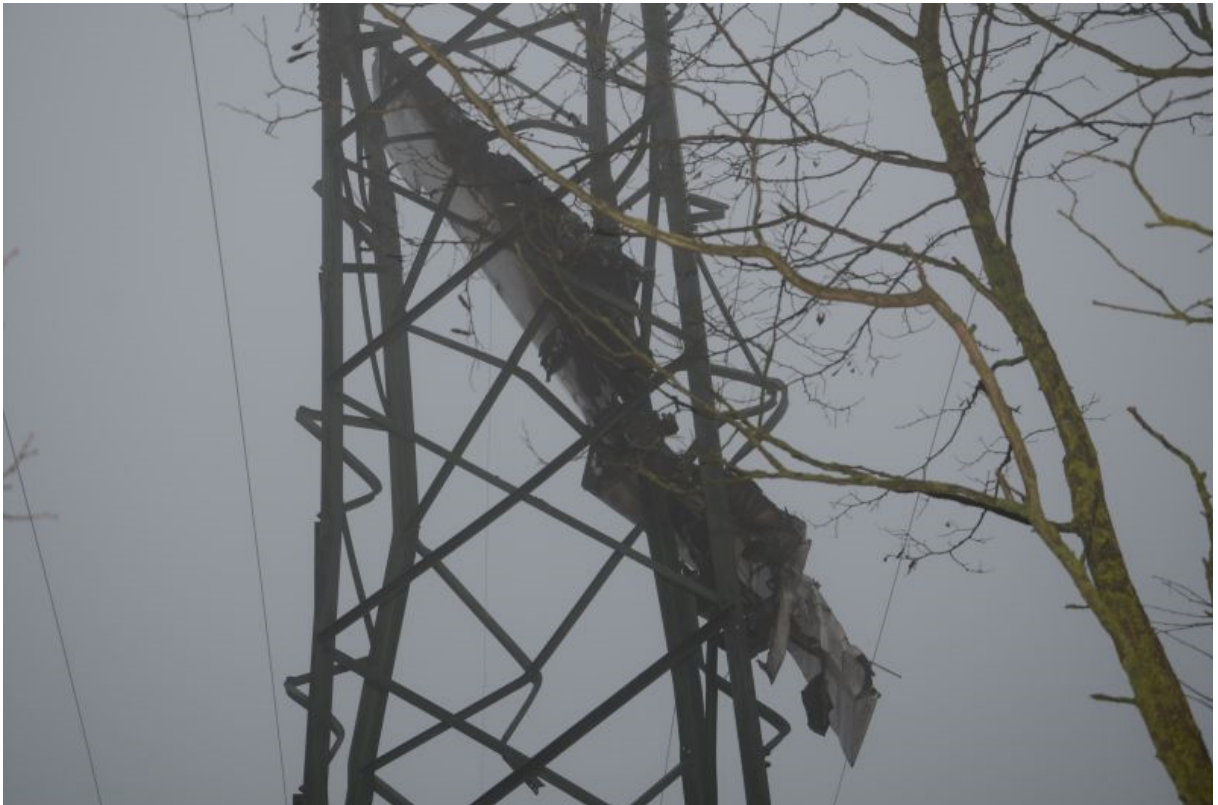
Wing, view toward the approach direction

The angle the right wing had had when penetrating the pylon indicated a left bank angle of about 60°. The right wing showed traces of fire. The flap was extended. At the foot of the pylon the right main landing gear, one speed brake, and the right elevator were found.

Between the initial contact with the trees below the plateau and the collision with the pylon the trajectory angle was about 20° upwards.

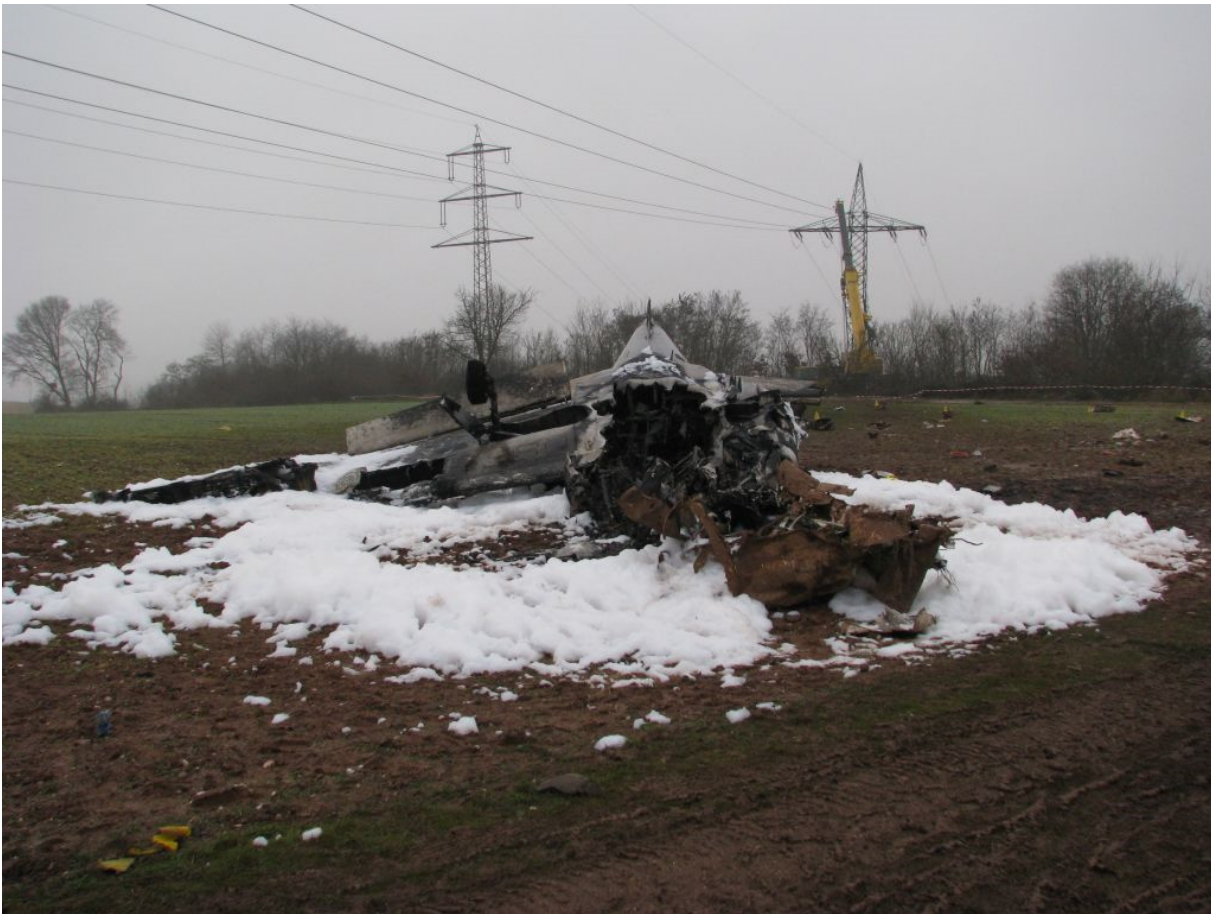
Main wreckage viewed toward the approach direction

The wreckage was lying on its back about 106 m from the pylon. The airplane fuselage pointed in the direction of 187°.

On the left wing the main landing gear was extended and locked; the flap was fully extended

During the collision with the power pole the airplane caught fire and then crashed upside-down. The damage on the main wreckage shows that the intensity of the fire was highest between the front part of the fuselage and the wings fitted with fuel tanks.

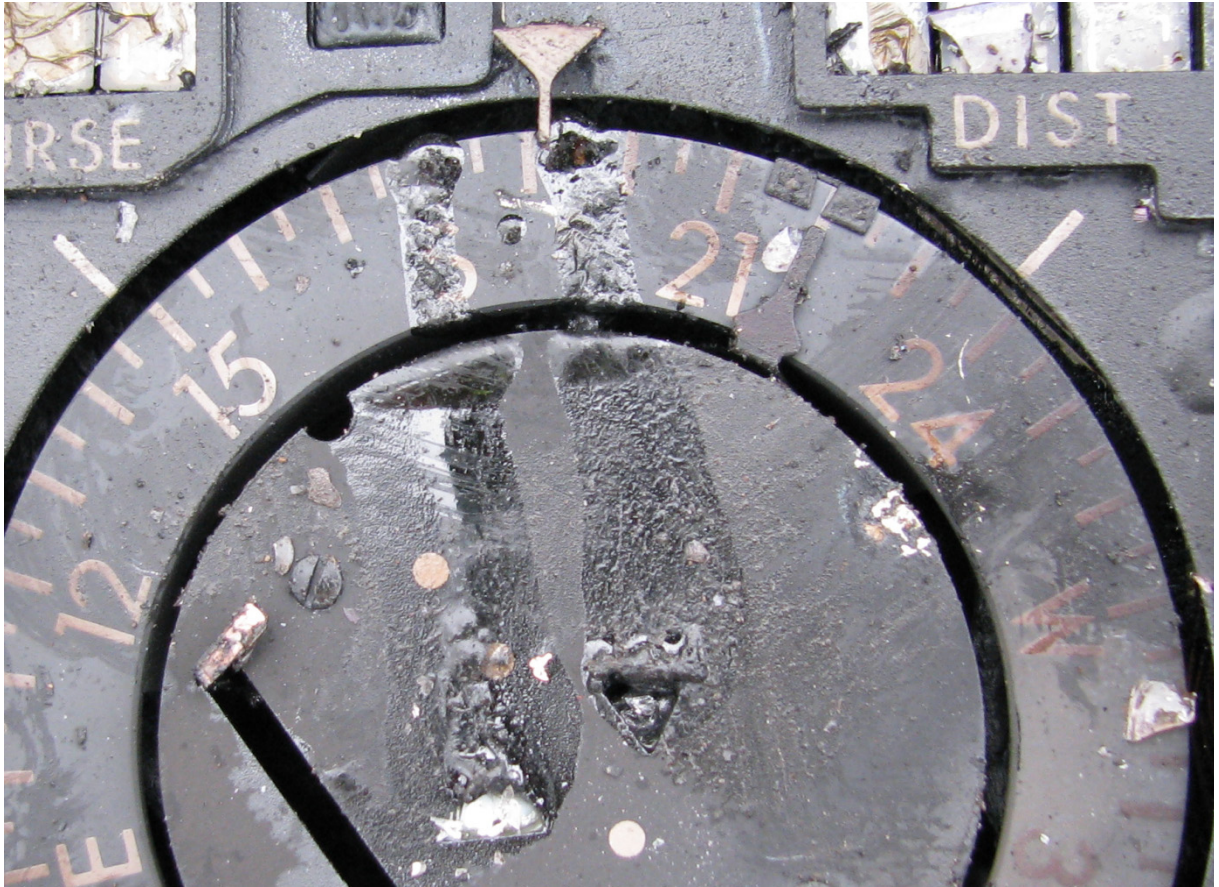
Horizontal Situation Indicator (HSI)

In the cockpit the landing gear lever was in position Down and the switches for the landing lights in On.
