AIRCRAFT ACCIDENT REPORT

TRANSAMERICA AIRLINES, INC.,
LOCKHEED L-188, N859U
SALT LAKE CITY, UTAH
NOVEMBER 18, 1979

NTSB-AAR-80-11
c.3

Adopted: August 26, 1980

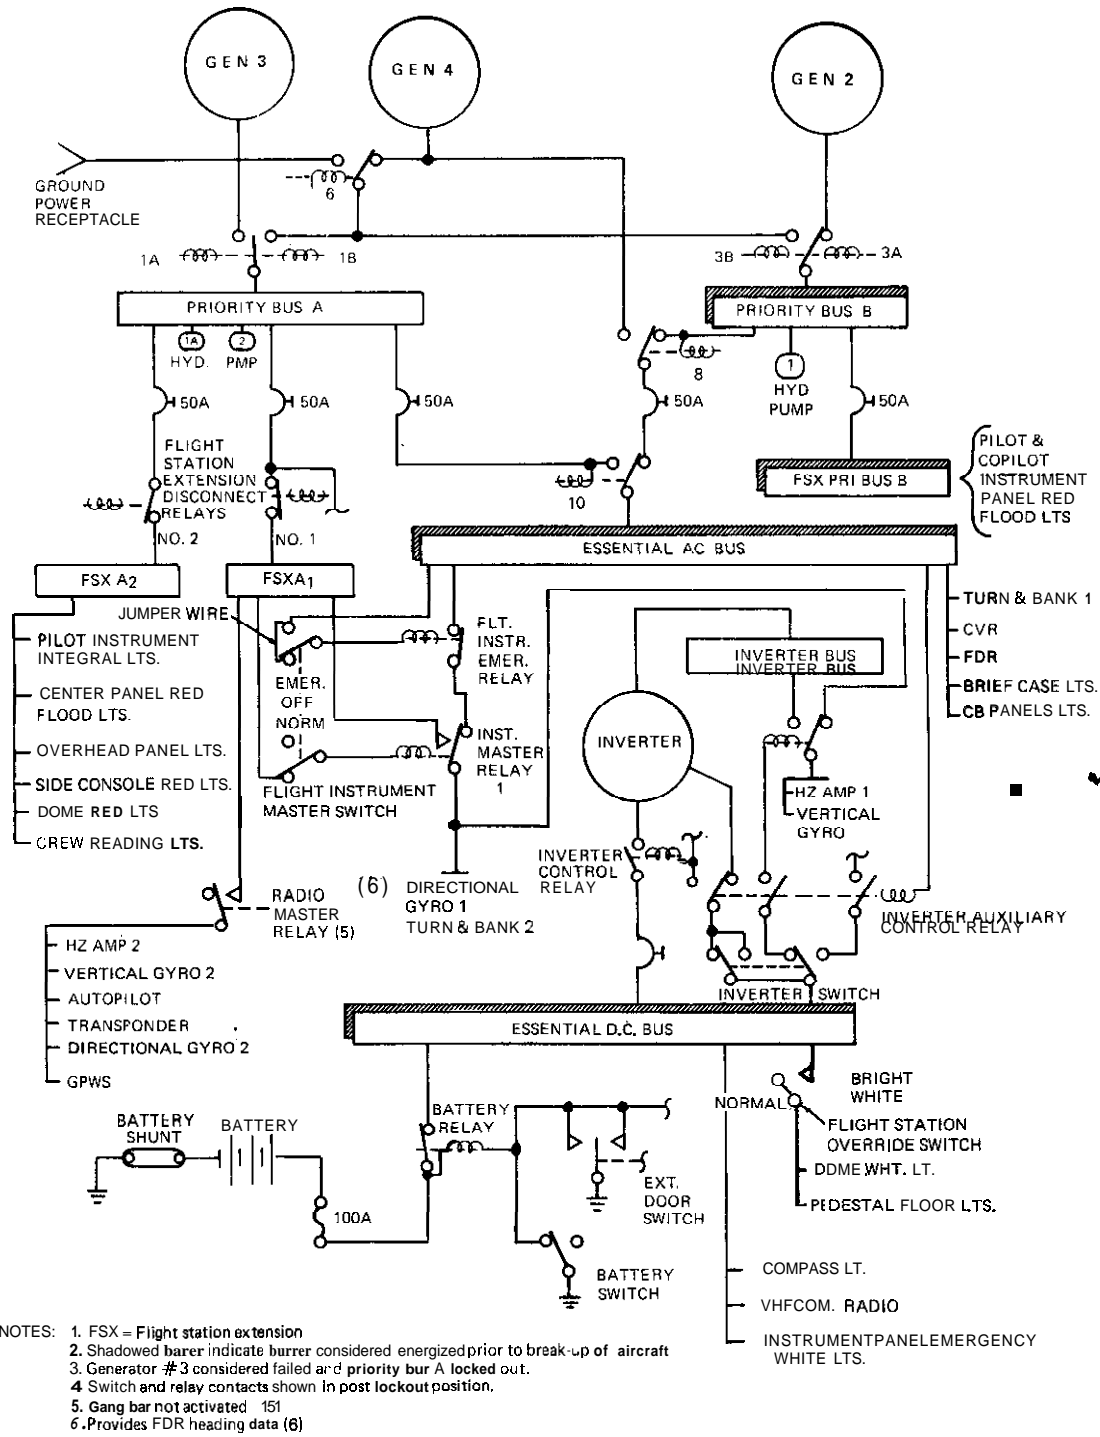
Figure 1. — Schematic of Electrical System, L-188, N859U

The design of the L-188's automatic transfer system provides for, in the event of a failure of the **No. 3** generator, that priority bus A be automatically powered by the **No. 4** generator. However, if priority bus A is locked out by the under voltage protection circuitry within the **No. 3** generator's control unit, the bus is completely inoperative and the essential a.c. bus is transferred to priority bus B which is powered by generator **No. 2**. Consequently, since the aircraft's transponder and integral instrument lights and the copilot's gyrosyn compass indicator remained inoperative, the Safety Board concludes that priority bus A was locked out by a system malfunction.

Tests showed that a disconnected ground wire on the **No. 2** generator such as was found on the accident aircraft had no effect on the operation of either priority bus A or priority bus B, or on the transfer of the essential a.c. bus to bus B when bus A was failed. Additionally, there was no evidence of malfunction or distress in the **Nos. 3** and **4** generators. Further, since a malfunction in either of these generators should have produced a trip light which would have been plainly visible to the crew, and since there was no mention on the CVR of a trip light, the malfunction apparently involved a fault on the priority A bus which prevented either the **No. 3** or **No. 4** generator from providing power to the bus. Accordingly, all equipment powered by the bus would have been inoperative. Because of the postaccident condition of the control components of the electrical system, the reason or reasons for the fault on the priority A bus could not be determined.
