No. 5

Lockheed L-1011 Tristar, HZ-AHK, accident at Riyadh,  
Saudi Arabia, on 19 August 1980.  
Report dated 16 January 1982,  
released by the Presidency of Civil Aviation, Saudi Arabia.

SYNOPSIS

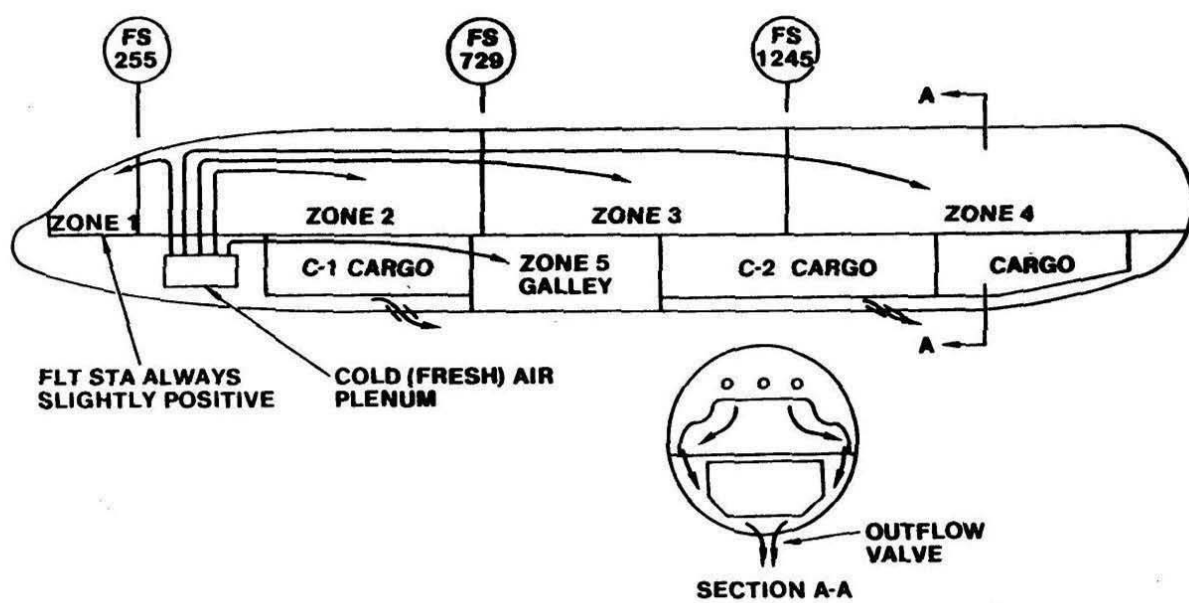
Figure 5. Ventilation schematic

The L-1011 has three pressurized cargo compartments. The forward compartment (C-1) extends from the rear of the ECS bay and nose wheel well to the galley. The mid compartment (C-2) extends from the main gear wells and hydro bay to FS 1625. The aft compartment (C-3) abuts the mid and extends aft to FS 1792 (Figure No. 5).

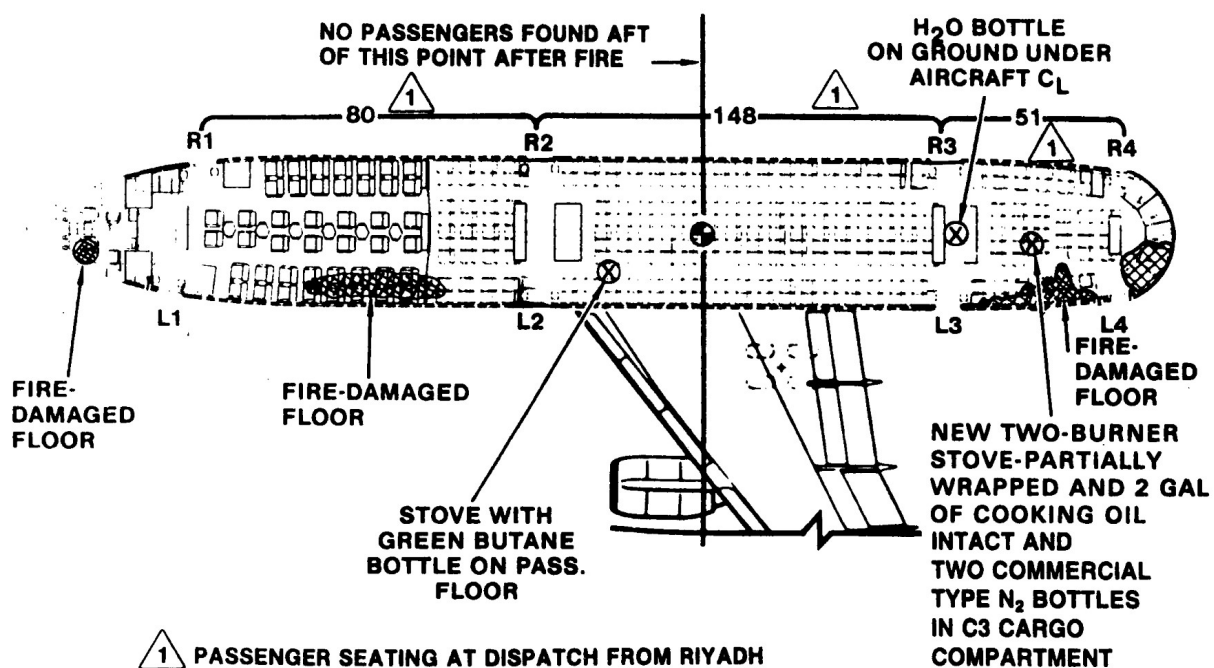
Figure 10. Passenger placement, fuselage fire damage (floor) and significant articles

Three of the CO<sub>2</sub> bottles were found under the first left-hand seat aft of L-3 door. One of the three bottles was a larger size and was identified as the one from the flight deck. The safety wire on that bottle was broken and the bottle discharged. The safety wire on one of the remaining two CO<sub>2</sub> bottles was also broken and the bottle discharged. The third bottle had a little pressure left in it and the safety wire was still intact, however, the wire was loose enough that the bottle could have been discharged without breaking the wire. The fourth CO<sub>2</sub> bottle was found on the first seat aft of the L-3 aisle seat. The extinguisher was under debris from the ceiling. The safety wire was broken and bottle discharged. The fifth bottle was found in the hole in the floor just forward of L-4. The bottle showed extreme heating. The safety wire was intact and the bottle was empty. The sixth CO<sub>2</sub> bottle was found just forward of R-3. The safety wire was broken; however, the bottle was only partly discharged.

The dry chemical extinguisher from the galley was located under the first seat aft of L-3, centre side of the left side aisle. The discharge nozzle was burnt completely off and the bottle was completely empty.

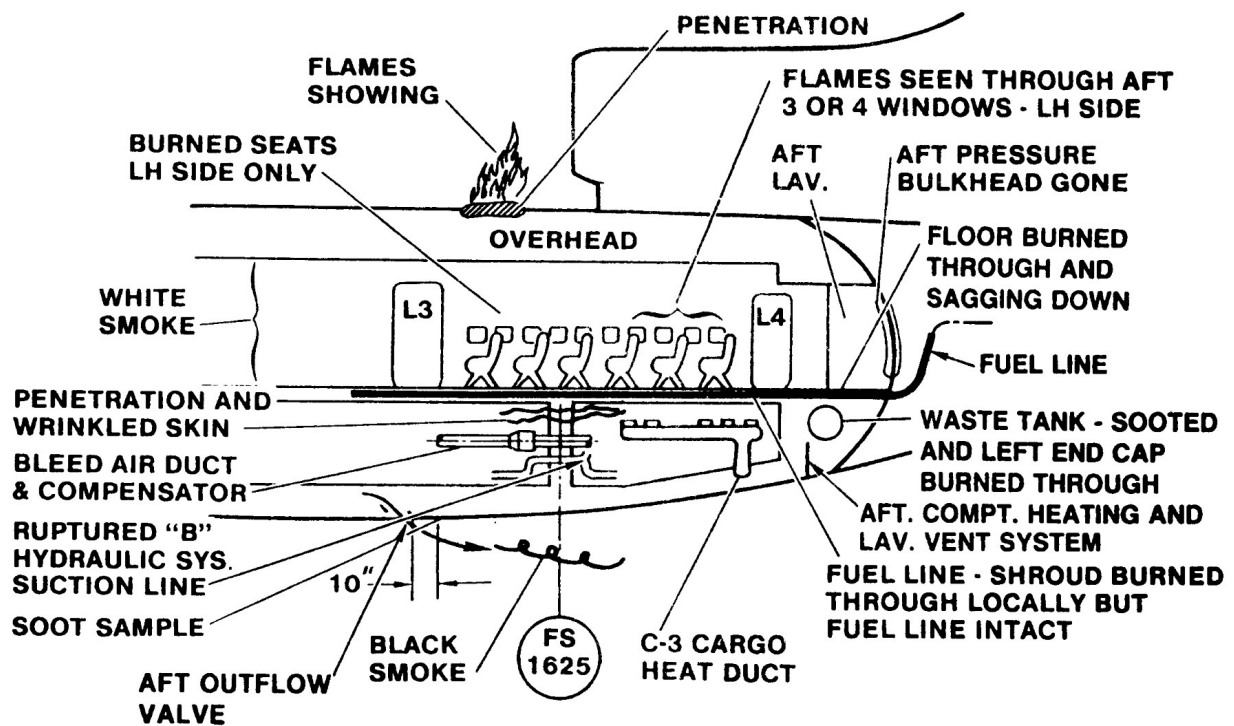
Figure 12. Aft fuselage conditions witnessed on ground

Those personnel who were in a position to observe the rear portion of the aircraft after it came to a stop noted a puff of heavy white smoke coming from beneath the aircraft aft of the wings. Most of them said that in less than a minute after their trucks were positioned, they observed smoke rising from the top of the fuselage just forward of the No. 2 engine intake. This smoke was followed almost immediately by flames (see Figure 12). All fire personnel reported that when this smoke and flame was sighted at the top of the fuselage, their monitors (turret discharge nozzle assemblies) were put into action and their agent was applied at a high rate. Those near the fire applied their agent against the fire. Those that were at the front half of the aircraft applied their agent along the fuselage from the cockpit back as far as their monitor pressure would reach. They stated that their purpose was to cool the fuselage. There were two exceptions:
