# NATIONAL TRANSPORTATION SAFETY BOARD

## AIRCRAFT ACCIDENT REPORT

KELLOGG COMPANY  
AVIONS MARCEL DASSAULT BREGUET  
FALCON 10, N253K  
MEIGS FIELD  
CHICAGO, ILLINOIS  
JANUARY 30, 1980

NTSB - AAR - 81 - 6

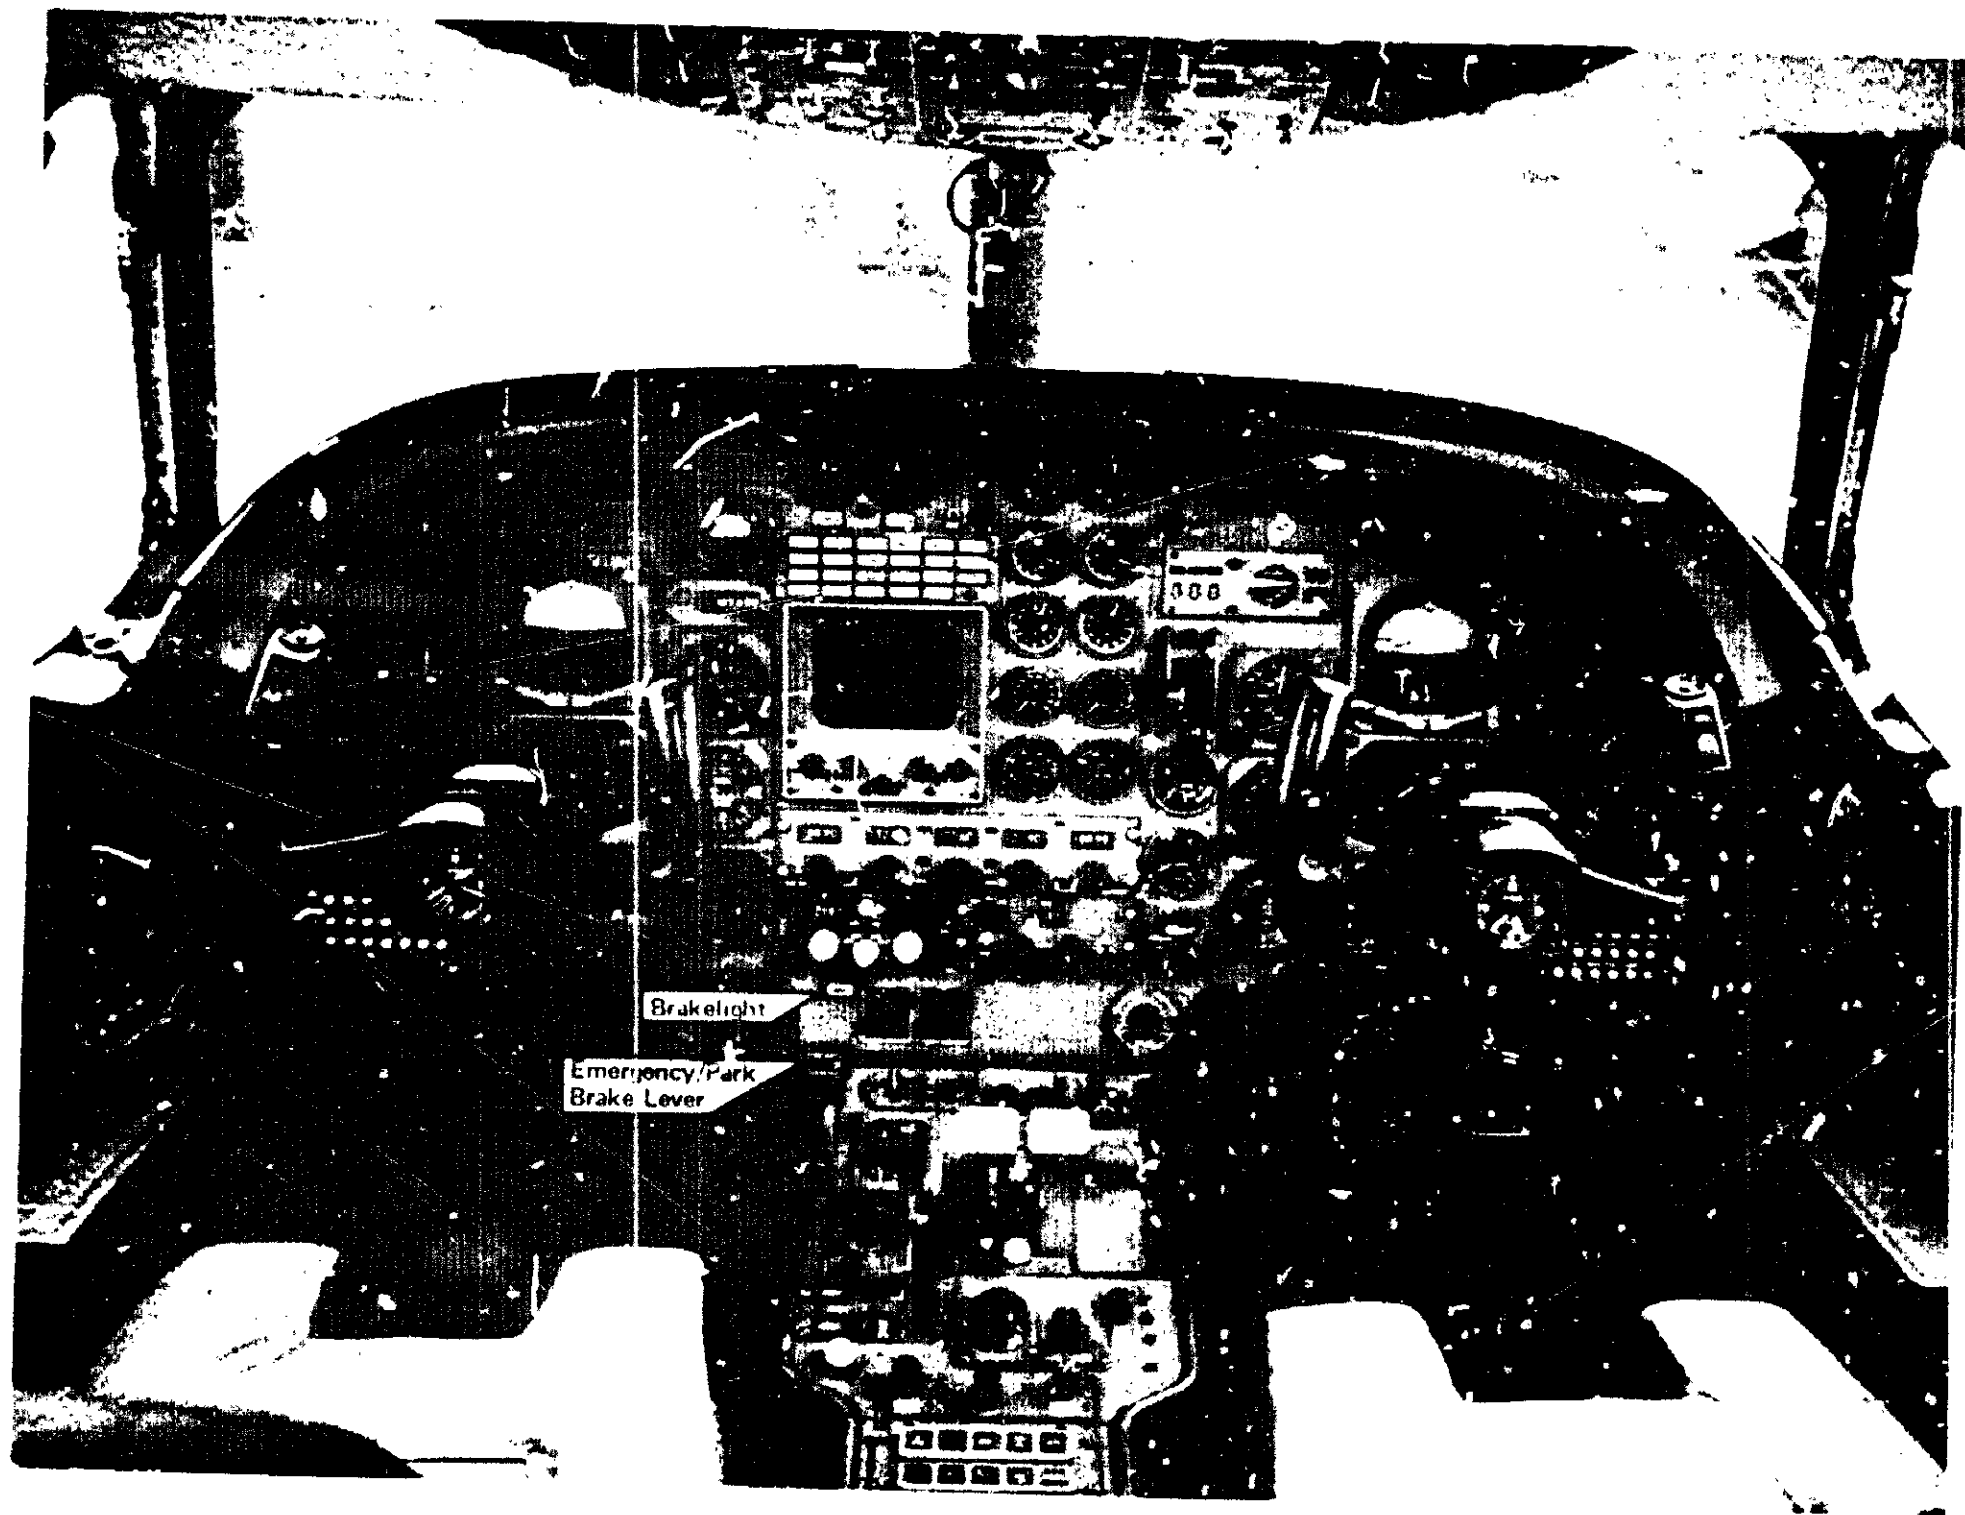
The Falcon 10 aircraft is equipped with an emergency/parking brake system, which operates from pressure supplied from the No. 2 hydraulic system directly to the wheel brakes through a proportional selector valve that is mounted in the lower left side of the nose section. Pressure to the emergency/park brake system is controlled by a lever which is located at the upper left corner of the center control pedestal, the lever is adjacent to the pilot's right knee. (See figure 1.)

Figure 1.-- Cockpit controls in Falcon 10 aircraft.

The emergency/park brake handle was found aft of the intermediate (parking) position and the top of the handle was bent to the left.
